Hawaii Department of Health

Clean Water Branch

Complaint - ALT Inspection

Facility Information	
Facility Name: Big Island Dairy (1)	Permit Number: HIU010287
Location: P.O. Box 49 Ookala, Hawaii 96774	Watershed: None
Tax Map Key(s):	
Receiving Water: Photograph#4	
Facility Representative(s): Brad Duff (General Manager)

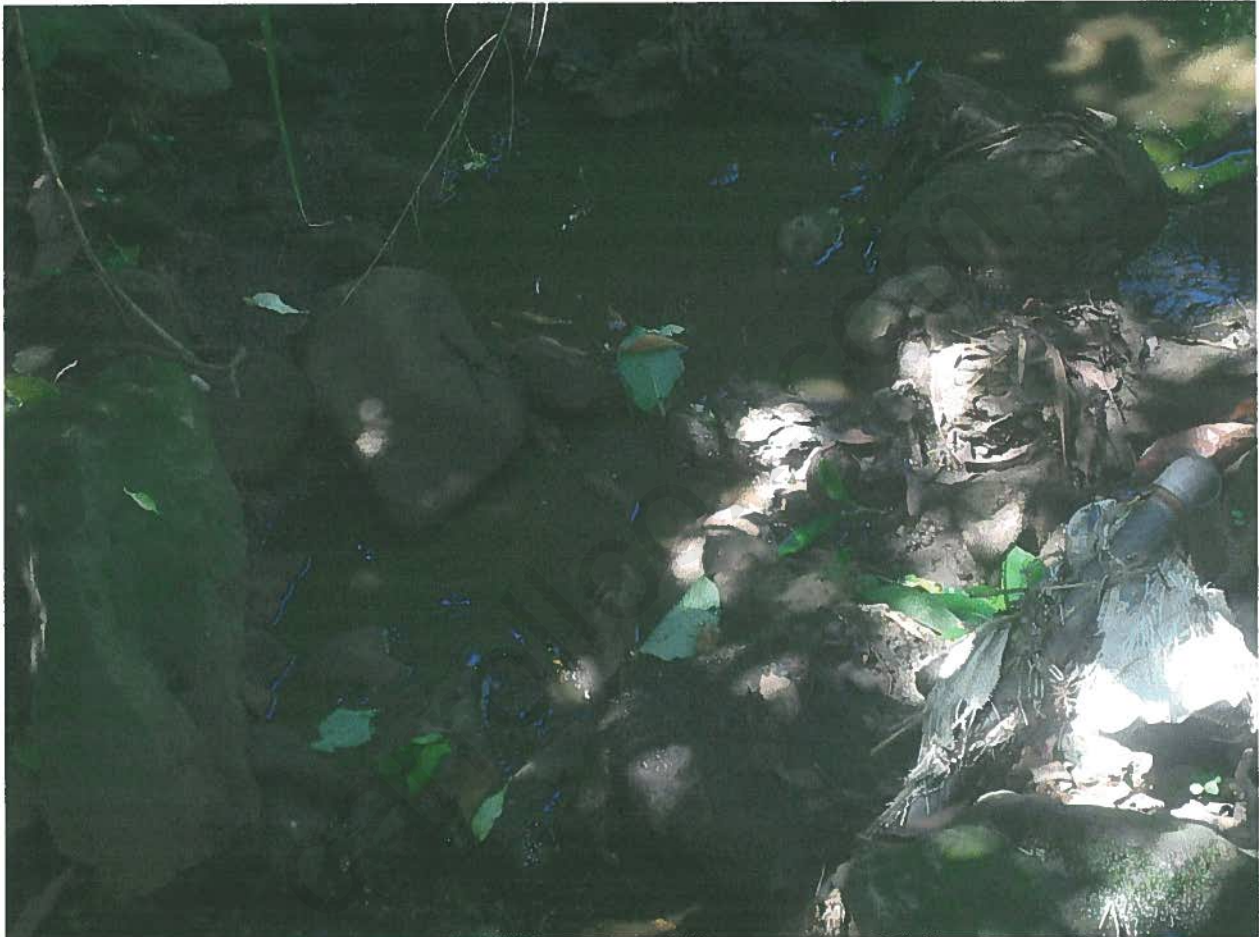
Photograph#1-This is a photo of the brown turbid smelly water flowing in the stream in the Ookala town and residential area where the complaint originated from.

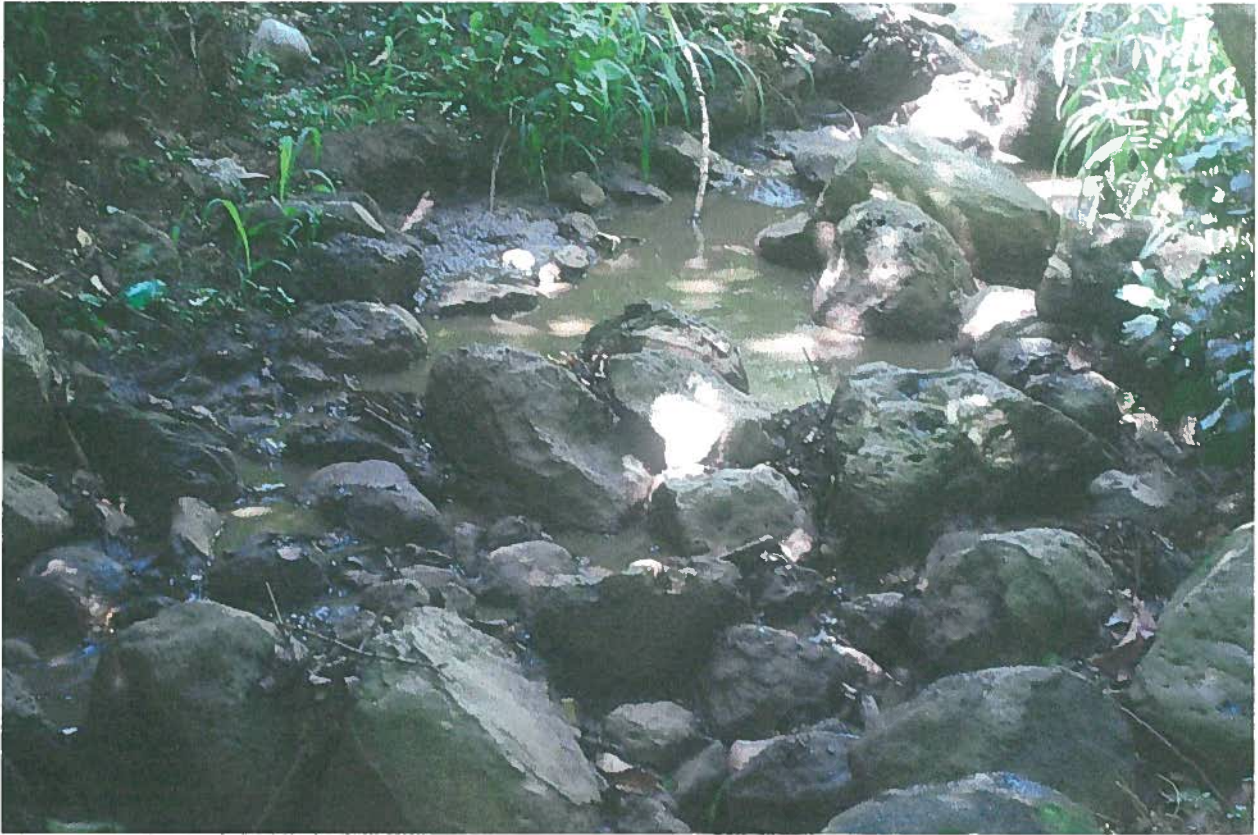
Photograph#2- This is another photo of the brown turbid smelly water flowing in the stream in the same Ookala area.

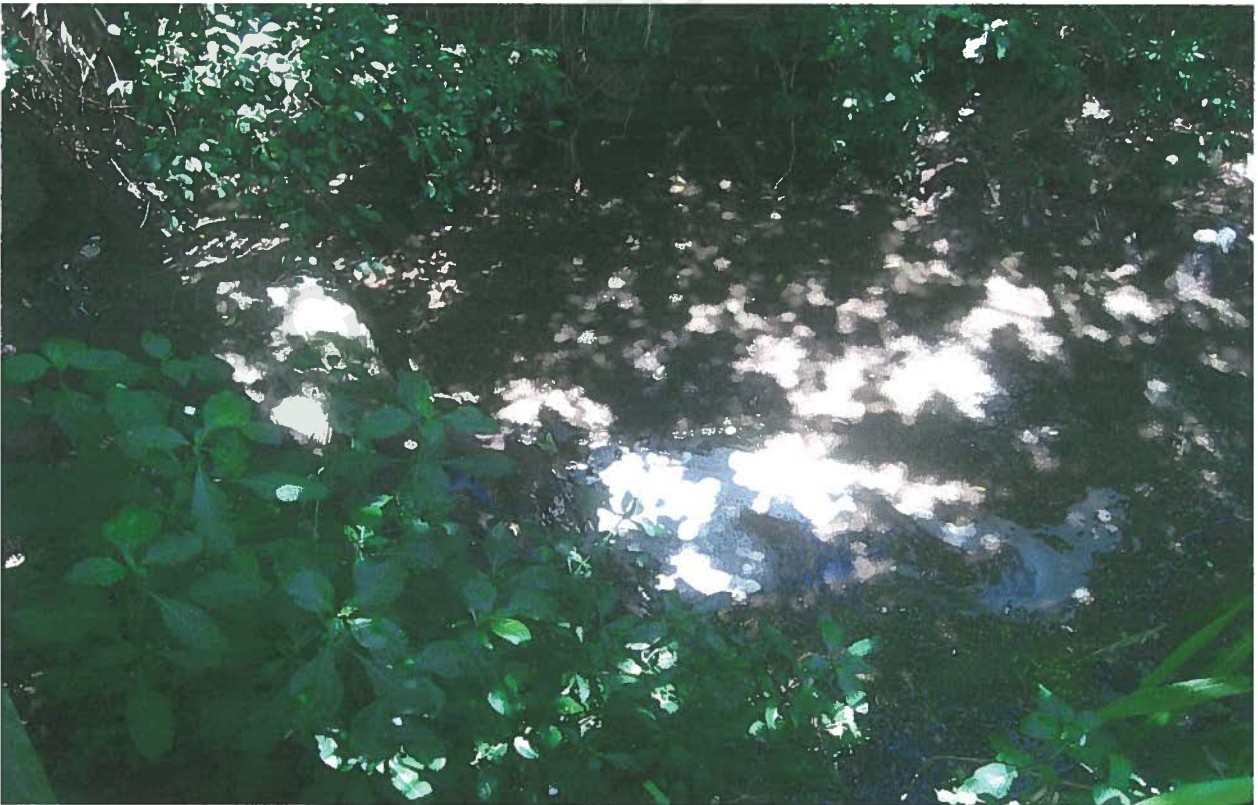
Photograph#3- This is a photo of a pond of brown turbid smelly water flowing in the stream in the same Ookala area.

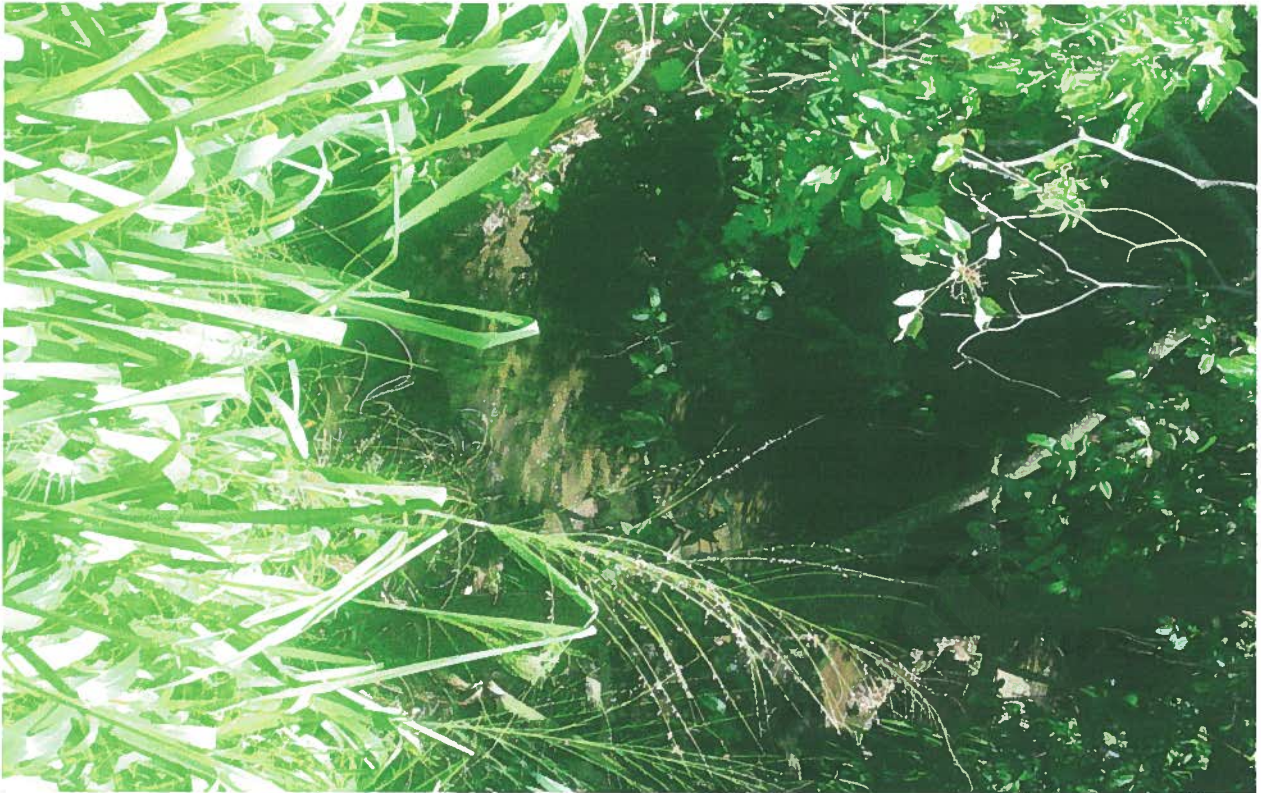
Photograph#4-This is a photo of the brown turbid smelly water in the stream from the highway.(This photo is sideways with the bottom of the photo being on the left.

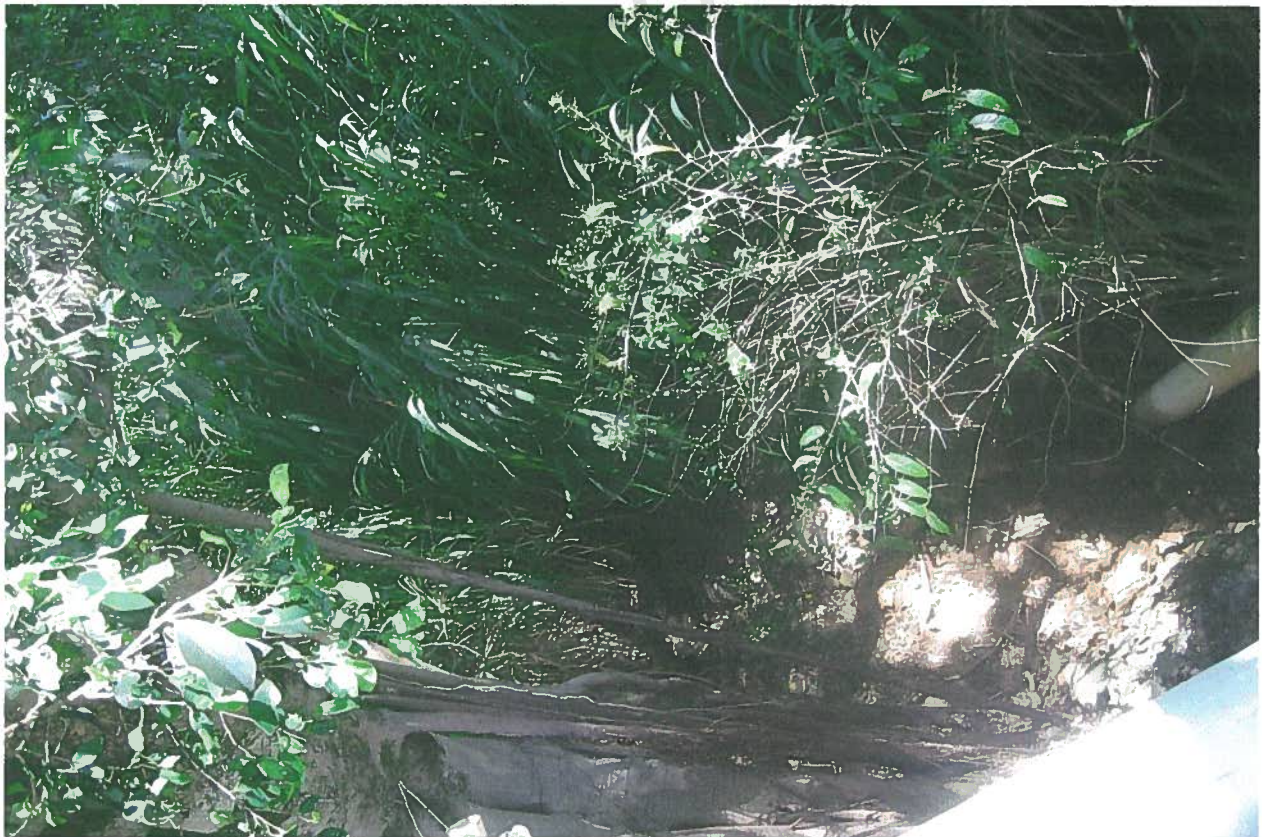
Photograph#5-This is a photo of the dry stream bed from the bridge at the dirt road intersection leading up to the dairy.

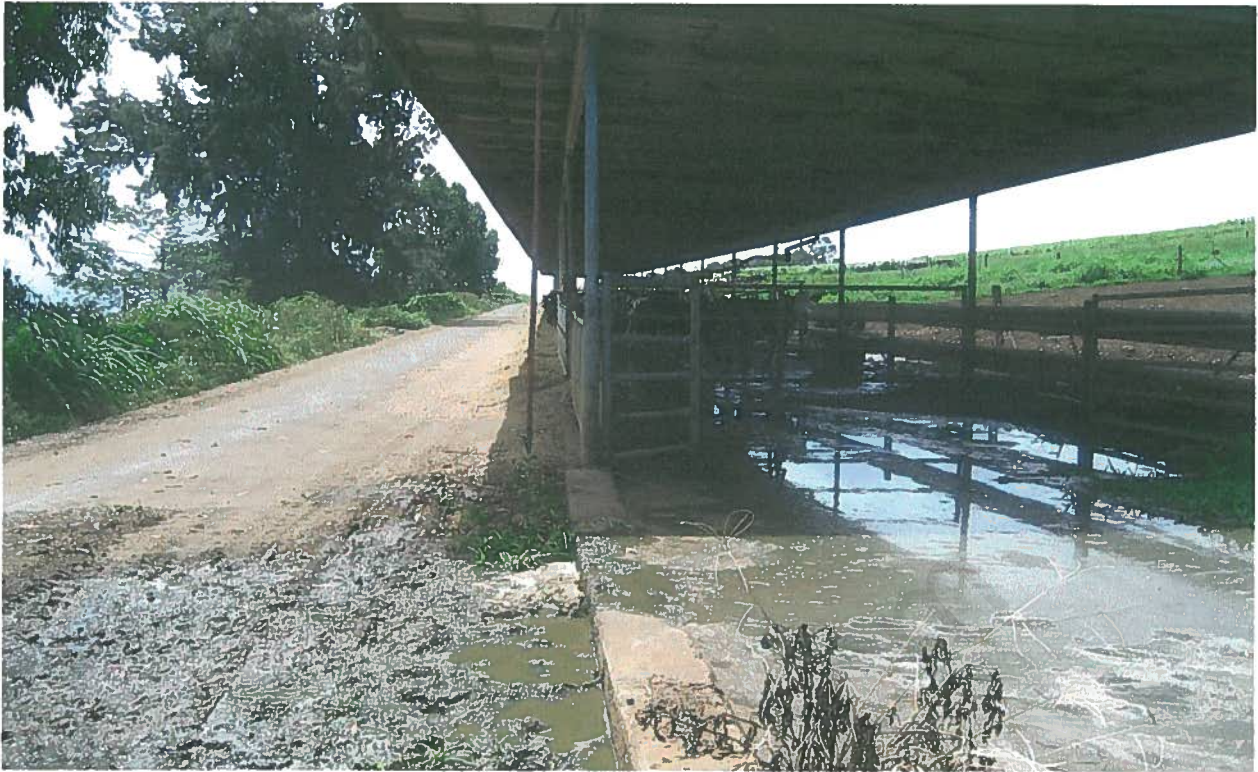
Photograph#6- This is a photo of the heifer shed with the waste area overflowing and spilling onto the dirt road.

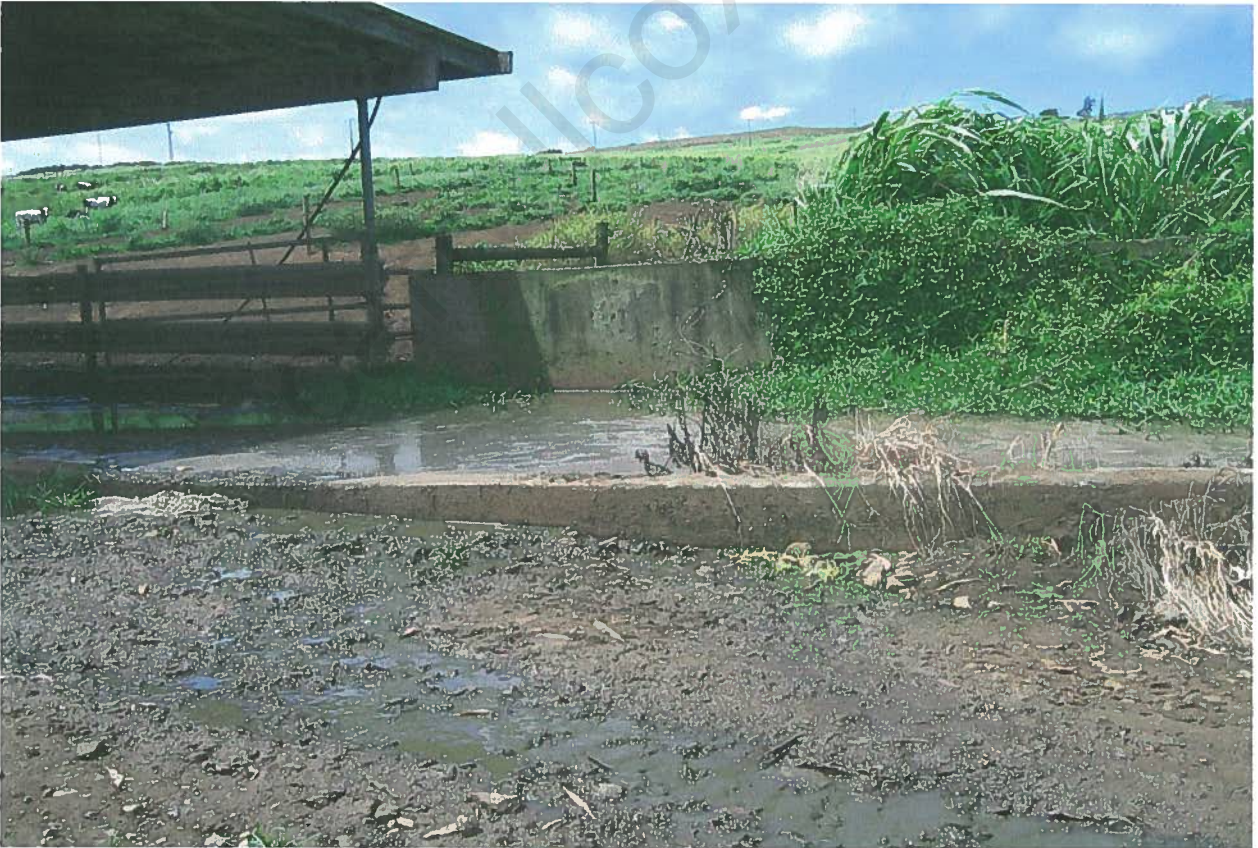
Photograph#7- This is another photo of the overflow spilling onto the dirt road.

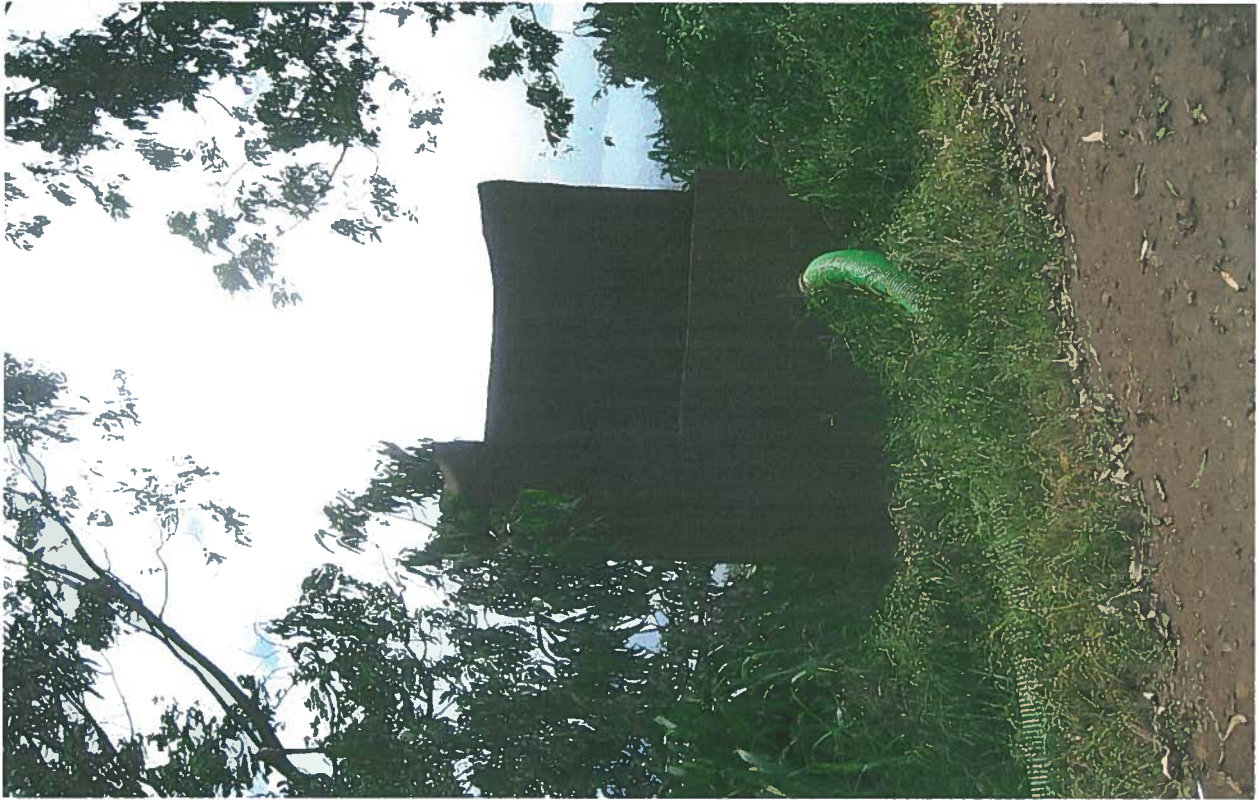
Photograph#8- This is a photo of the sewage holding tank located across the dirt road from the heifer shed and on the top border to the pasture area containing the water cannon.

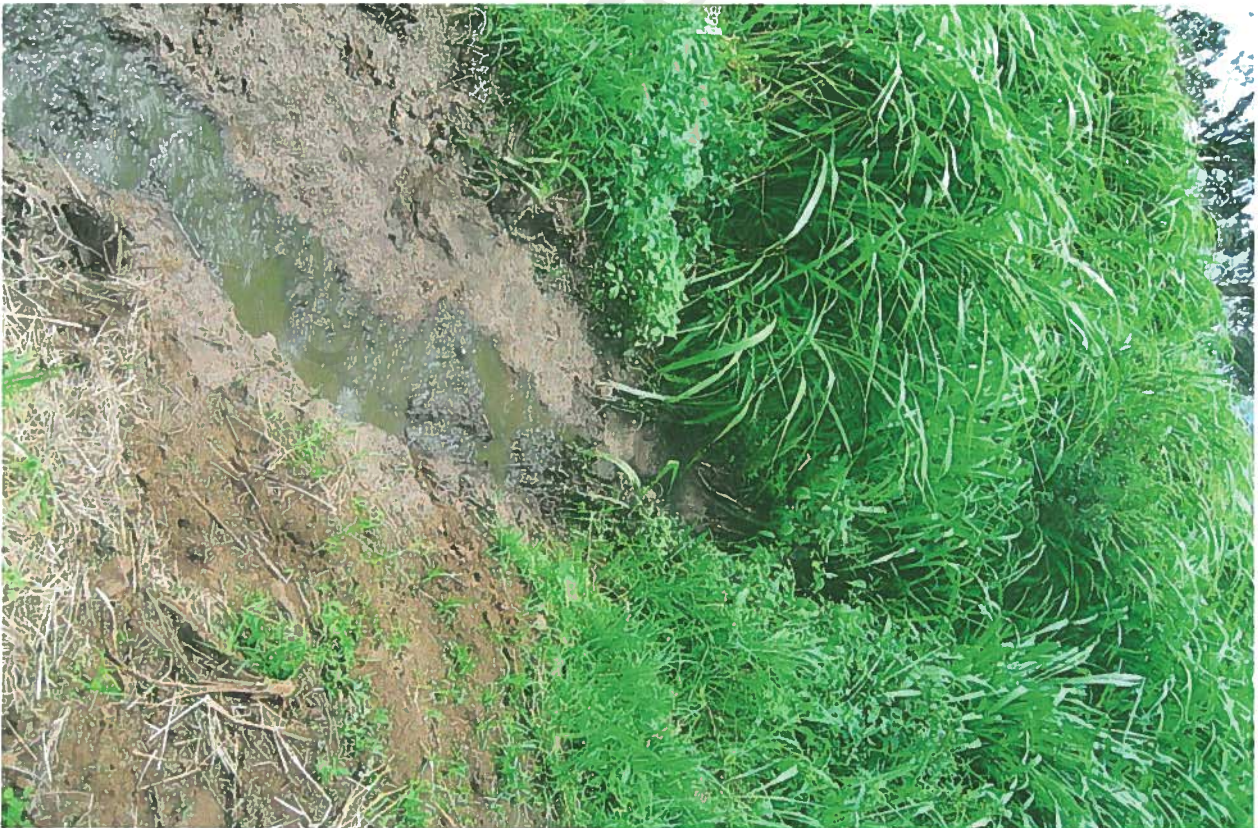
Photograph#9- This is a photo of the well-defined flow path coming from the vegetated area around the sewage holding tank.

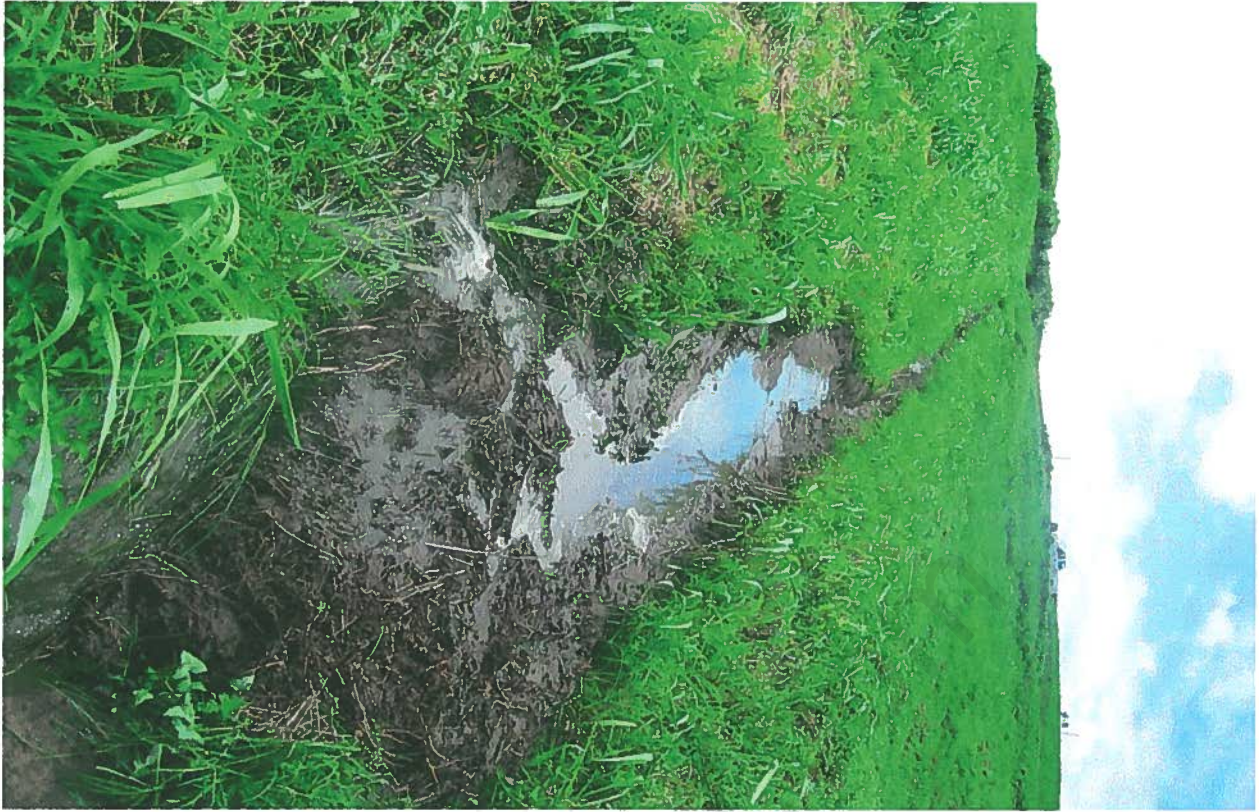
Photograph#10- This is a photo of the same well-defined flow path, but located down slope from the water cannon.

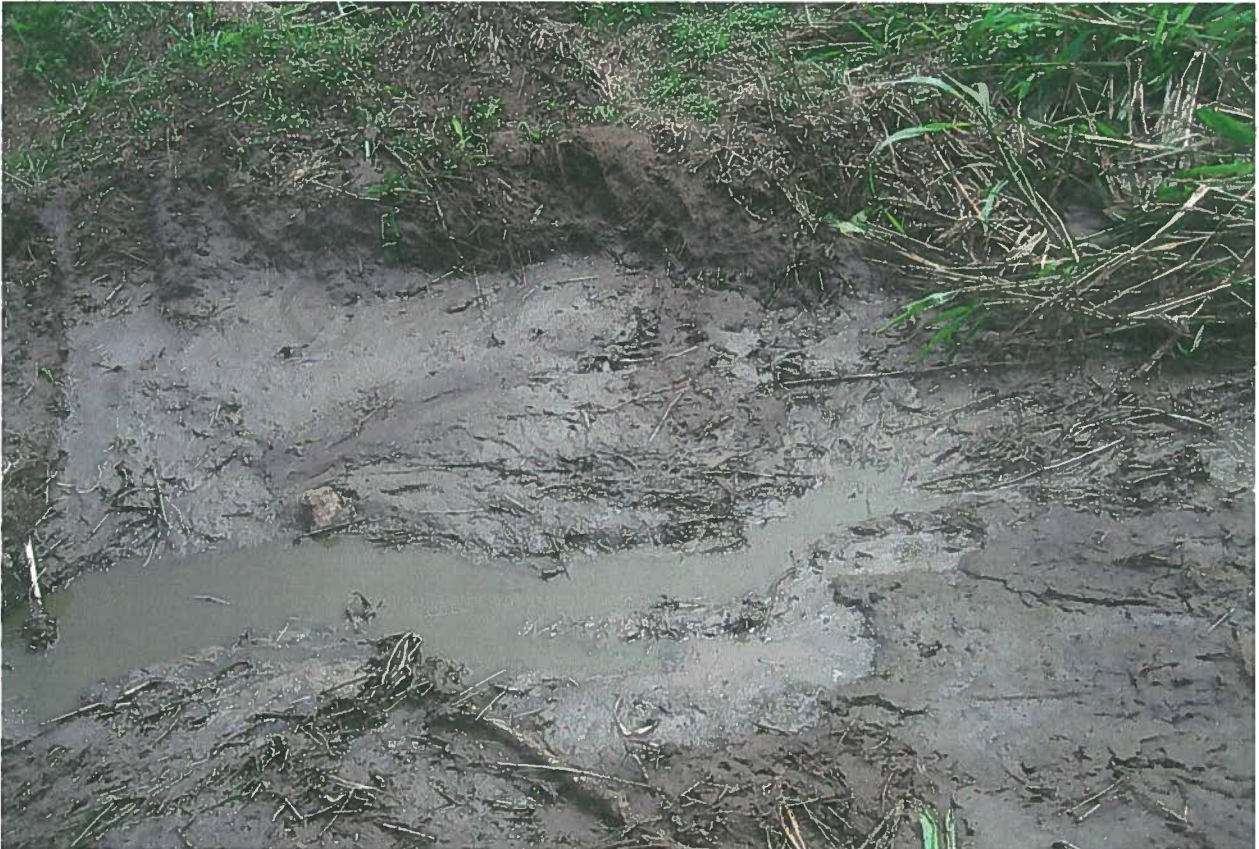
Photograph#11- This is another photo of the well-defined flow path downslope of the water cannon.

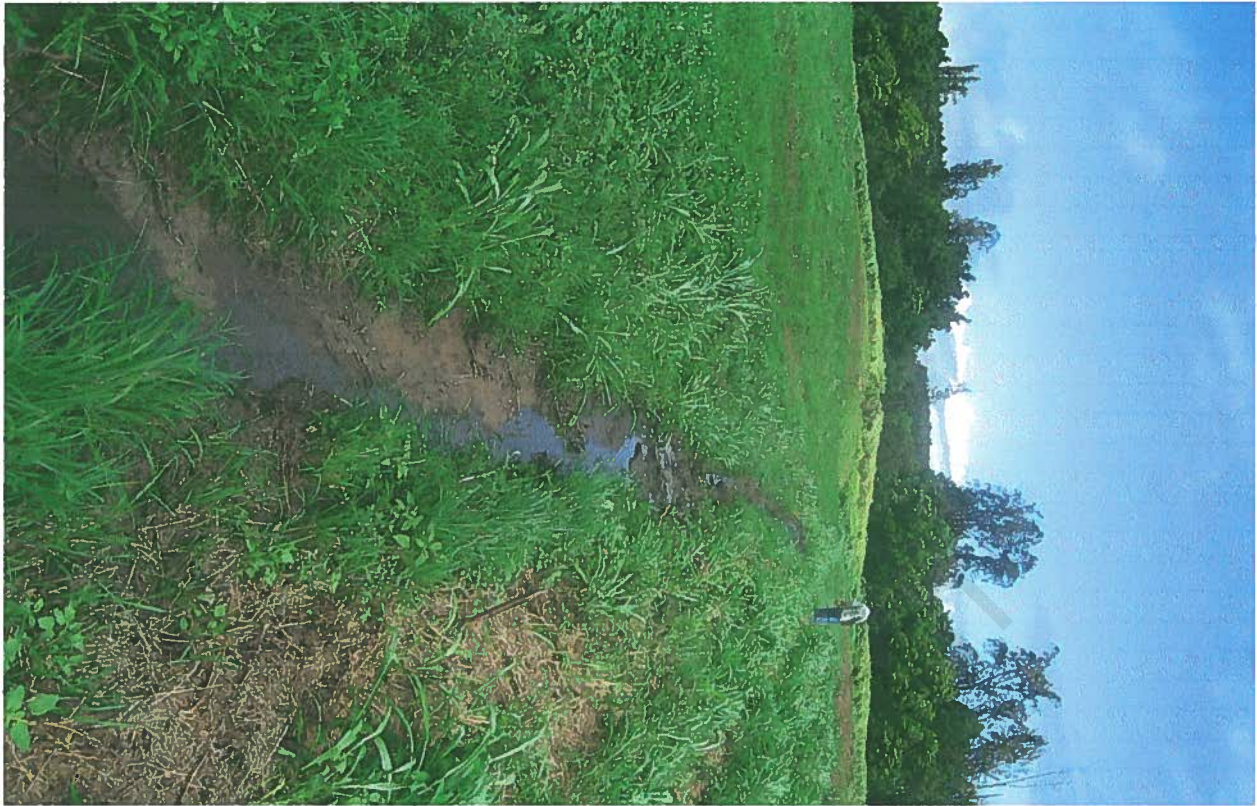
Photograph#12- This is another photo of the well-defined flow path downslope of the water cannon, with the stream located at the tree line.

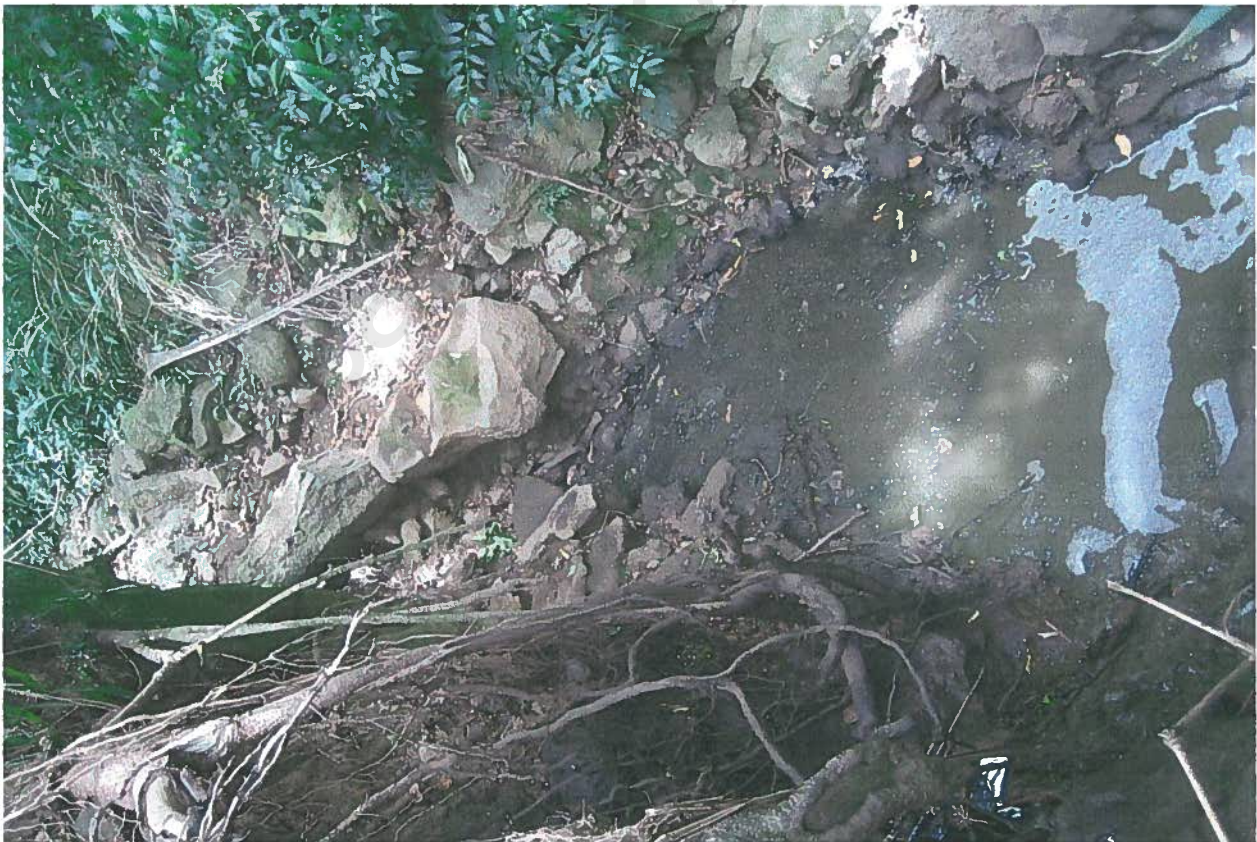
Photograph#13- This is photo of the brown sewage water entering the stream, with the stream bed above the enter point being dry.

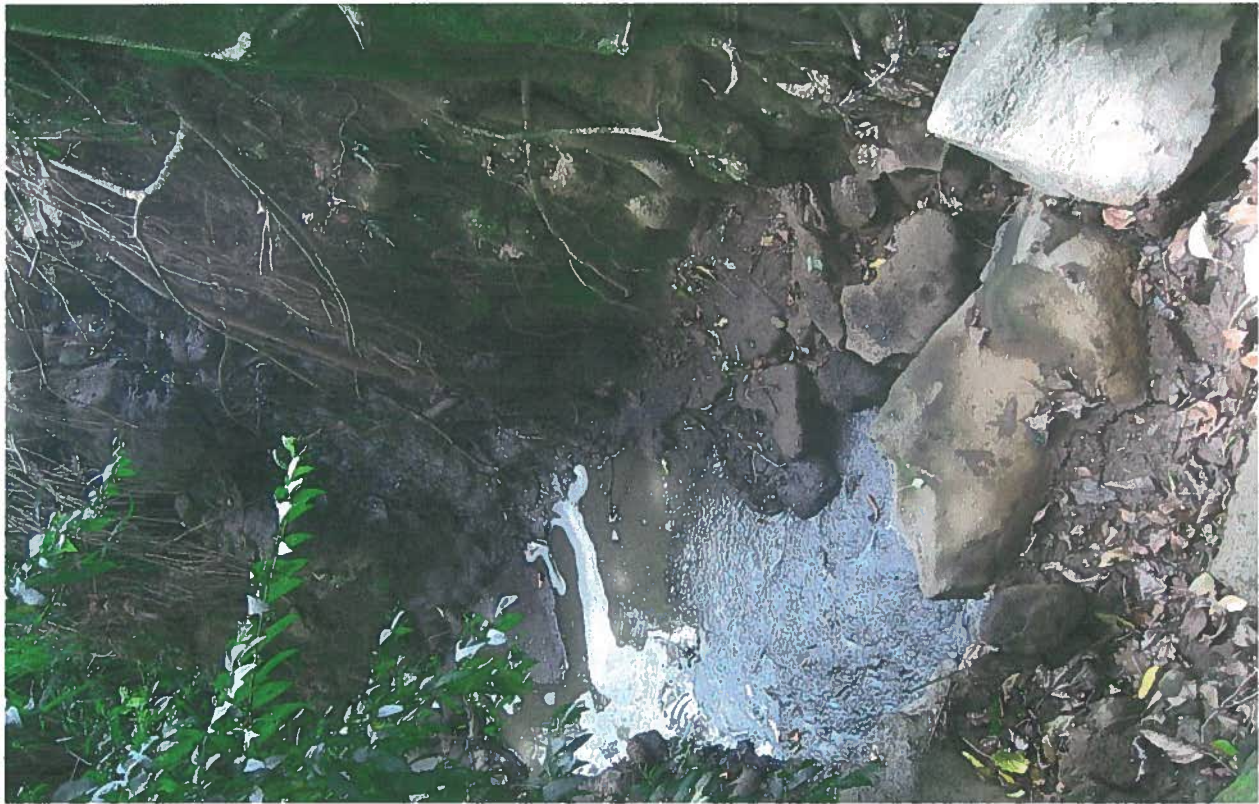
Photograph#14- This is another photo of the brown sewage water in the stream, with the sewage water entering from the left side of the photo and continuing to flow downstream toward the left .

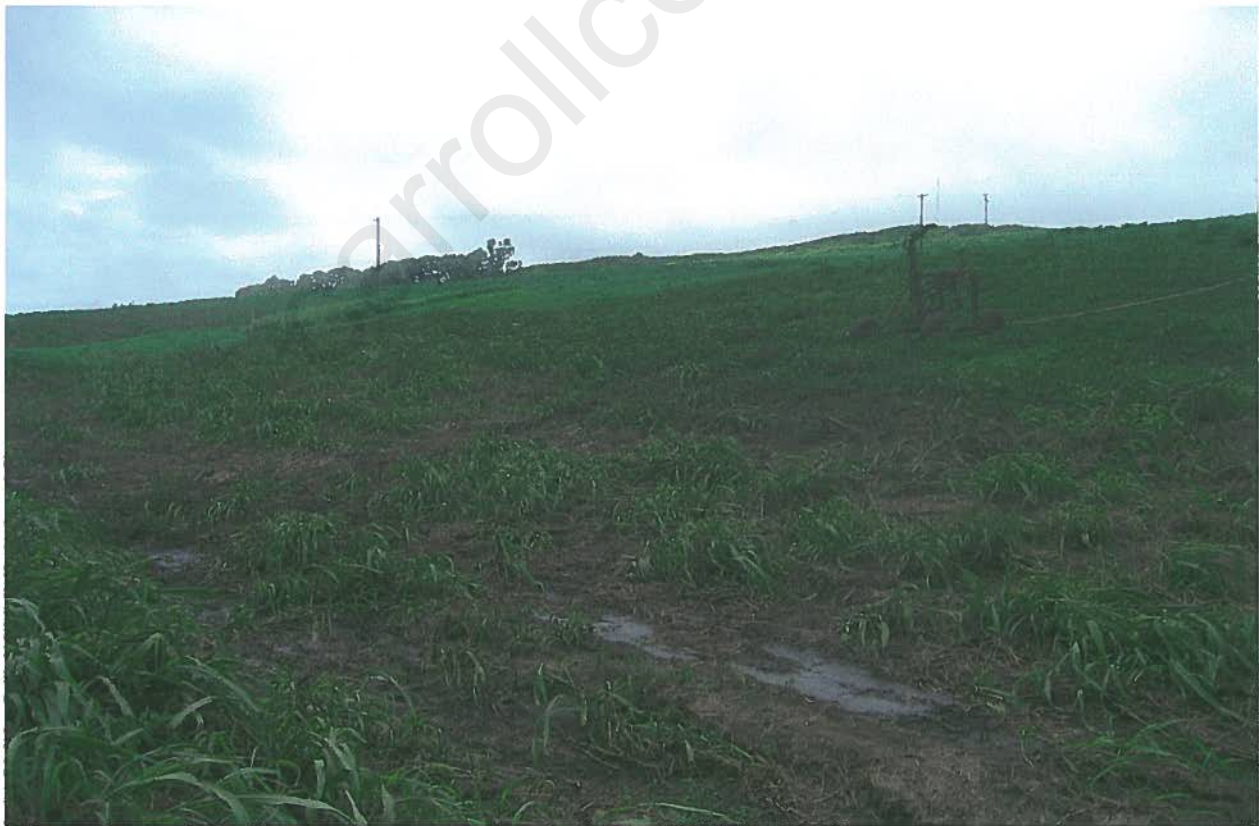
Photograph#15- This is a photo of the water cannon.

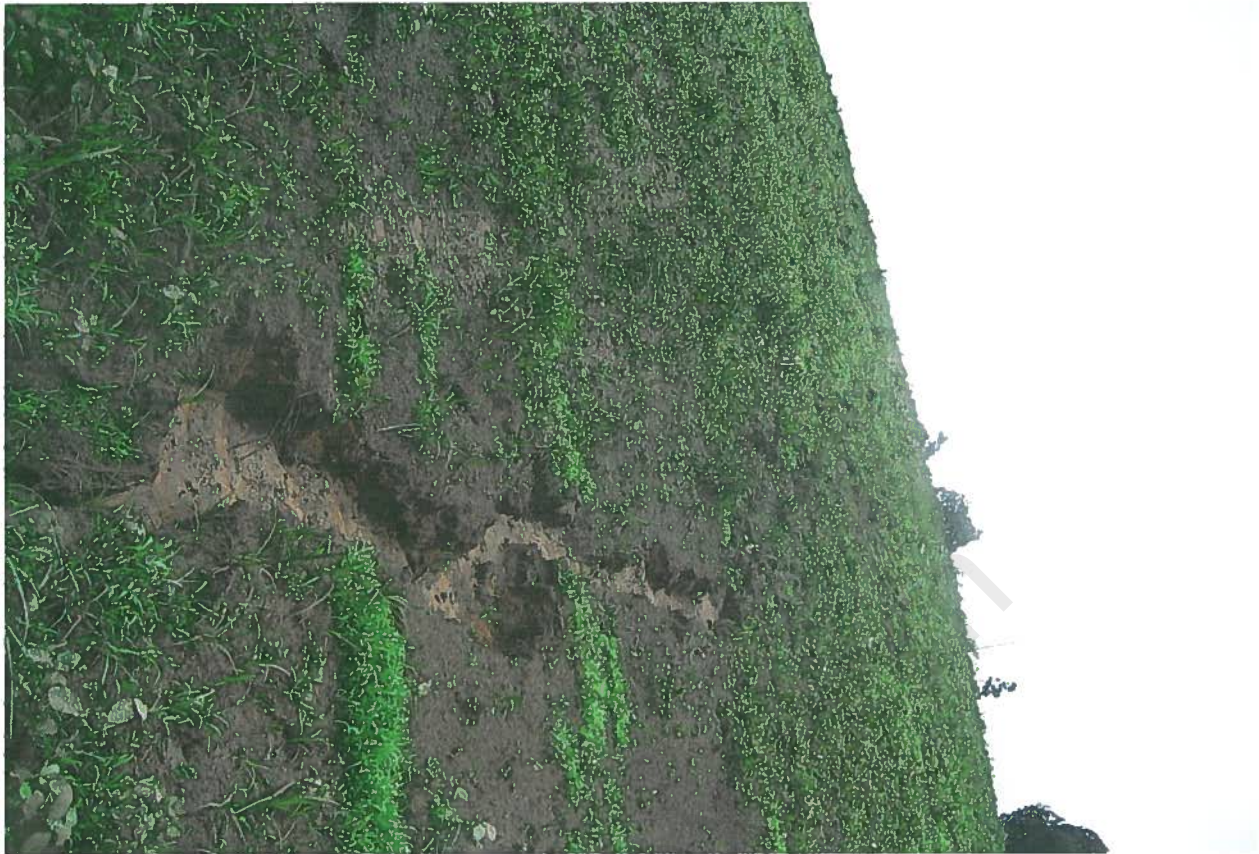
Photograph#16- This is a photo of an erosion channel downslope of the water cannon.

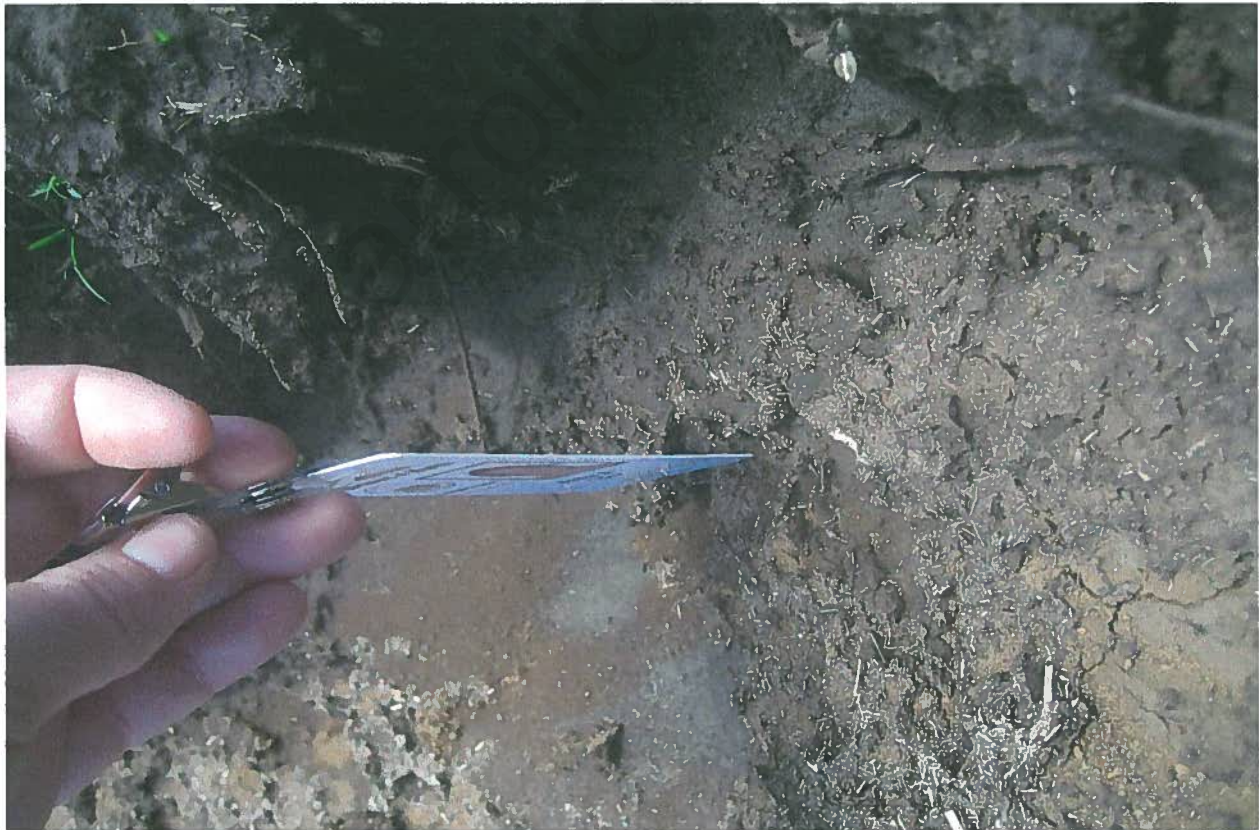
Photograph#17- This is a photo showing the depth of the erosion channel.

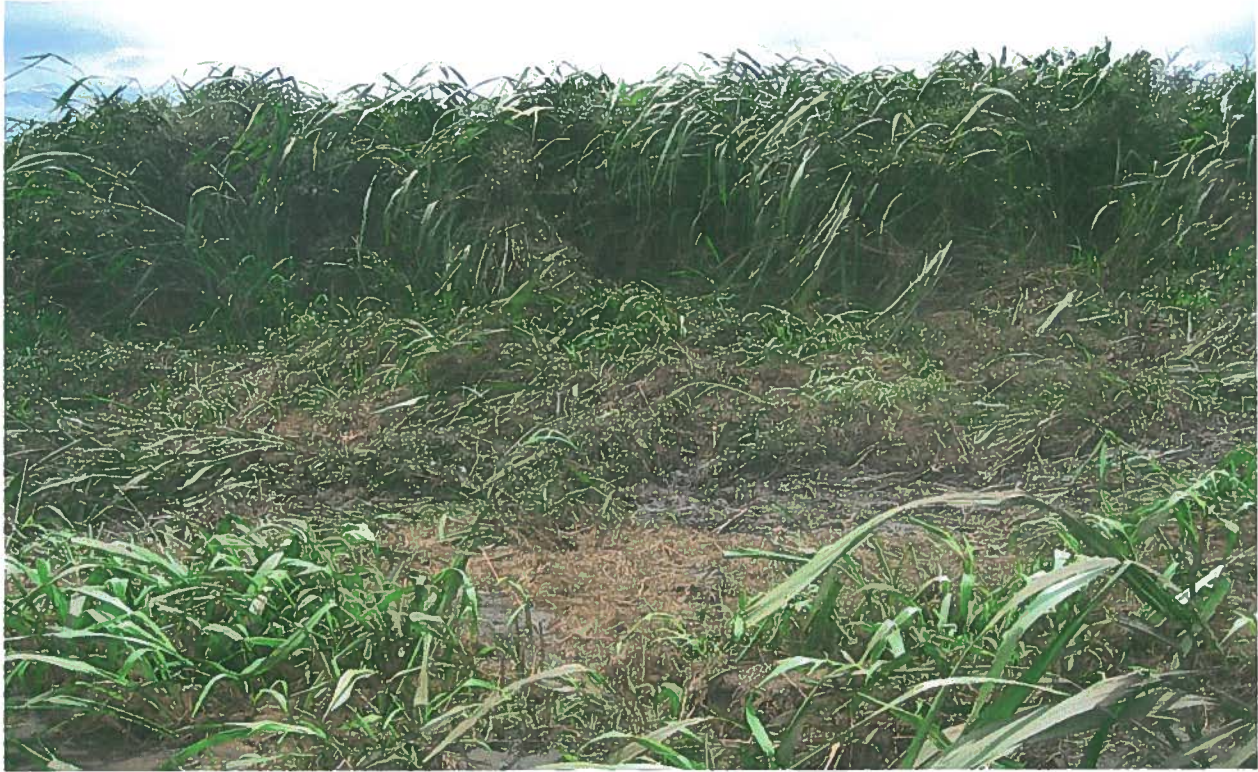
Photograph#18 This is a photo of the area below the water cannon, leading toward the well-defined flow path.

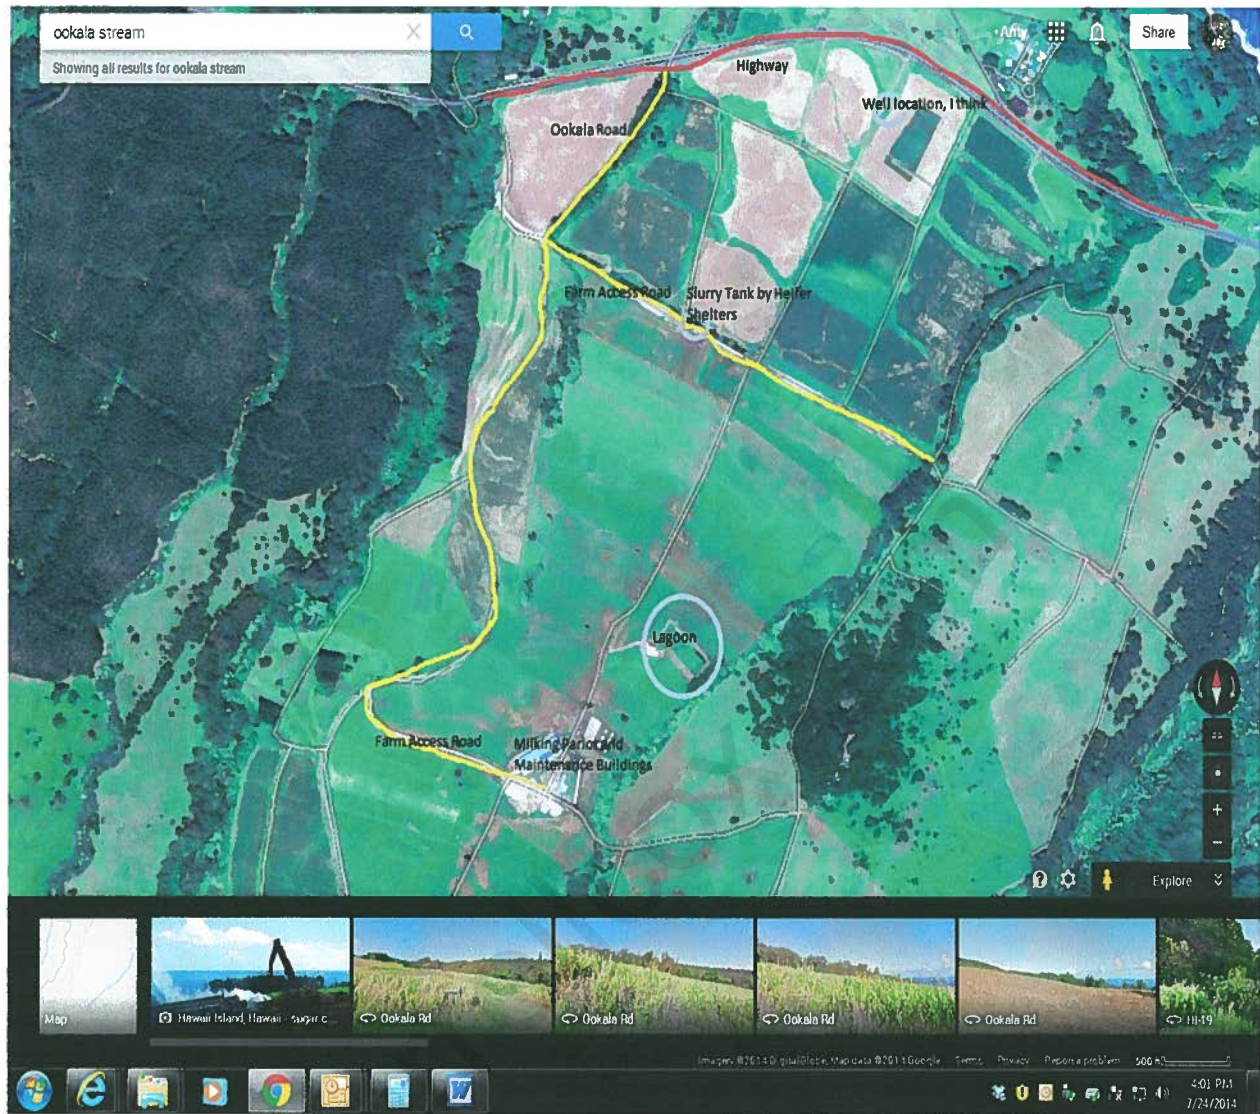
Attachment#2(This is an overview of the dairy from Google earth)

The well-defined flow path starts in the area near the slurry tank by the heifer shelters, then flows down in between the light brown and dark green parcels, then flows left in between the 2 large and medium dark green parcels toward the Ookala road, and then down toward the highway with the stream flow along the side of the Ookala road. The water cannon was located near the middle of the light brown area directly below the heifer shelter.
