Hawaii Department of Health Clean Water Branch Complaint Inspection Report

On May 2, 2018, the Department of Health (DOH), Clean Water Branch (CWB) (hereinafter, DOH-CWB) conducted an inspection of Big Island Dairy (Dairy) located at 39-3261 Hawaii Belt Road, Ookala, Hawaii 96720; TMK: (3) 9-0-020:080. The inspection was conducted as part of ongoing enforcement oversight of the Dairy as well as in response to a wastewater spill to Alaialoa Gulch during wastewater incorporation activities. Based on observations from the inspection, the DOH-CWB finds that the Dairy discharged wastewater from its incorporation activities on April 13, 2018. Further, the DOH-CWB identified additional areas where the Dairy had a high risk for polluted discharges. These areas included the Dairy's pasture areas, well overflow area, and the wastewater lagoons. This inspection report identifies observations and findings noted by the inspector. An annotated photograph log is included as part of this report and referenced as applicable.

Complaint Inspection Report
Inspection Report
Site Name: Big Island Dairy
File No.: HIU010287

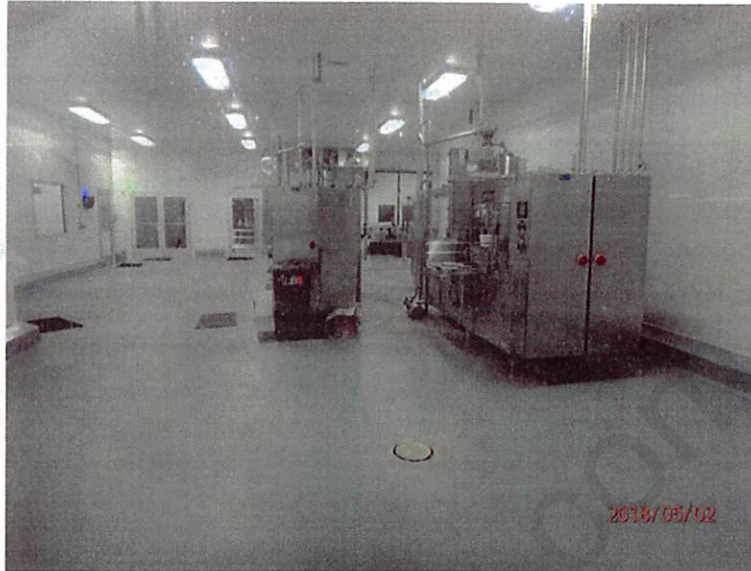
Photograph 1.

Description: View, inside of the creamery, no operations were taking place at the time of the inspection and no evidence of recent or impending operation.

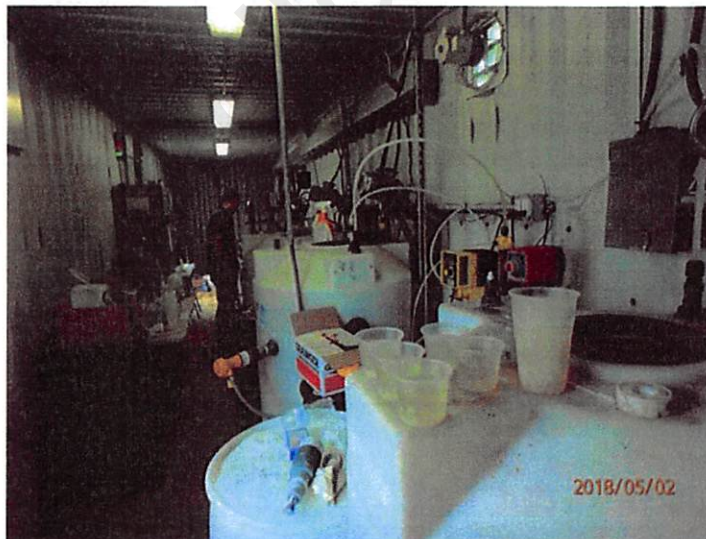
Photograph 2.

Description: View, inside creamery wastewater treatment system. Treatment system was in recirculation mode and no discharge was occurring.

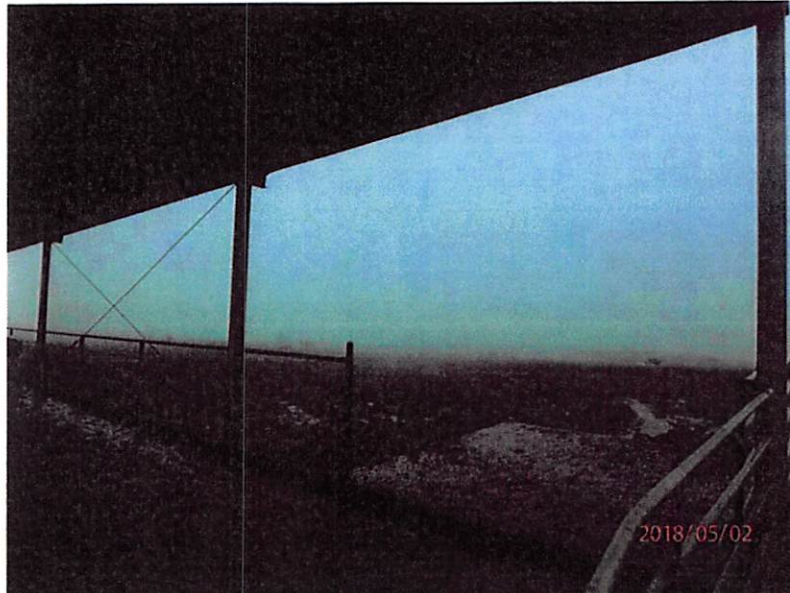
Photograph 3.

potential to discharge sediment during storm events (refer to, Photograph 3 & 4).

J. Mecham said that the area was completely covered in grass prior to the heavy rains over the last several months. J. Mecham stated they would start reducing the number of cattle in this pasture in the next several weeks and that pasture management would be improved.

Description: View, facing north, of the upper pasture area that has experienced heavy rains and grazing. Run off is not visible but presented a high potential for sediment to be transported off site.

19. At the closing conference M. Kurano notified Site Representatives that the upper pasture presented a high risk of discharging pollutants to State waters. It was recommended that Best Management Practices (BMPs) be implemented and a pasture management plan be developed. It was confirmed that all crops had been switched to grass from corn and other crops were no longer being grown on site (refer to, Photographs 13 & 14).

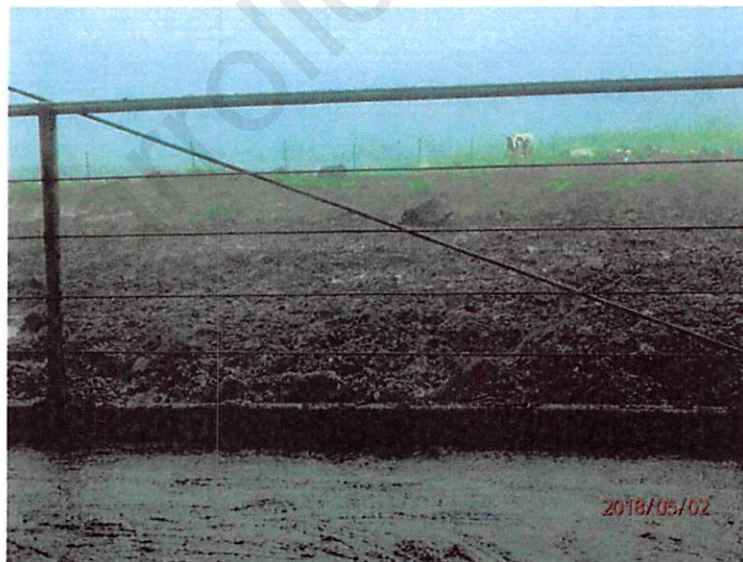
Photograph 4.

Description: Close up view, facing north, of earth disturbance in upper pasture area. Vegetation can be seen on the outskirts of the pasture area but no vegetation existed with in the enclosure.

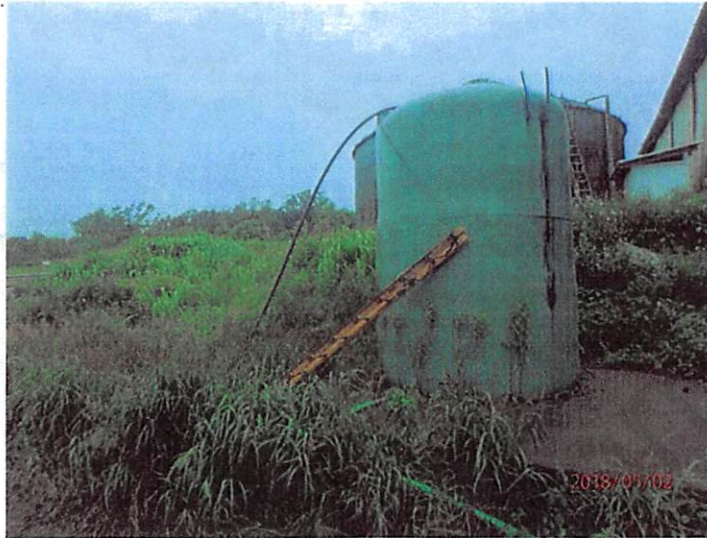
Photograph 5.

5. The Inspection Team and Site Representatives then departed the upper pasture for the well overflow location. Upon arriving I saw a clear flow path and evidence of erosion from the water storage tank heading across a racetrack that drained to Kaohaoha Gulch. This was the same location that previously held cattle as noted in inspection HA0291. J. Mecham said now this area was only used as a pass through to move cattle from one pasture to another. The Dairy has been looking to hire a plumber to replumb the well water tanks which would eliminate this erosion problem but has not been able to secure a local plumber.

Description: View of water tank, water overflows via a white PVC pipe not in the picture and then flows over the ground and subsequently flows to Kaohaoha Gulch.

-
20. Similarly, it was recommended that BMPs be implemented by the Dairy at the well water overflow location to prevent sediment from discharging to State waters until a plumber can be hired to re-route overflow water.
 21. It was noted that strong noxious odors were observed in discrete locations. Specifically, the aeration basin and the inflow to the wastewater lagoon. S. Manning stated that the Dairy is looking at odor control options and seeking professional advice.
 22. Site Representatives showed a desire and willingness to address all concerns raised by the DOH-CWB and the community. The closing conference concluded at approximately 2:00 PM and the Inspection Team departed the Dairy.

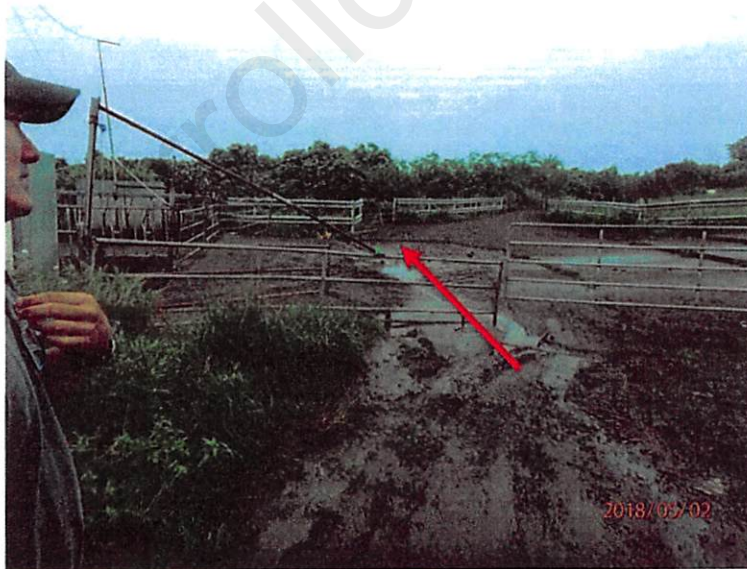
Photograph 6.

Description: View, facing east, of flow path from well water tank overflow headed towards Kaohaoha Gulch. Red arrow points in direction of flow.

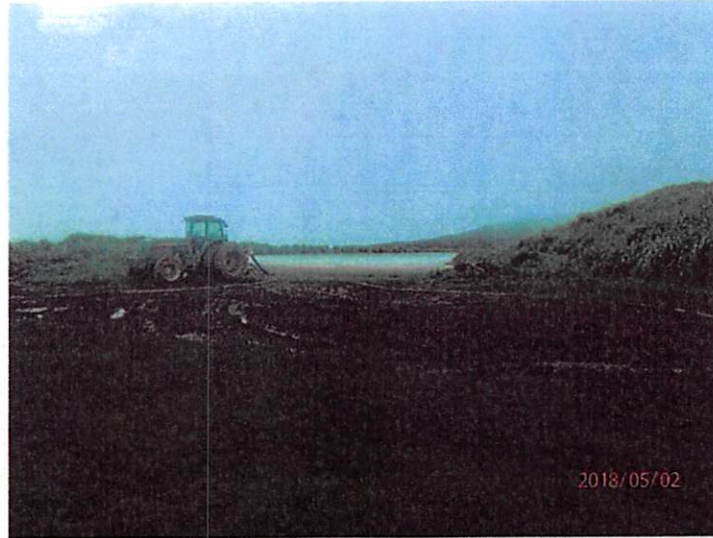
Photograph 7.

8. The Inspection Team and Site Representatives then drove to the wastewater lagoons. Upon arriving at the main wastewater lagoon, I saw a tractor and large pump. S. Manning said they had been incorporating earlier in the day but were forced to stop because the ground was already saturated from recent rain events (refer to, Photograph 7).

Description: View, facing east, of wastewater lagoon and tractor used to pump wastewater for incorporating activities.

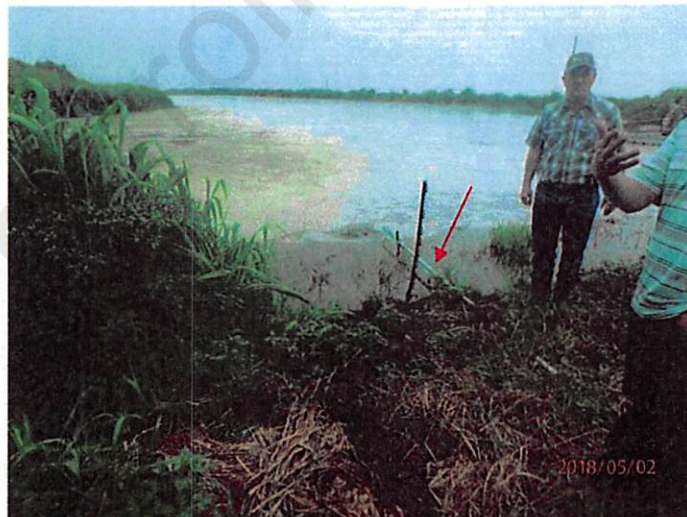
Photograph 8.

9. Upon arriving at the spillway on the southeast end of the lagoon I saw that the lagoon had approximately six (6) inches of freeboard (refer to, Photograph 8). I stated concern about the level of freeboard in the lagoon. S. Manning and J. Mecham stated that incorporation activities had been limited due to weather but the Dairy had been incorporating when able and when the weather is dry draw down of wastewater could occur relatively quickly.

Description: View, facing northwest, standing on the spillway for the main wastewater lagoon. Red arrow points to the marker measuring remaining free board in the lagoon. Approximately six (6) inches of free board existed at the time of inspection.

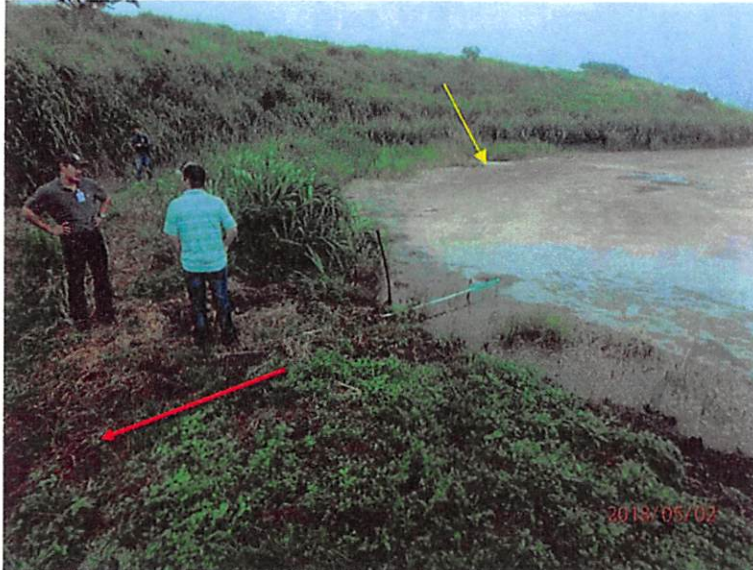
Photograph 9.

10. Upon inspecting the spillway, I did not witness any evidence of recent discharge from the wastewater lagoon and the spillway appeared to be in working condition (refer to, Photographs 9 & 10).

11. As I approached the inflow pipe on the south side of the wastewater lagoon, a strong odor was noticeable in the low-lying area near the inflow pipe for the wastewater lagoon (refer to, Photograph 9).

Description: View, facing south, of spillway. Red arrow points in direction of potential flow and yellow arrow points to inflow location where significant sewage odors were noticeable.

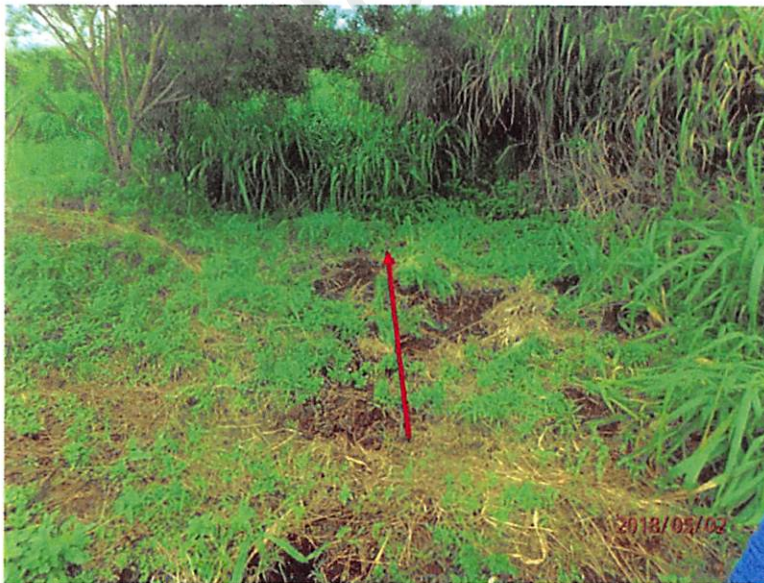
Photograph 10.

Description: View, facing southeast, of the spillway for the wastewater lagoon. Red arrow points in the direction of potential flow. No evidence of recent discharge was seen.

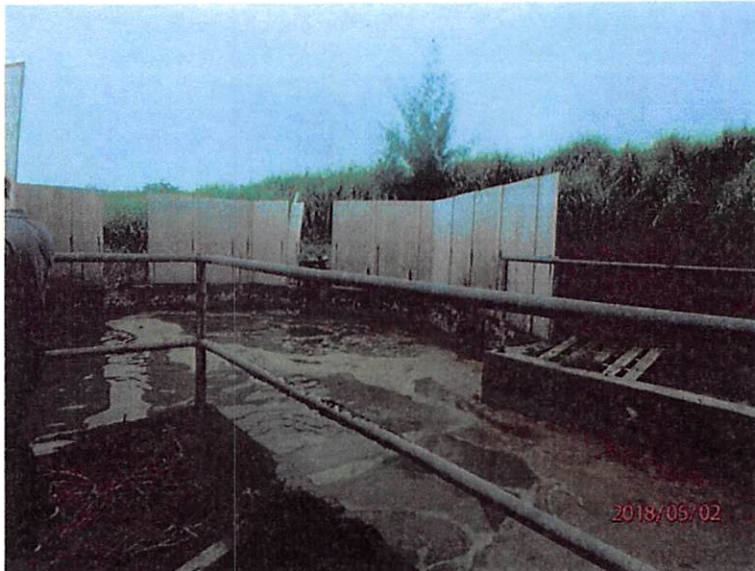
Photograph 11.

6. The inspection then continued at the composter/wastewater sump. Upon parking and exiting the vehicle, an objectionable odor was immediately apparent and got stronger as I moved towards the wastewater sump. J. Mecham stated that they had installed several sheets of plywood to act as windbreaks and were investigating a perimeter of aromatic bushes.

7. No evidence of a recent spill or wastewater discharge was observed in the area of the wastewater sump. S. Manning and J. Mecham both confirmed that the basin is designed to overflow in to a bypass vault that is plumbed directly to the wastewater lagoons. In the event that the wastewater was to exit the sump and flow via the ground the wastewater would drain to Kaohaoha Gulch (refer to, Photographs 11 & 12).

Description: View, facing east, of the wastewater sump. Plywood has been erected to create a wind break. Strong odors in the area were strongest near the basin. Basin was in good operating condition at time of inspection.

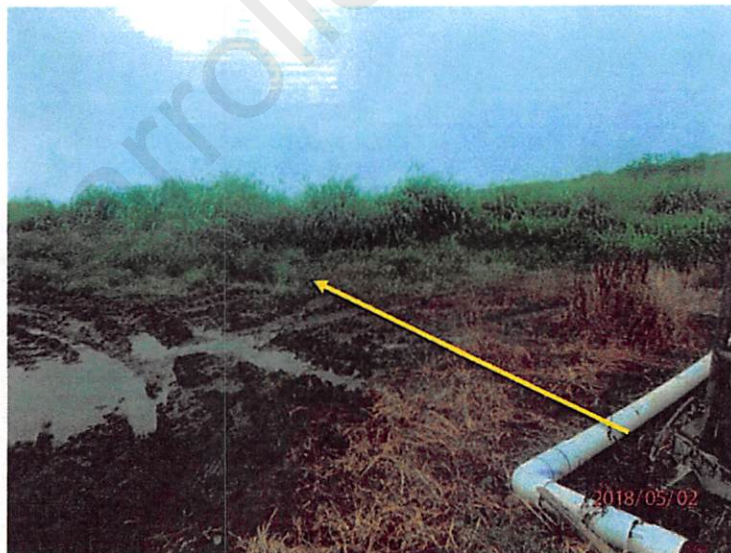
Photograph 12.

Description: View, east, of overflow path from wastewater sump Towards Kaohaoha Gulch. No evidence of an overflow was present. Yellow arrow shows approximate potential flow path.

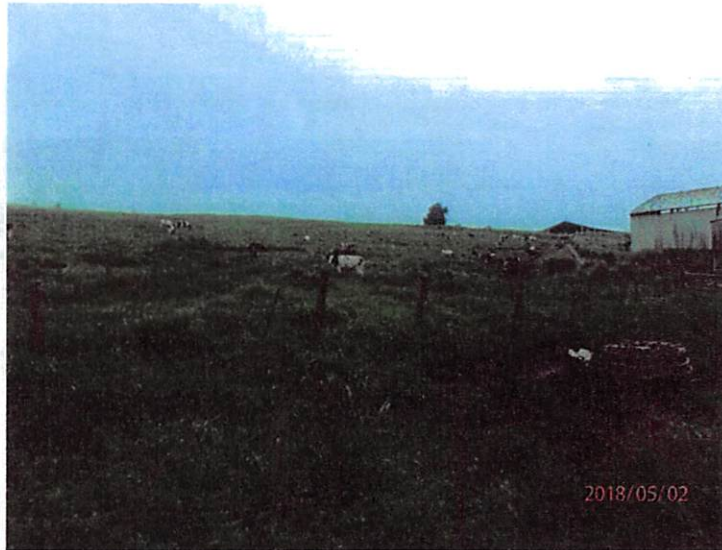
Photograph 13.

- g. In following up on findings from the previous inspection reports noted above J. Mecham and S. Manning stated that going forward, the entire property will only grow feed grass and no other crops were onsite. This was confirmed by the Inspection Team during the site walk that all fields on site were established with grass and no other crops were being grown. (refer to, Photographs 13 & 14).

Description: View, facing south, of established grass fields. All other crops have been removed from the Dairy.

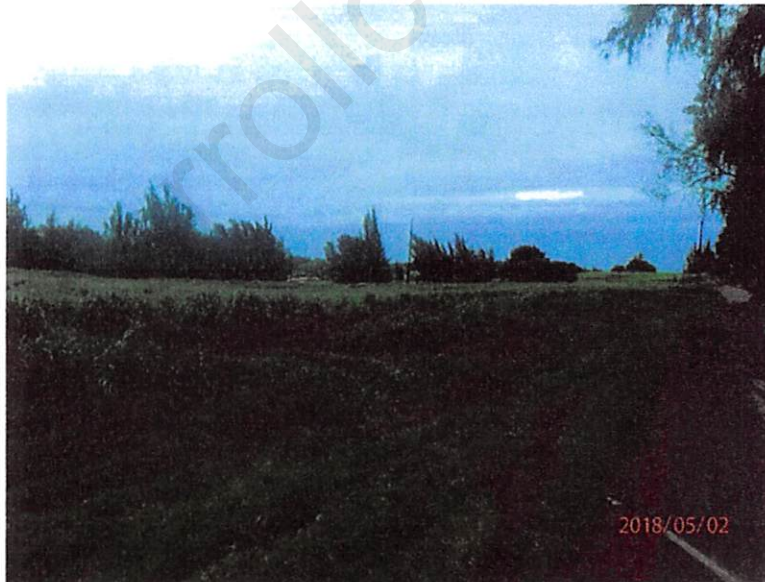
Photograph 14.

Description: View, facing north, of established guinea grass. All other crops have been removed from the Dairy.

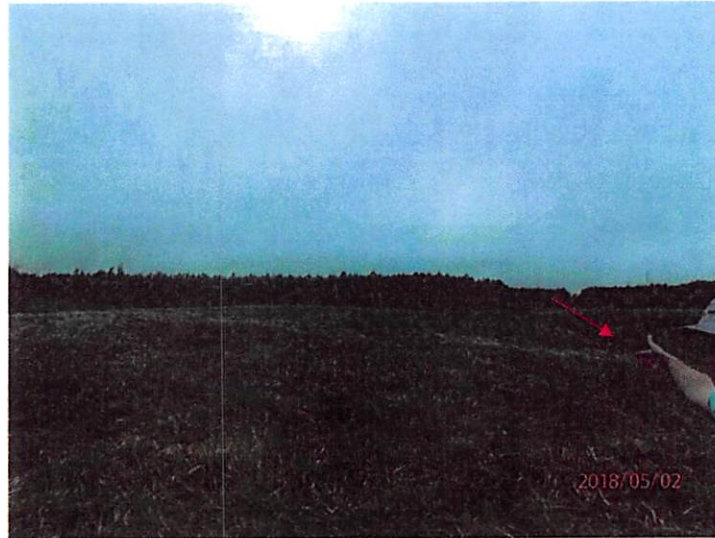
Photograph 15.

14. J. Mecham explained to me that the wastewater had flowed along the swale at the bottom of field 1A, across the road way and subsequently down the hillside into Alaialoa Gulch (refer to, Photographs 15-18).

Description: View, facing southwest, of Field 1A where the spill of lagoon wastewater occurred on April 13, 2018. Red arrow shows approximate flow path eastward toward Alaialoa Gulch.

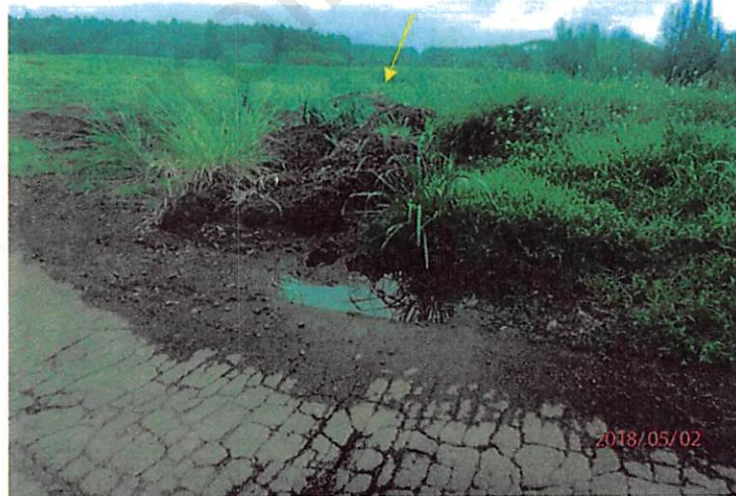
Photograph 16.

12. The inspection then continued at "field 1A" where the spill of wastewater occurred on April 13, 2018. Upon arriving at field 1A I saw a large berm that appeared to have been recently put in place at the low point in the field (refer to, Photograph 16 & 17).

Description: View, facing southwest, in line with the spill flow path of the berm (yellow arrow) constructed by the Dairy to contain spilled wastewater. Note, ponded water in picture is storm water.

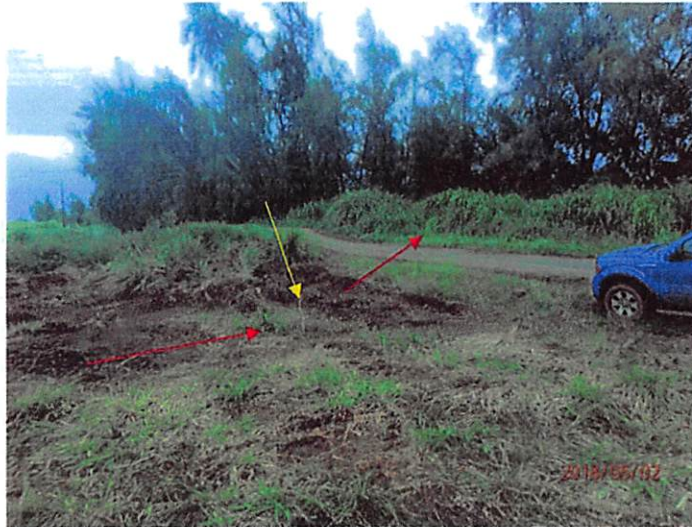
Photograph 17.

Description: View, facing northeast, of berm (yellow arrow) and flow path (red arrow) towards Alaialoa Gulch.

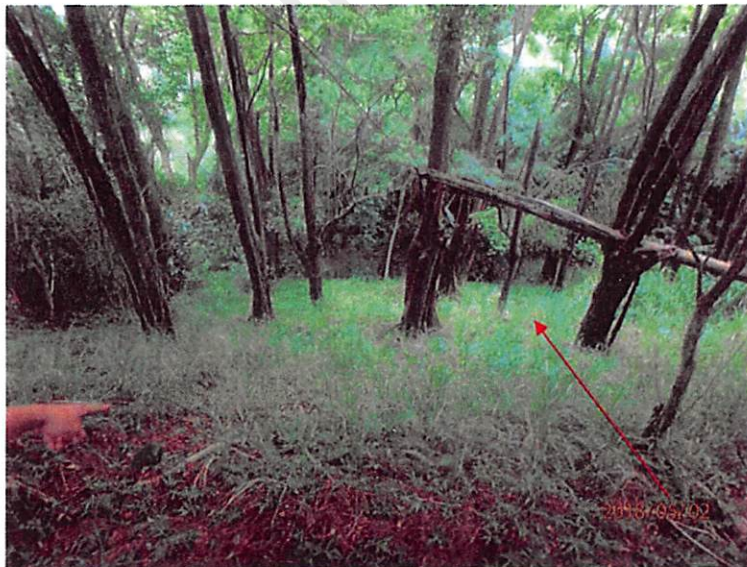
Photograph 18.

Description: View of where spilled wastewater flowed in to Alaialoa Gulch. No evidence of erosion or ponding. Red arrow shows approximate area wastewater flowed in to Alaialoa Gulch.

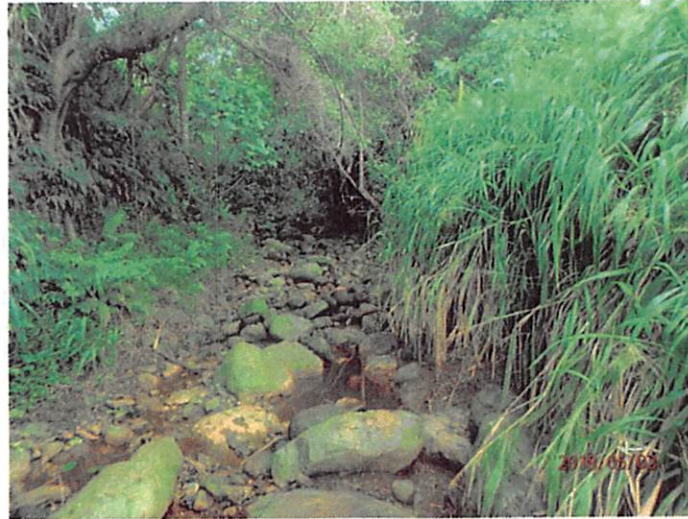
Photograph 19.

17. Upon entering Kaohaoha Gulch, I witnessed several standing pools of water that contained some suspended solids but were generally clear. The river bed was visible in most areas. I did not see any evidence of bedding, feed or wastewater in the Gulch. None of the odors noted earlier in the inspection, near the wastewater sump and inflow to the wastewater lagoon, were present in Kaohaoha Gulch.

Description: View looking upstream of Kaohaoha Gulch. No bedding, feed or wastewater was present in the gulch. Strong odors were not present in the gulch either.

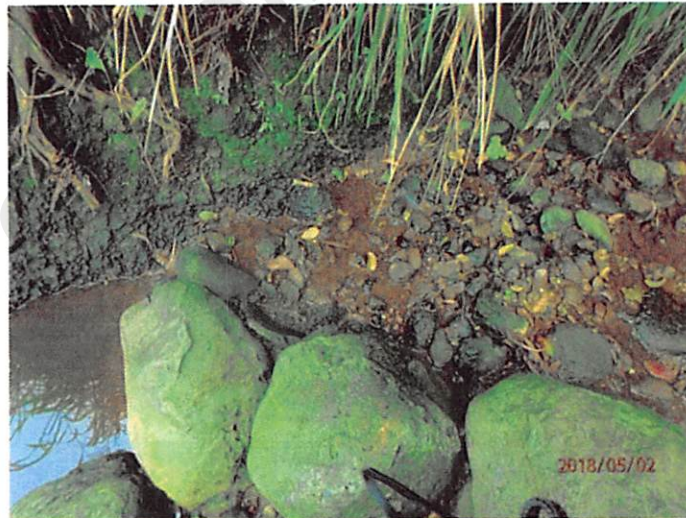
Photograph 20.

Description: Close up view of ponded water in Kaohaoha Gulch. River bed generally visible through ponded water and no evidence of recent discharge was observed.
