**Concentrated Animal Feeding Operation
NPDES Inspection Report**
Facility Name: Big Island Dairy
NPDES Permit No.: Not Permitted

Date and Time: December 14, 2016 **Entry:** 10:00 a.m. **Exit:** 4:45 p.m.

Facility Name: Big Island Dairy

Facility Address: 39-3308 Hawaii Belt Road; Hilo, Island of Hawaii, Hawaii 96720

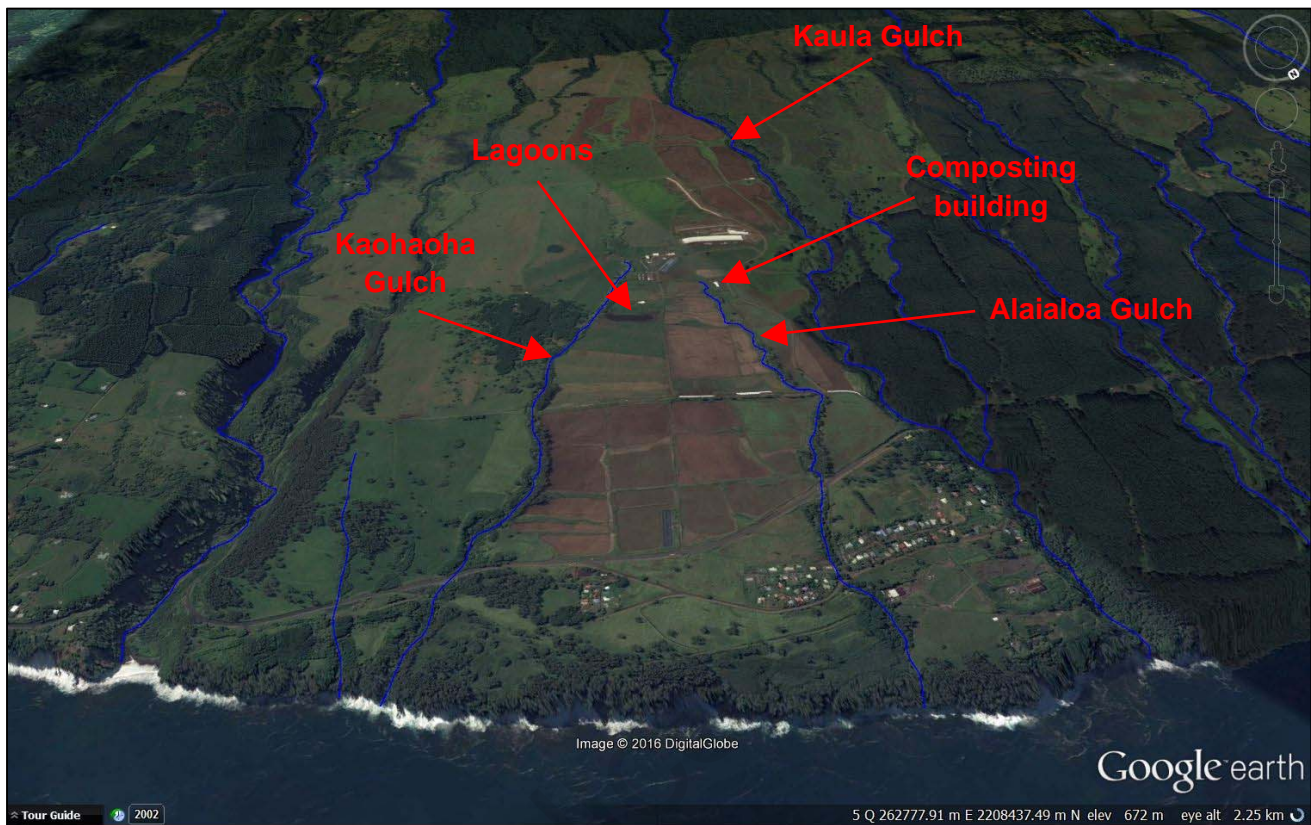
Kaohaoha Gulch flows through the center area of the property and due to its location, appeared to be the gulch most potentially impacted by CAFO operations. The gulch flows along the east side of the dairy operations area (i.e., cow barns, milking barn, hospital, lagoons) and low elevation irrigated croplands. A discharge from the Facility's wastewater lagoons would likely enter this gulch upon overflow (refer to Figures 2 and 3).

2. During the inspection, I observed the potential for the Facility to discharge pollutants to Kaohaoha Gulch, an identified State water and water of the U.S. As part of the Facility tour, I inspected the new, lower 2.5 million-gallon wastewater lagoon, including its southeast overflow spillway (refer to Photographs 26 through 28, and 31 through 33). While standing on the overflow spillway, which was saturated and coated in unstable muck and standing water, I estimated the freeboard underneath the lagoon's overflow spillway at approximately twelve inches (refer to Photograph 34). The lower lagoon was not equipped with a depth marker. Facing southeast from the overflow spillway, I observed a clear flow pathway down a heavily vegetated conveyance channel that flowed from the lagoon to the southeast (refer to Photographs 35 and 36). Based on aerial imagery, this conveyance channel flows directly into Kaohaoha Gulch, approximately 100 feet southeast of the lower lagoon overflow spillway (refer to Figures 1 through 3).

Figure 3. GoogleEarth aerial image, oriented southwest, of BID and Ookala, HI, imagery date December 6, 2014. The blue lines designate streams identified on the EPA My Waters Mapper application. The red arrows and callouts identify the Facility's main three receiving waters: Kaohaoha Gulch, Alaiialoa Gulch, and Kaula Gulch, as well as the lagoons located adjacent to Kaohaoha Gulch and manure composting building near the origin of Alaiialoa Gulch.

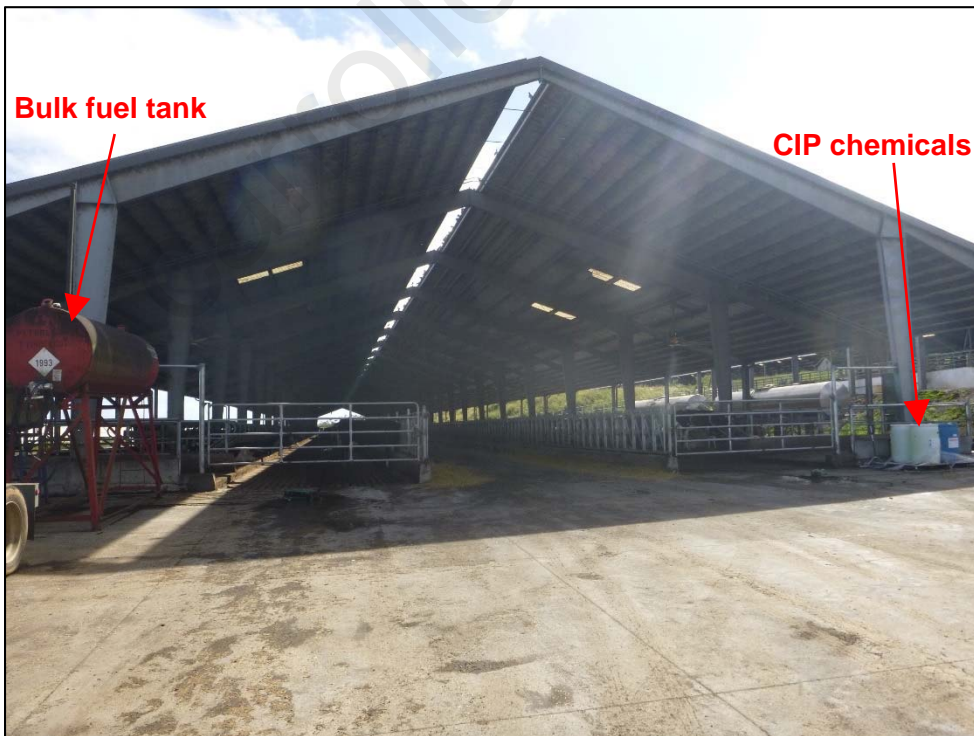
5. During the inspection, I observed 4 bulk gasoline and diesel aboveground fuel storage tanks: 2 at the lower freestall barn and 2 at the maintenance building (refer to Photograph 4). Based on the approximate size of the aboveground storage tanks, it appeared that the Facility had the potential to store greater than 1,320 gallons of fuel onsite, and as such, may be subject to spill prevention control and countermeasure rule specified in 40 CFR Part 112.12. The Facility should ensure that the bulk fuel aboveground storage tanks are either a double-walled tank, or stored within secondary containment to minimize the possibility of a leak or spill.

Photograph 4. View of the Facility's newly constructed lower 1,000-cow freestall barn. Note the bulk fuel tank and CIP chemicals. Photo by A. D'Angelo; 12/14/16.

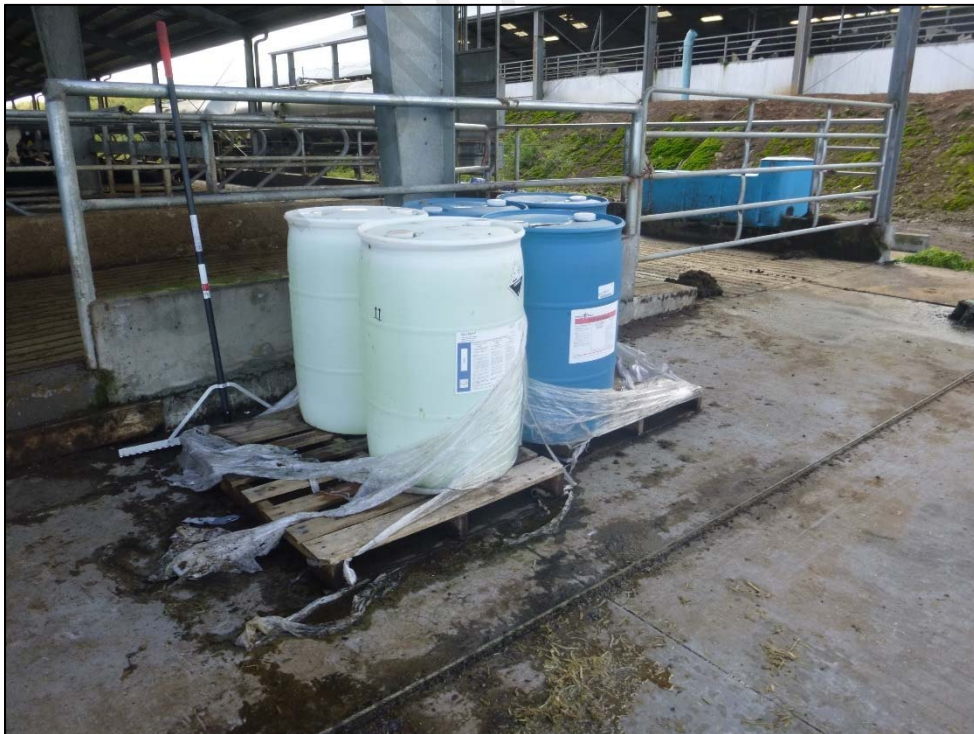
tour, I observed multiple 55-gallon drums of caustic detergent and acid (incompatible chemicals) stored together on a pallet, outdoors without secondary containment (refer to Photographs 4 and 10). Milking cows are directed through a copper sulfate hoof bath when entering and exiting the milking barn to prevent spread of disease and bacteria in an area of high cow traffic (refer to Photograph 11). Milk product is stored in two 20,000-gallon milk silos. Well water used for general dairy operations is stored in a 17,000-gallon aboveground tank located adjacent to the milk silos.

4. During the inspection, I observed chemical storage practices that may present hazardous conditions for Facility employees and livestock. Specifically, I observed multiple 55-gallon drums of caustic detergent and acid stored together on pallets, outdoors without secondary containment (refer to Photographs 4 and 10). After the inspection, I reviewed the Safety Data Sheets (SDSs) for the two CIP chemicals and verified that the chemicals were incompatible based on their pH: Solution[®] chlorinated alkaline detergent 11.5 standard pH units; CIP Acid Cleaner 2.4 standard pH units. Mr. Duff stated that due to a lack of storage space, surplus CIP chemicals are stored on wooden pallets outside each of the freestall barns. Due to the incompatibility of acids and bases, uncontained drums of the two CIP chemicals stored adjacent to each other can create environmental and health hazards in the event of a spill or leak. This concern is elevated due to the truck/tractor traffic at the freestall barns associated with feed and bedding operations.

Photograph 10. View of two 55-gallon drums of acid and two 55-gallon drums of caustic detergent used in the milking barn CIP system. The drums were stored outside, without overhead coverage or containment, and in close proximity to each other. Photo by A. D'Angelo; 12/14/16.

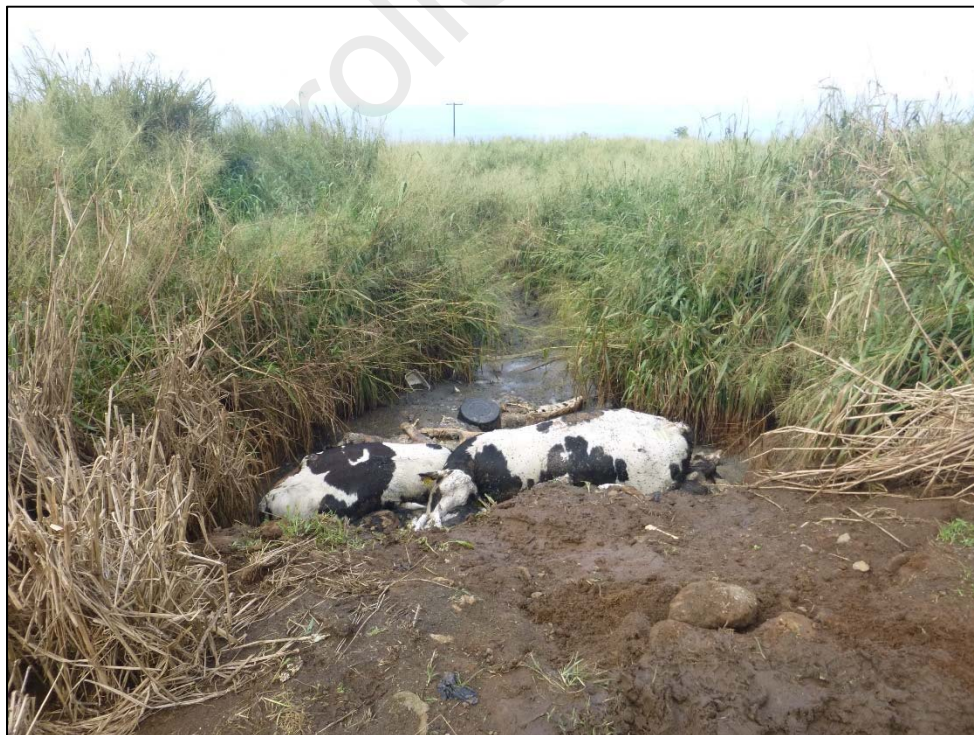
The BID Representatives stated that mortalities are buried onsite. The mortality burial pit that was in use at the time of the inspection was located in an existing gulch located between the covered manure separation cells access roadway and the newly constructed 2.5 million-gallon lower wastewater lagoon (refer to Photograph 14). Mr. Duff stated that any storm water runoff that comes into contact with the open mortality burial pit would sheet flow into the lower lagoon.

Photograph 14. View, facing northeast, of the Facility’s active mortality burial pit, which was located near the manure separation cells, in an existing gulch that drains into the lower lagoon. Photo by A. D’Angelo; 12/14/16.

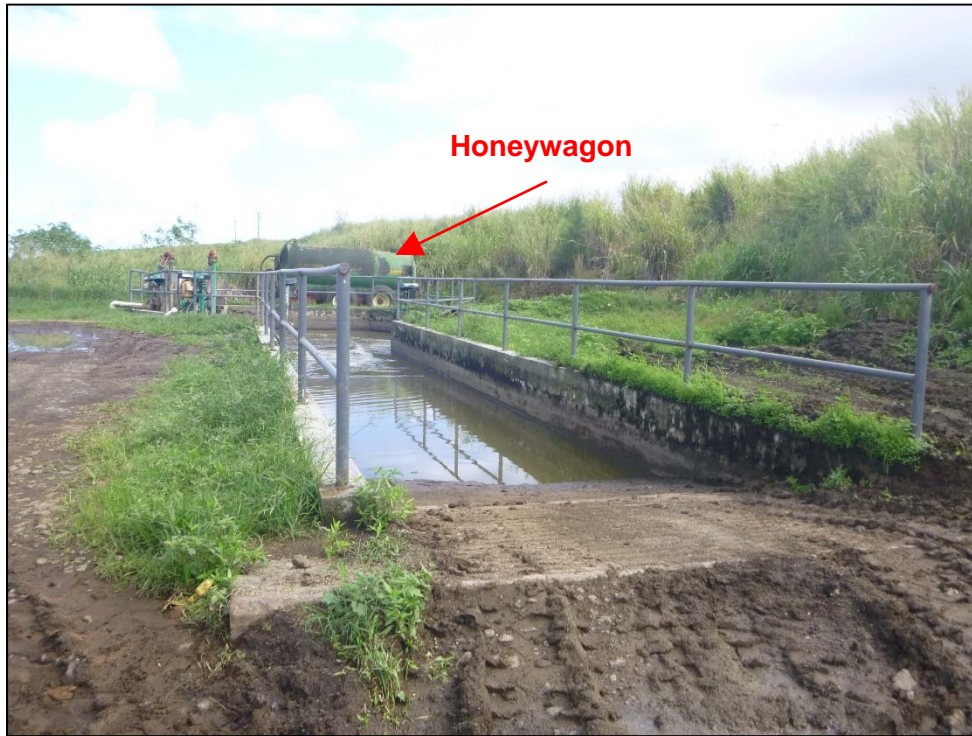
- Steep topography of the BID property, and
 - High annual rainfall amount.
3. During the inspection, I observed a potential for pollutants from the Facility's manure composting operations to contaminate storm water runoff. The manure composting building is located near the origin of Alaialoa Gulch (refer to Figure 3). Storm water runoff from the manure composting building, and uncovered concrete cow bedding loading area appears to most likely flow into the upgradient reach of Alaialoa Gulch. As previously stated, during the visit to the manure composting building, I observed a tractor actively loading a trailer with cow bedding (refer to Photographs 15 through 19, and 21).

Photograph 15. View of the Facility's manure composting building collection pit. Waste streams from the freestall barns, calf barn, and milking barn gravity flow into this collection pit. Note the honeywagon stored behind the collection pit. Photo by A. D'Angelo; 12/14/16.

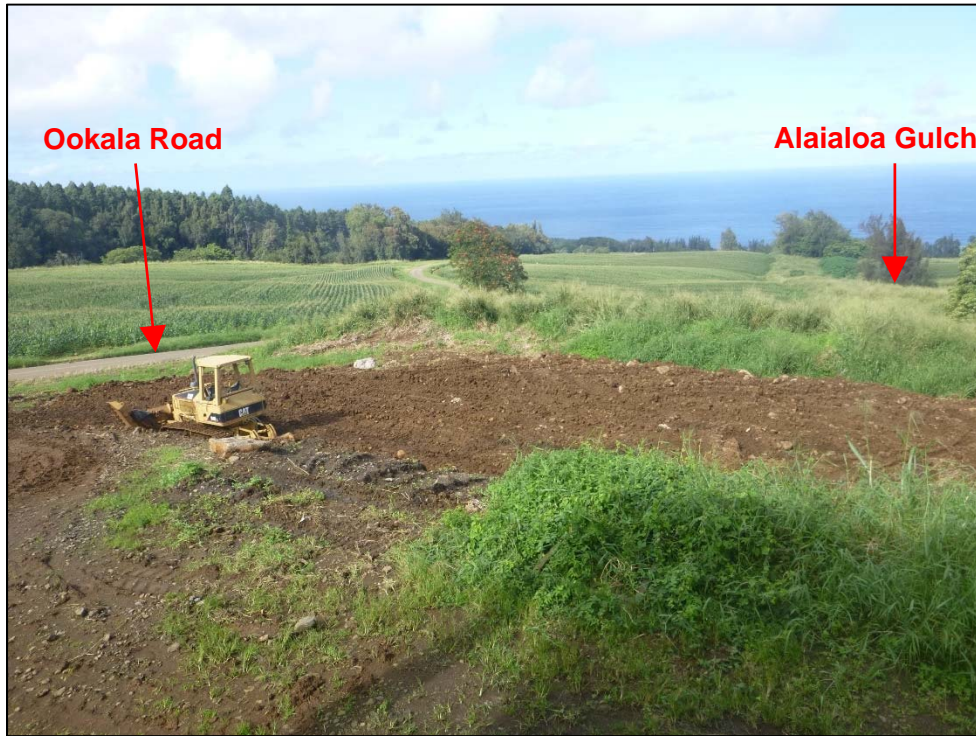
Photograph 21. View, facing north, of a disturbed area near Ookala Road. This area will be paved to store the honeywagon shown in Photographs 15 and 20. I observed a vegetated buffer between the disturbance and Alaiialoa Gulch. Photo by A. D'Angelo; 12/14/16.

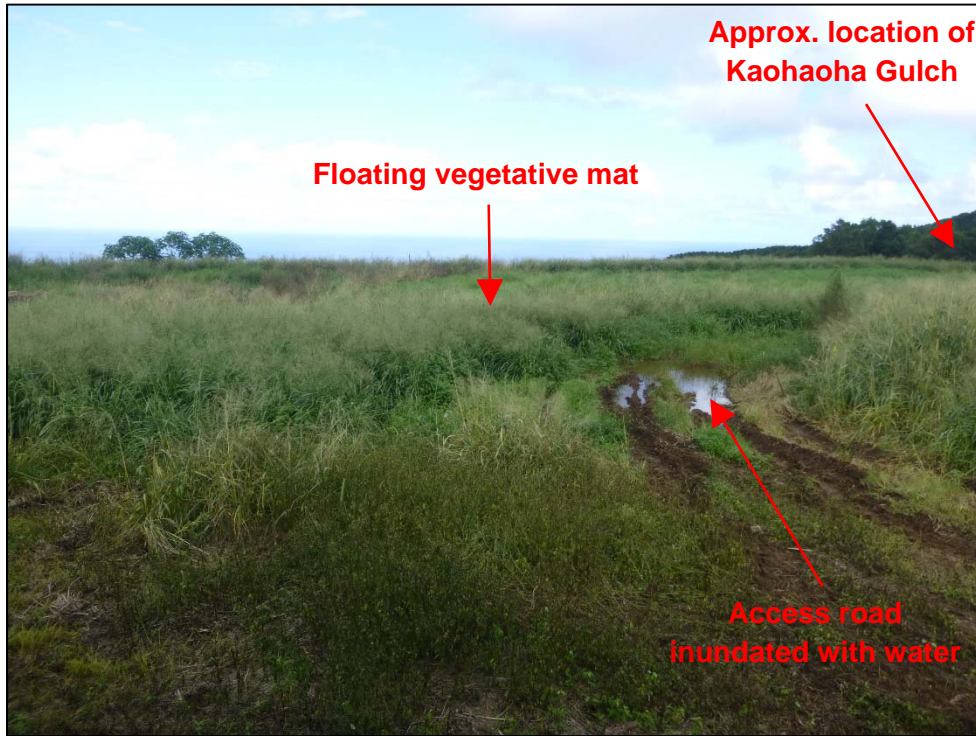
At the time of the inspection, Mr. Kurano and I observed the large vegetative mat on the surface of the upper lagoon (refer to Photograph 25). Mr. Duff stated that the vegetative mat has been present since the property was purchased in 2012, and that it has prevented Facility personnel from accessing the lagoon or identifying the depth of accumulated solids. As such, Mr. Duff stated that the upper lagoon had not been cleaned since at least 2012, and that he was unaware of the depth of solids in the lagoon or the exact date of the last cleaning event. Mr. Kurano and I observed that the upper lagoon was not equipped with a depth marker at the time of the inspection.

- Potential overloading of solids in the upper lagoon,
 - Possibility of storm water runoff from upgradient areas entering the lagoons,
 - Inaccessibility of the upper lagoon's east abutting side to Kaohaoha Gulch (refer to Photograph 25),

Photograph 25. View, facing east, of the upper lagoon which contained a floating vegetative mat. An access road along the south side of the lower lagoon was innundated with water. Photo by A. D'Angelo; 12/14/16.

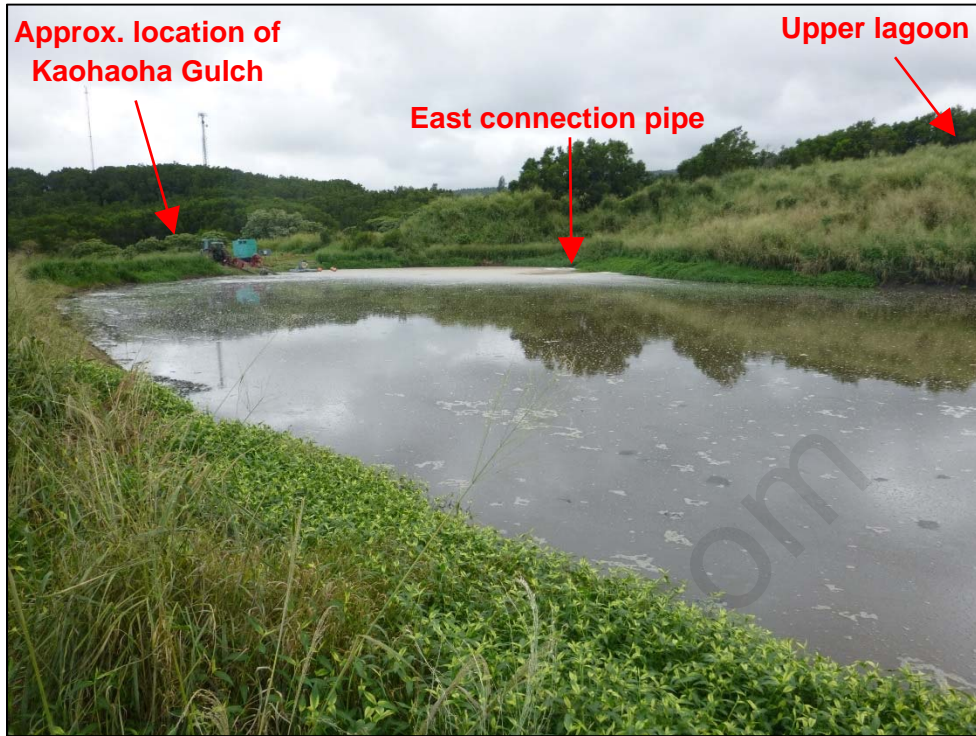
Additionally, the lower lagoon contained a floating agitator unit which was used to agitate and suspend manure solids in the lower lagoon prior to engaging the draw pumping system for irrigation (refer to Photograph 28). Due to the minimal freeboard in the lower lagoon, there exists a possibility of spillover from lagoon into the overflow spillway due to agitation activities that may occur near the overflow spillway.

Photograph 27. View, facing southeast, of the lower lagoon. I observed a floating agitator unit, draw pumping system, and overflow spillway on the southeast side of the lagoon. Photo by A. D’Angelo; 12/14/16.

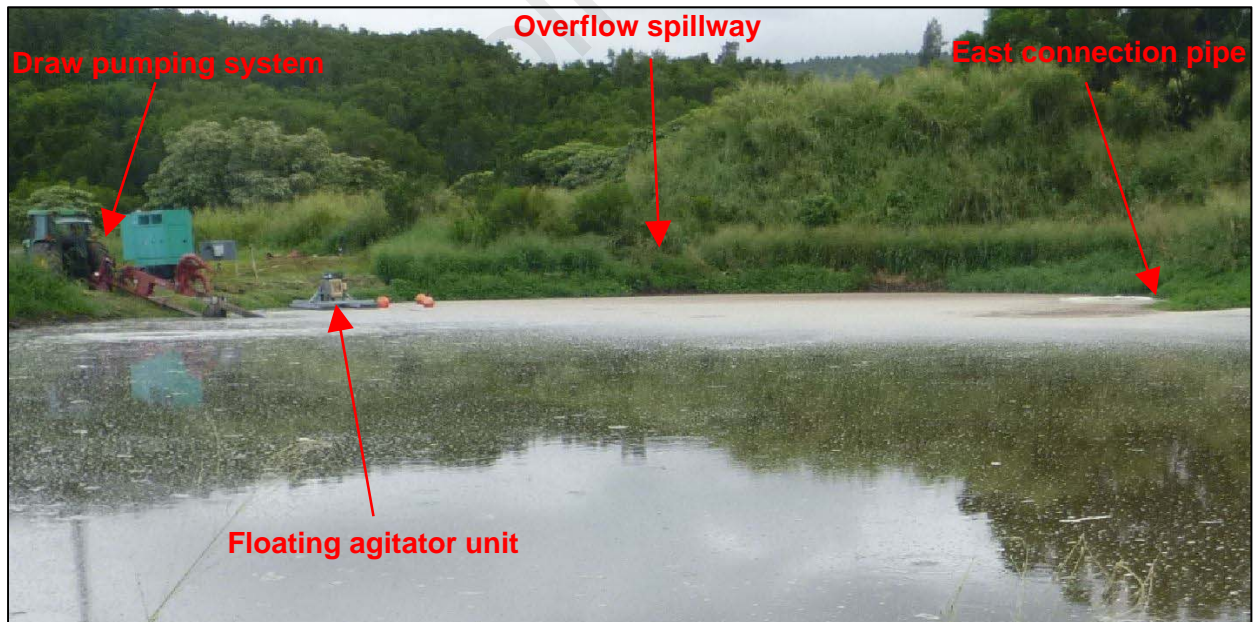
Photograph 28. Zoomed-in version of Photograph 27, showing the floating agitator unit, draw pumping system, and overflow spillway of the lower lagoon. Photo by A. D’Angelo; 12/14/16.

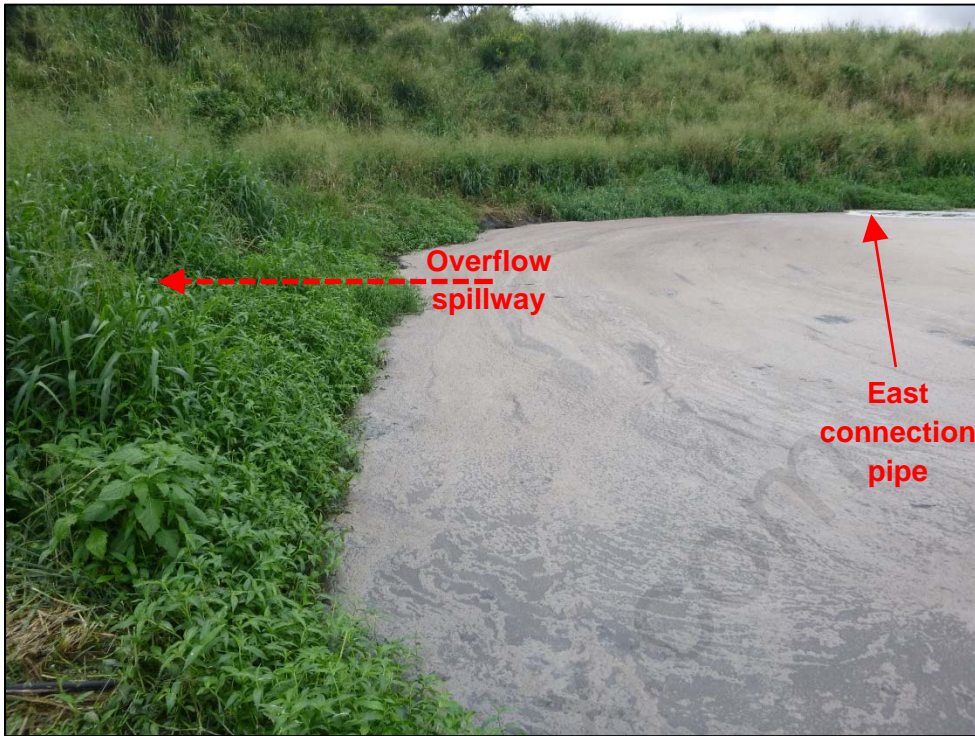
- Proximity of the upper and lower lagoons to Kaohaoha Gulch (refer to Figures 2 and 3),
- Presence of the lower lagoon overflow spillway and conveyance channel into Kaohaoha Gulch (refer to Photographs 31 through 36),
- Minimal freeboard available in the lower lagoon (refer to Photographs 31 through 34),

Photograph 31. View, facing south, of the approximate location of the lower lagoon overflow spillway. Photo by A. D'Angelo; 12/14/16.

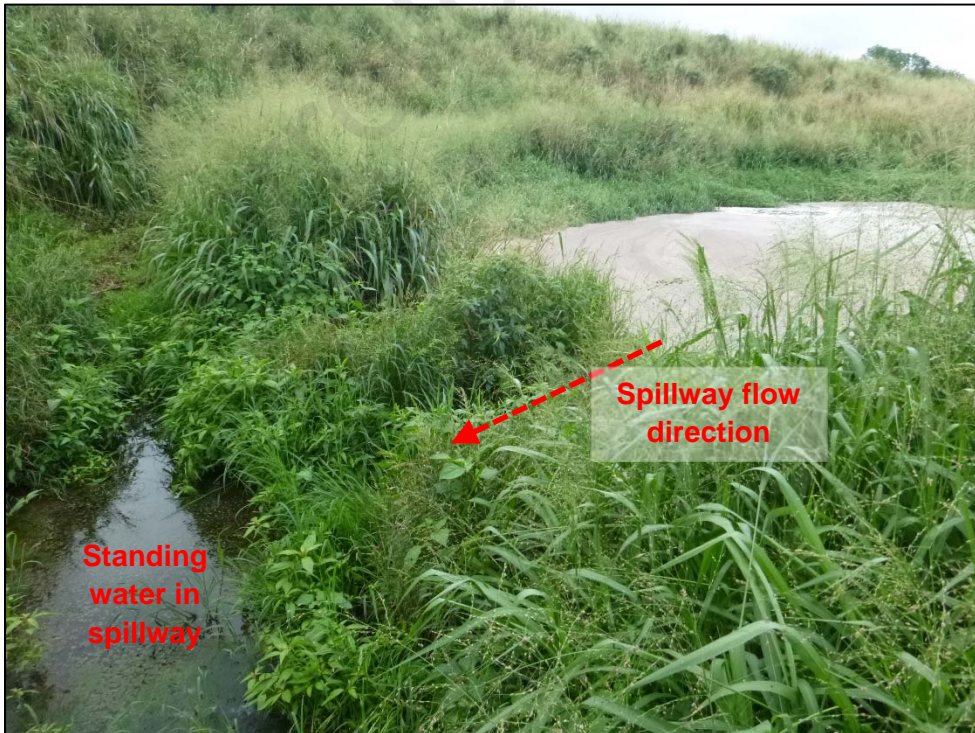
During the inspection, I observed algae growth and standing water in the lower lagoon's overflow spillway (refer to Photographs 32, 33, and 35). Mr. Duff stated that he did not believe that the standing water present in the lower lagoon overflow spillway was from the lagoon, but from storm water runoff from upgradient land caused by recent heavy rainfall. This was inconsistent with a statement made by the BID Representatives during the opening conference, when they stated that the lagoons do not receive storm water runoff. The upper lagoon is located directly upgradient from the lower lagoon and overflow spillway (refer to Photograph 27). As previously stated, Mr. Duff informed Mr. Kurano and I that a large floating vegetative mat on the surface of the upper lagoon prevented Facility employees from accessing the lagoon for cleaning, and as such, the upper lagoon had not been cleaned since the current owners purchased the Facility in 2012. At the time of the inspection, the upper lagoon was not equipped with a depth marker. Additionally, Mr. Duff stated that the majority of flow from the upper lagoon is transferred to the lower lagoon via the east connection pipe. At the time of the inspection, an access road that runs along the south side of the upper lagoon was inundated with water; therefore, the perimeter of the upper lagoon, including the east side of the lagoon that abuts Kaohaoha Gulch was inaccessible (refer to Photograph 25).

Photograph 32. View, facing southwest, of the lower lagoon overflow spillway. Note the presence of algae growth and standing water in the overflow spillway. Photo by A. D'Angelo; 12/14/16.

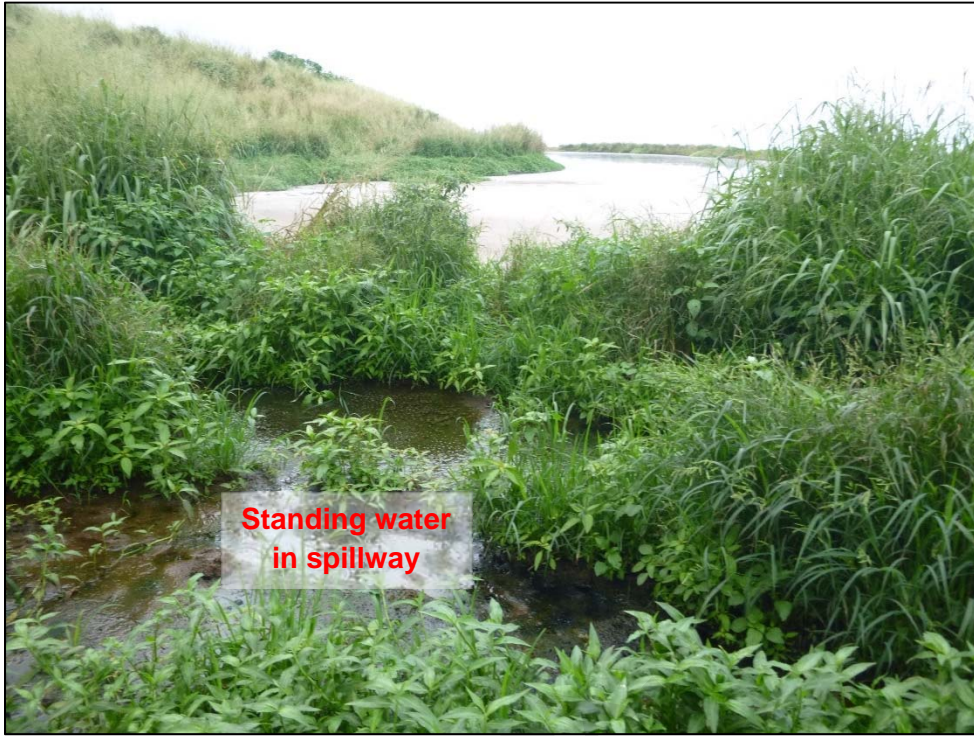
Photograph 33. View of algae growth and standing water in the lower lagoon overflow spillway. Photo by A. D'Angelo; 12/14/16.

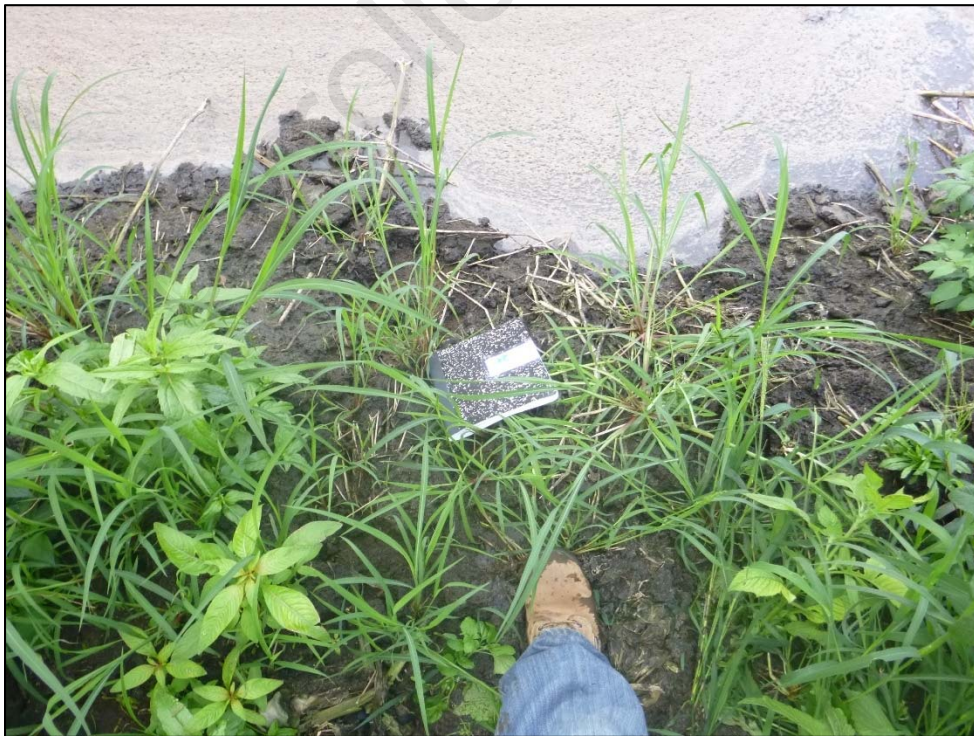
Photograph 34. Standing on the lower lagoon overflow spillway, I estimated the freeboard of the lagoon at approximately twelve inches (note the notebook for reference). Photo by A. D'Angelo; 12/14/16.

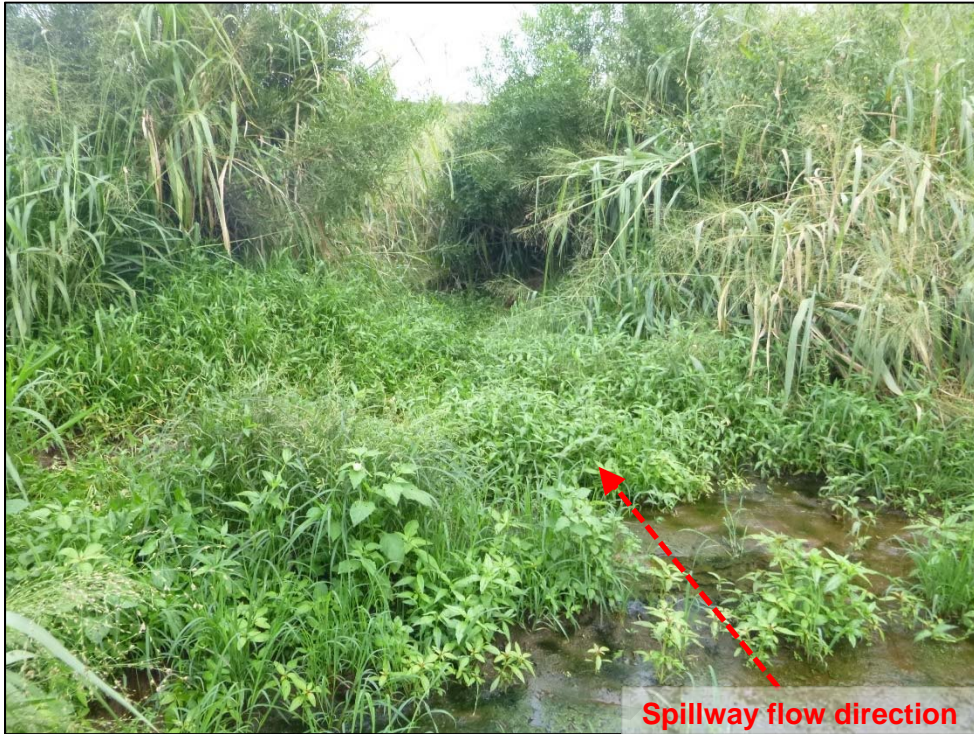
Photograph 35. View, facing southeast from the lower lagoon overflow spillway, down the vegetated channel that connects the lagoon to Kaohaoha Gulch. Photo by A. D'Angelo; 12/14/16.

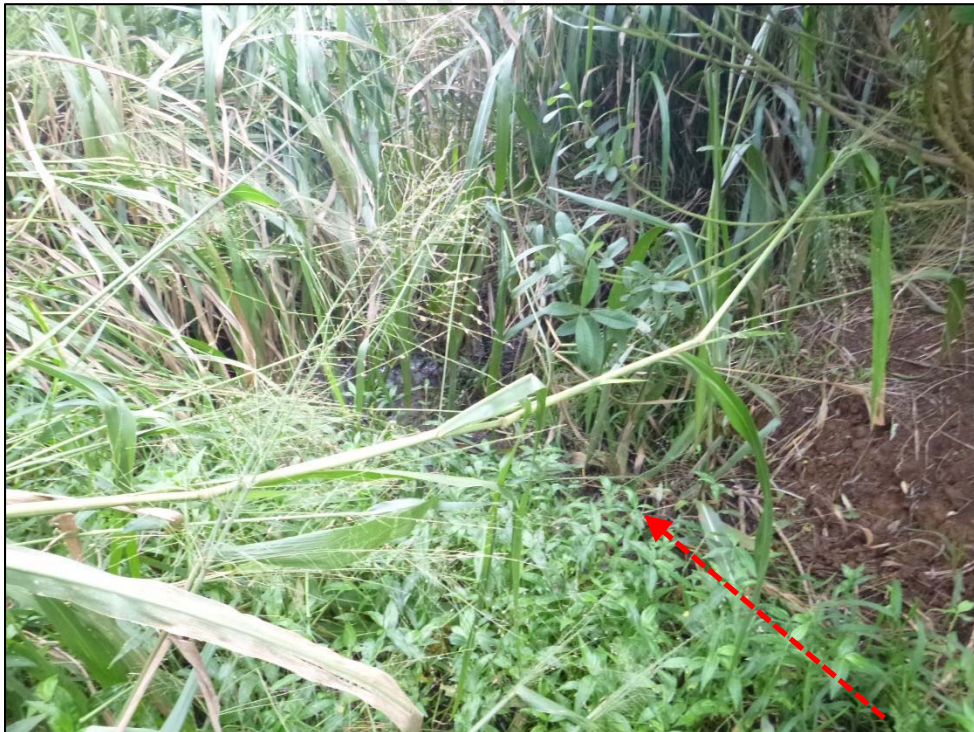
During the opening conference, I asked the BID Representatives if the newly constructed lower lagoon was lined and if it was equipped with an overflow spillway. The BID Representatives did not believe the lower lagoon contained a liner and were initially unaware if the lower lagoon contained a spillway. It should be noted that historical aerial imagery from August 2014 potentially shows a liner on the bottom of the lower lagoon; however, the presence of this liner was not confirmed during the inspection. Before visiting the lagoons, Mr. Duff informed Mr. Kurano and I that a dairy employee went down to the lower lagoon and confirmed that the southeast side of the lower lagoon contained an overflow spillway. We visited the overflow spillway of the lower lagoon and observed algae growth and standing water in the spillway (refer to Photographs 28, and 31 through 33). While standing on the overflow spillway, which was saturated and coated in unstable muck, I estimated the freeboard underneath the lagoon's overflow spillway at approximately twelve inches (refer to Photograph 34). Facing southeast from the overflow spillway, I observed a clear flow pathway down a heavily vegetated conveyance channel that flowed to the southeast (refer to Photographs 35 and 36). Based on aerial imagery, this conveyance channels flows directly into Kaohaoha Gulch, approximately 100 feet southeast of the lower lagoon overflow spillway (refer to Figures 1 through 3). I was unable to hike down the conveyance channel due to unstable mucky conditions and thick vegetation (refer to Photograph 36).

Photograph 36. The channel downgradient of the lower lagoon overflow spillway was heavily vegetated; however, I observed clear channelization and a flow pathway toward Kaohaoha Gulch. Photo by A. D'Angelo; 12/14/16.
