SITE SAMPLING REPORT

August 2014

MI/DU PCB TESTING FOR USCG MAILI EASTERN FENCE LINE, MAILI, OAHU, HAWAII

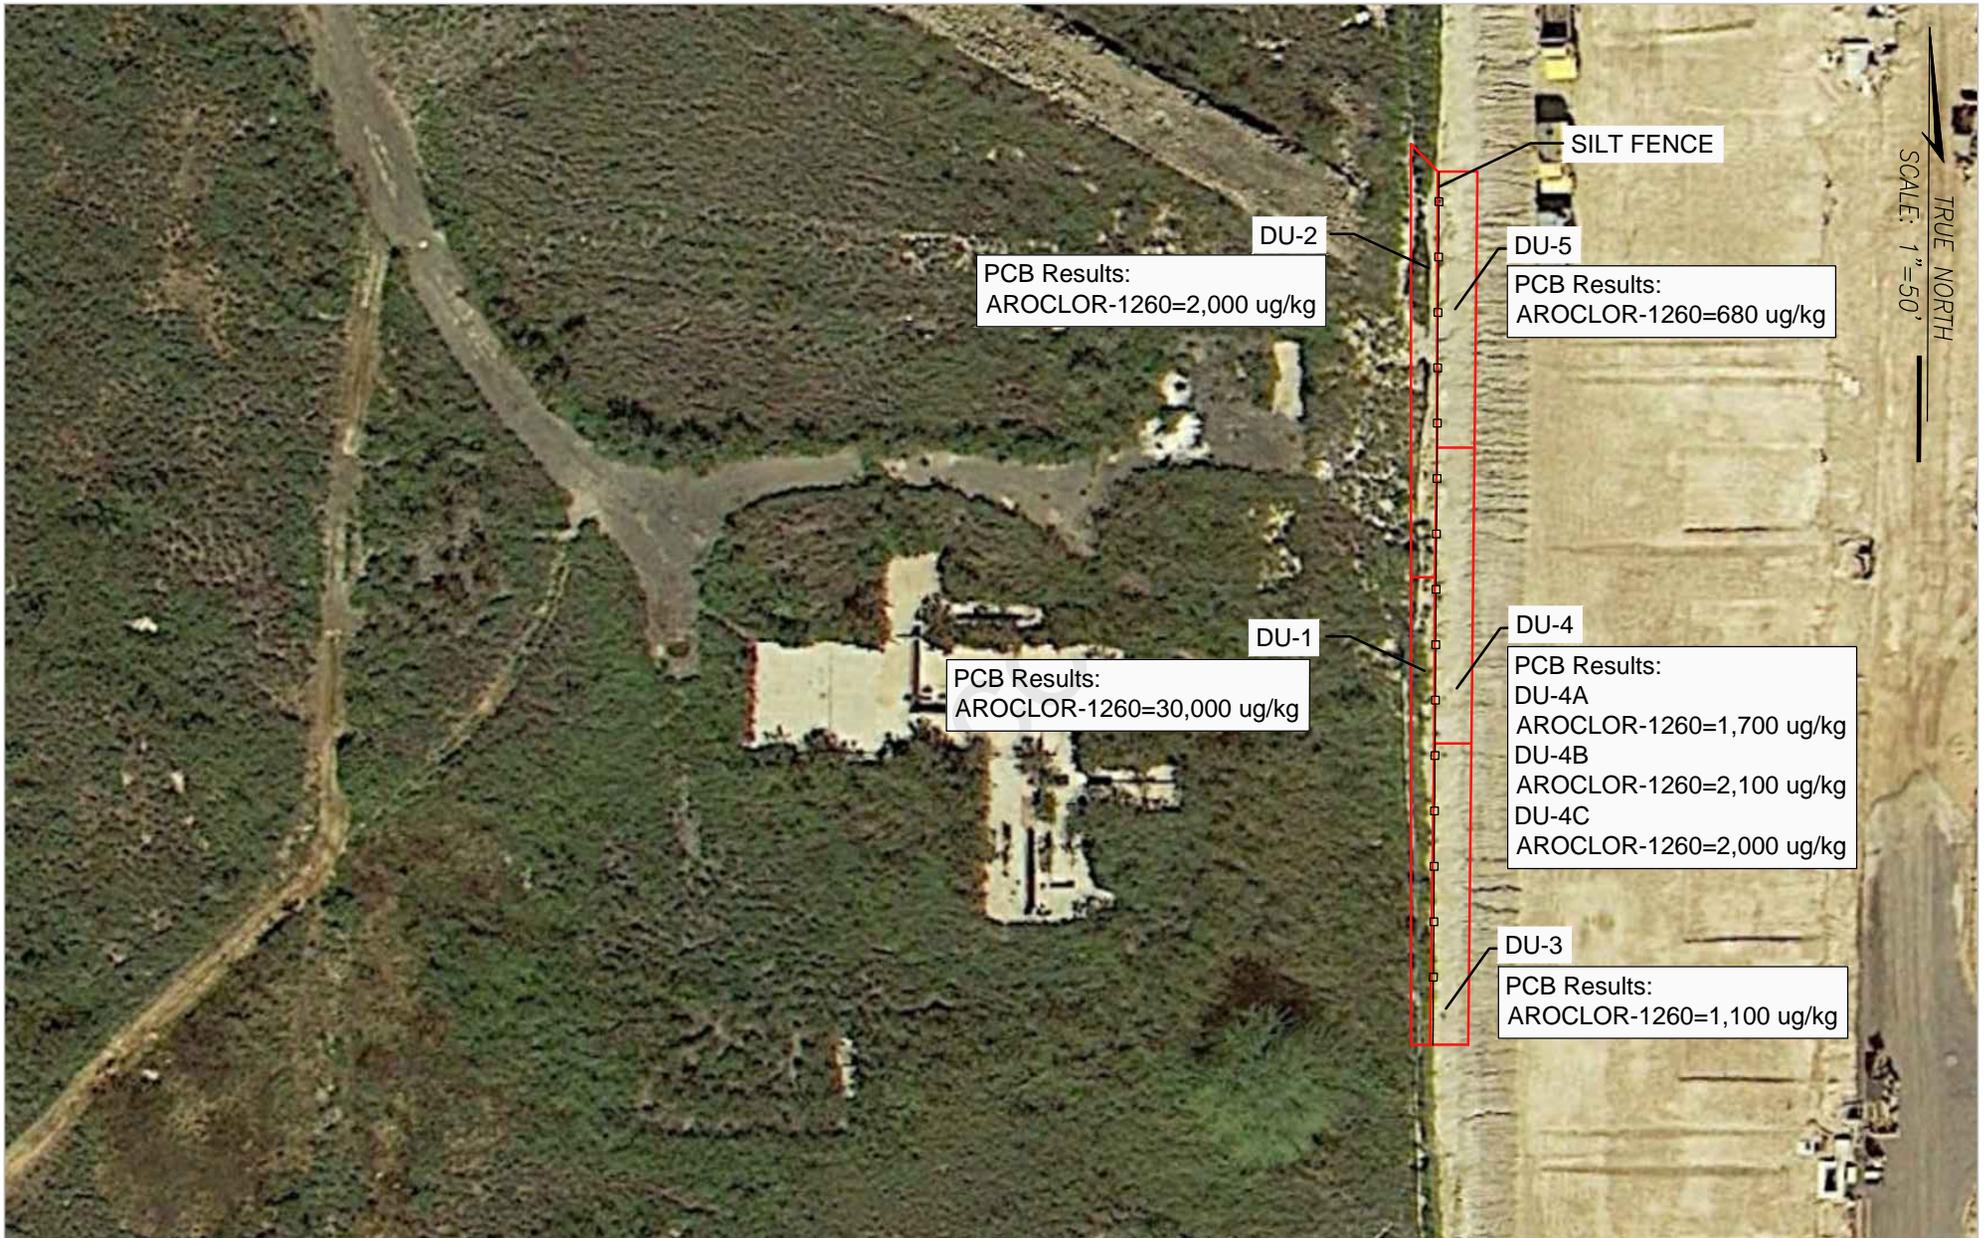
DATE: AUG 2014	PROJECT TITLE: M/DU PCB TESTING FOR USCG MAILI EASTERN FENCE LINE MAILI, OAHU, HAWAII
FIGURE TITLE: SITE MAP AND JUNE 2014 SAMPLING RESULTS	FIGURE NO.: 2

Decision unit (DU) boundaries were located in the field using a hand-held global positioning system (GPS) device. The boundaries of the five DUs are shown on Figure 2.

Table 1 presents the soil sample analytical results for the June 26, 2014 sampling event. Figure 2 shows the results of analysis for the samples collected in relation to each DU. The complete analytical laboratory report is presented in Appendix C.

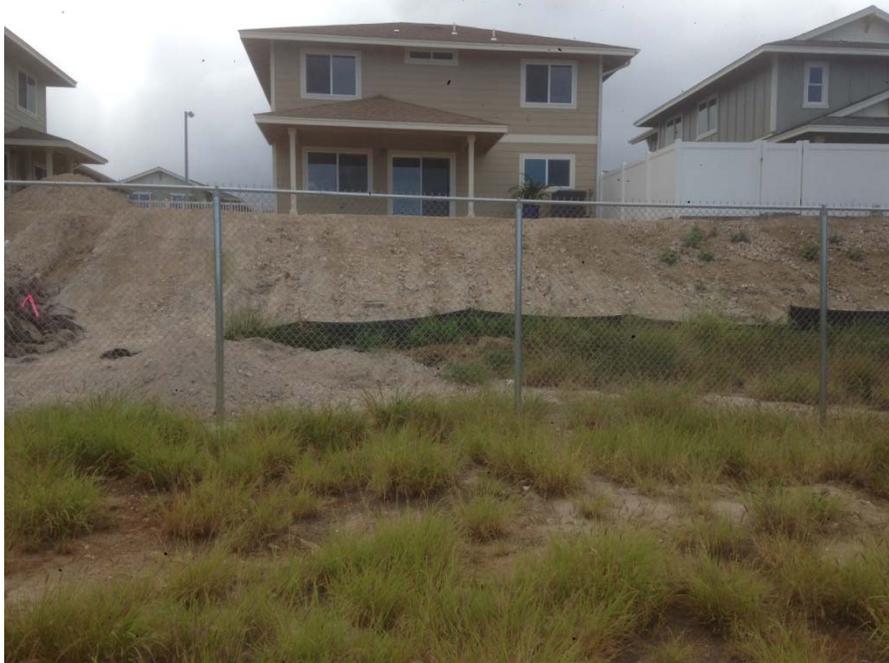
Photo A-1: Looking east from inside of fenced PCB-impacted area. New housing area in background.

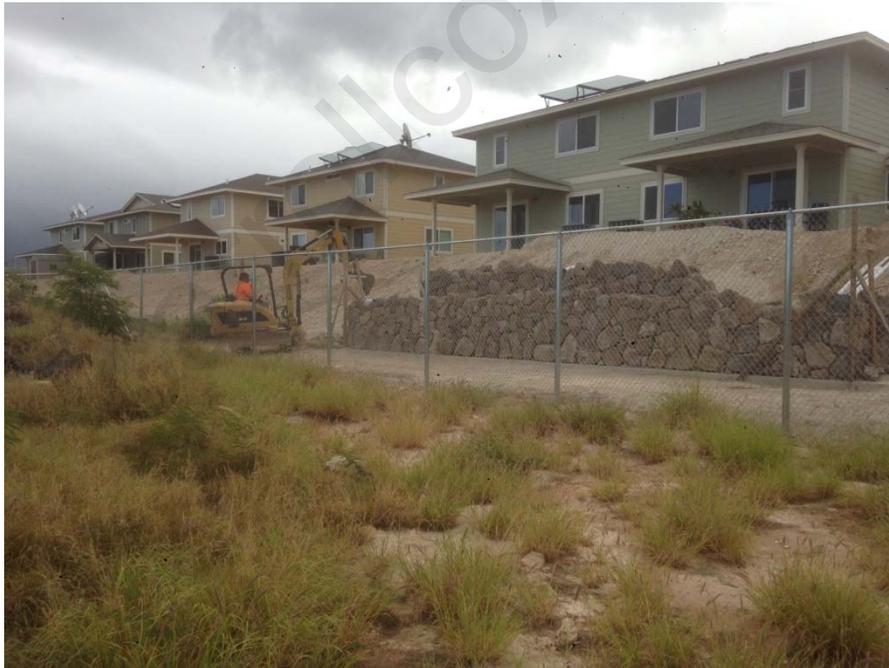
Photo A-2: Looking northeast from inside fenced PCB-impacted area. Construction of retaining wall in progress at the time of soil sample collection.

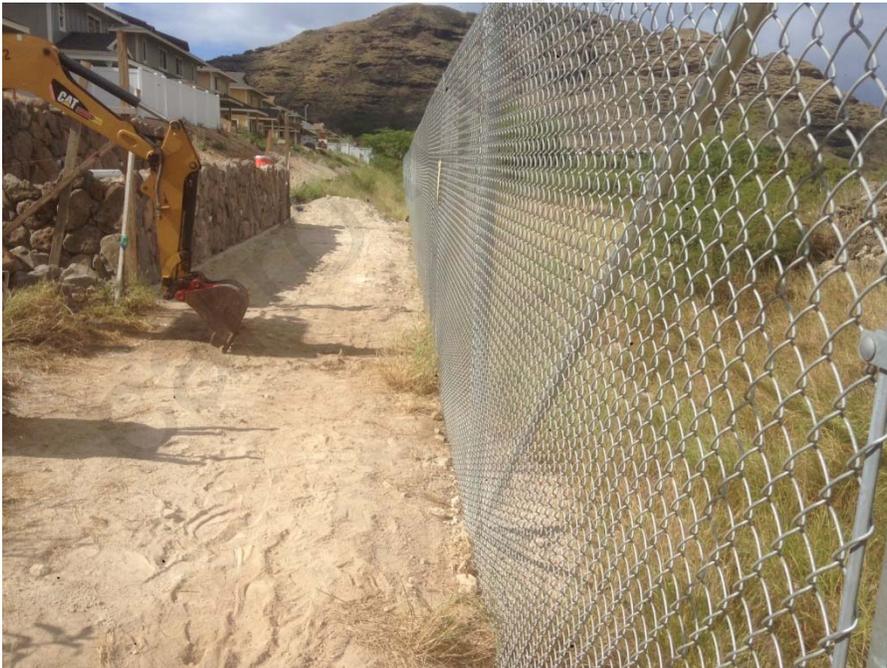
Photo A-4: Looking south from northeastern corner of fence. DU-5 is in the foreground on the eastern side (rock wall side) of the fence.

*Note: Construction of a rock wall on
eastern end of DU-5 - soil
is disturbed

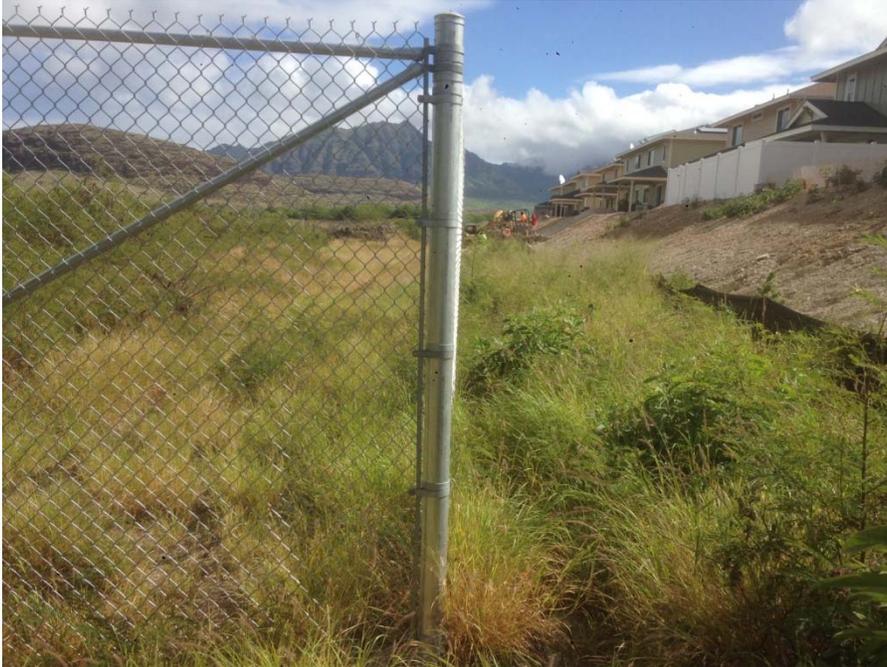
Photo A-5: Looking north from the southeastern corner of the fence. DU-3 is in the foreground on the eastern side of the fence, while DU-1 is in the foreground on the western side of the fence.

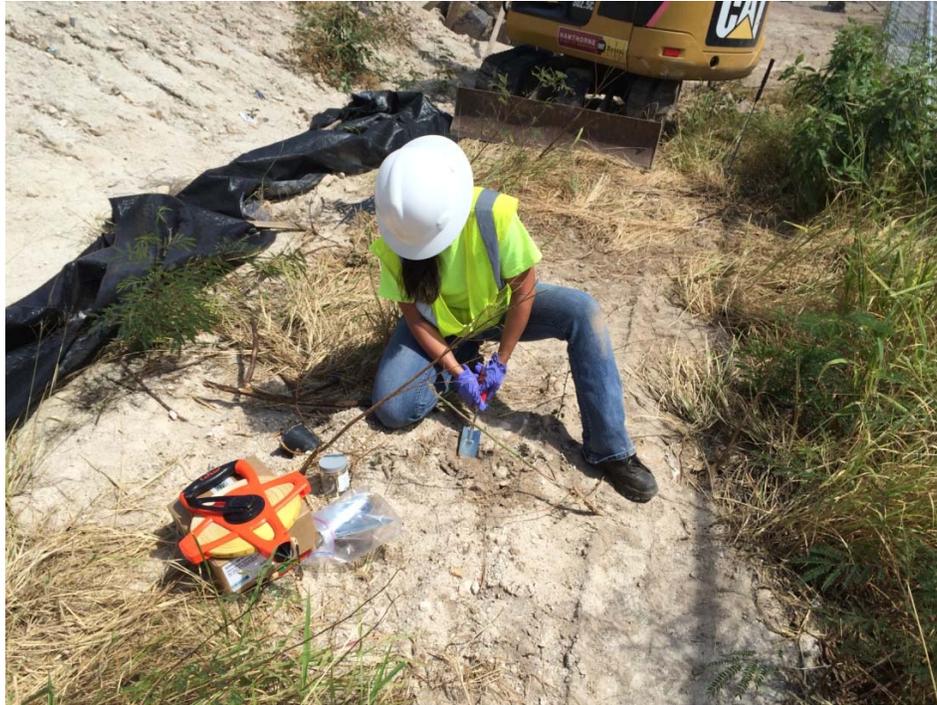
Photo B-1: Soil sample collection at sample location DU-3-05. USCG fence to the right (west) and slope to housing to the left (east).

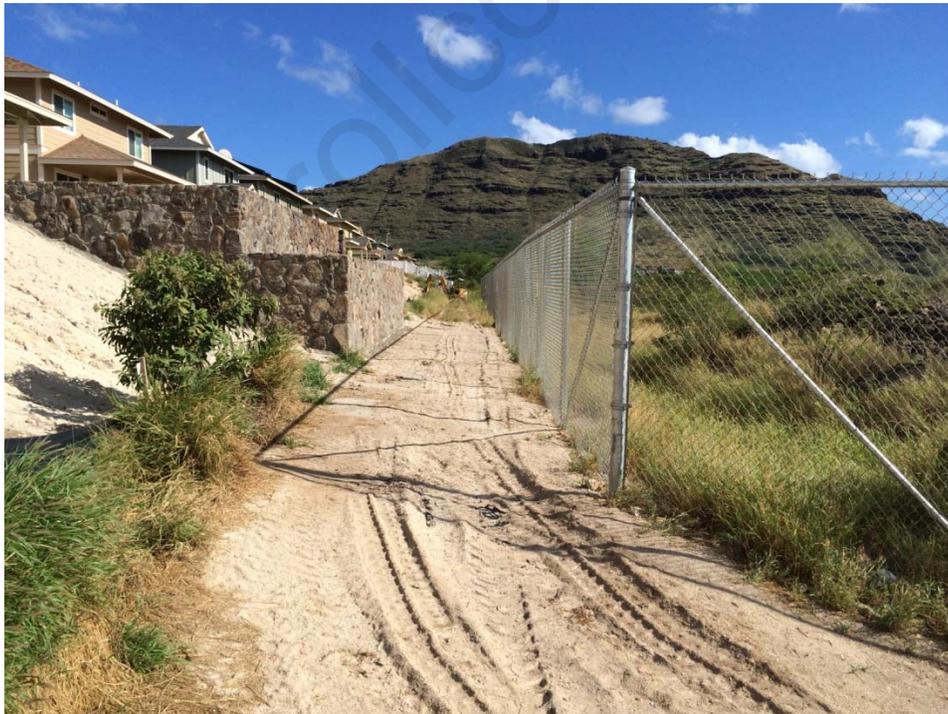
Photo B-2: Looking south with DU-5 in the foreground and DU-4 and DU-3 in the background. USCG fence to the right (west) and slope to housing to the left (east).
