Hawaii Department of Health

Clean Water Branch

Complaint - ALT Inspection

Facility Information	
Facility Name: Big Island Dairy (1)	Permit Number: HIU010287
Location: P.O. Box 49 Ookala, Hawaii 96774	Watershed: None
Tax Map Key(s):	
Receiving Water: Photograph#4	
Facility Representative(s): Brad Duff (General Manager)

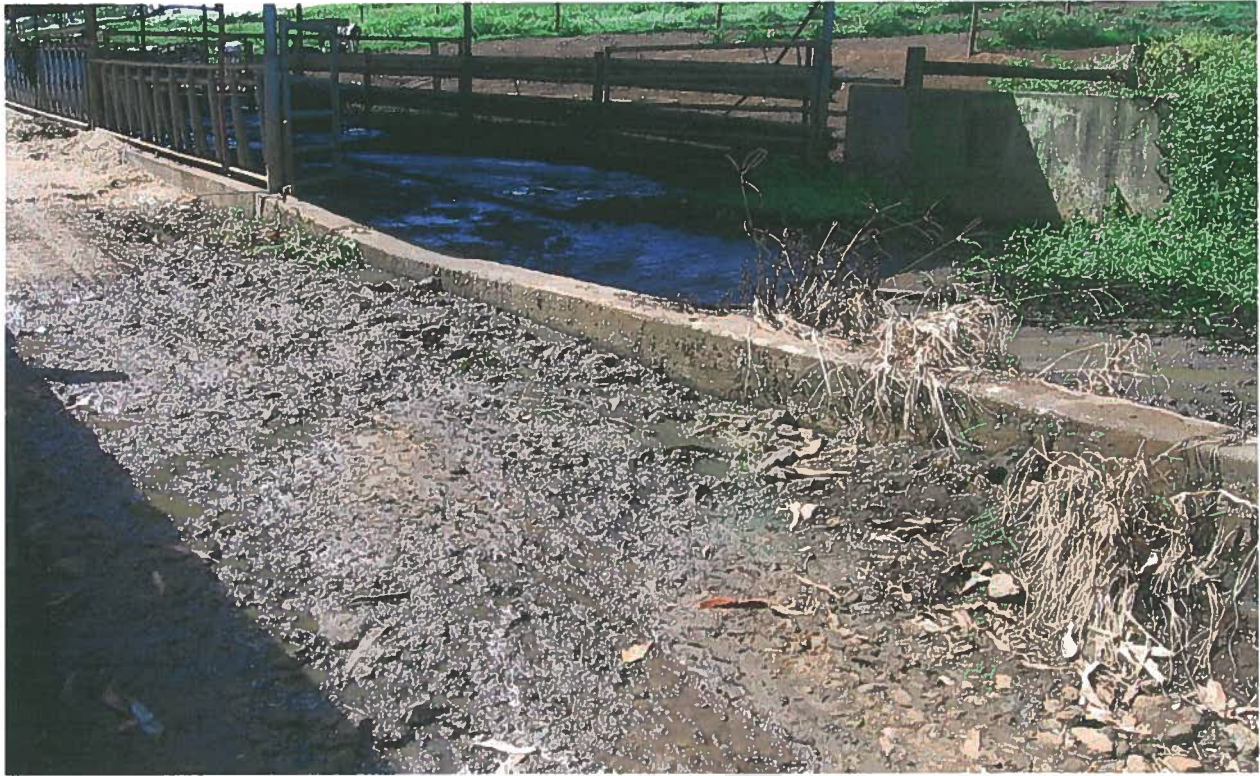
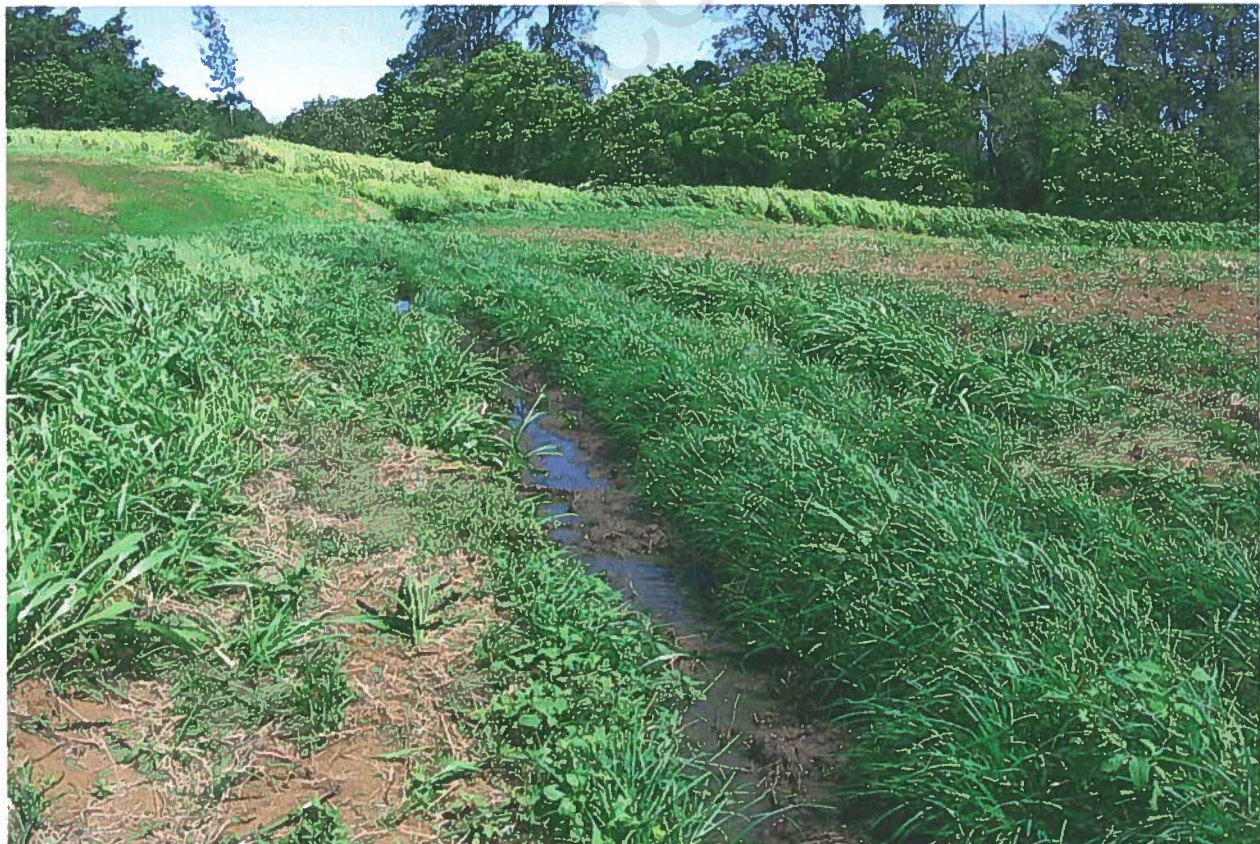
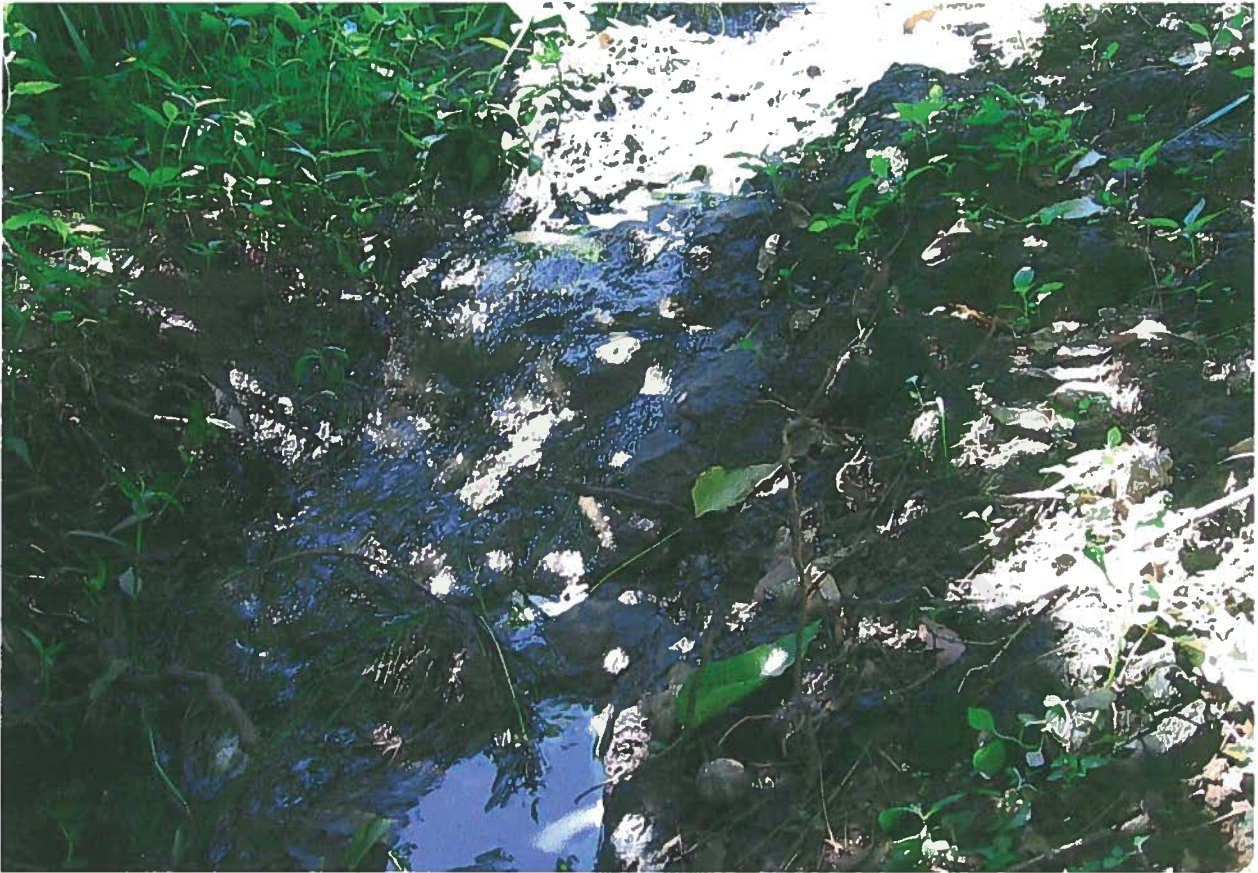
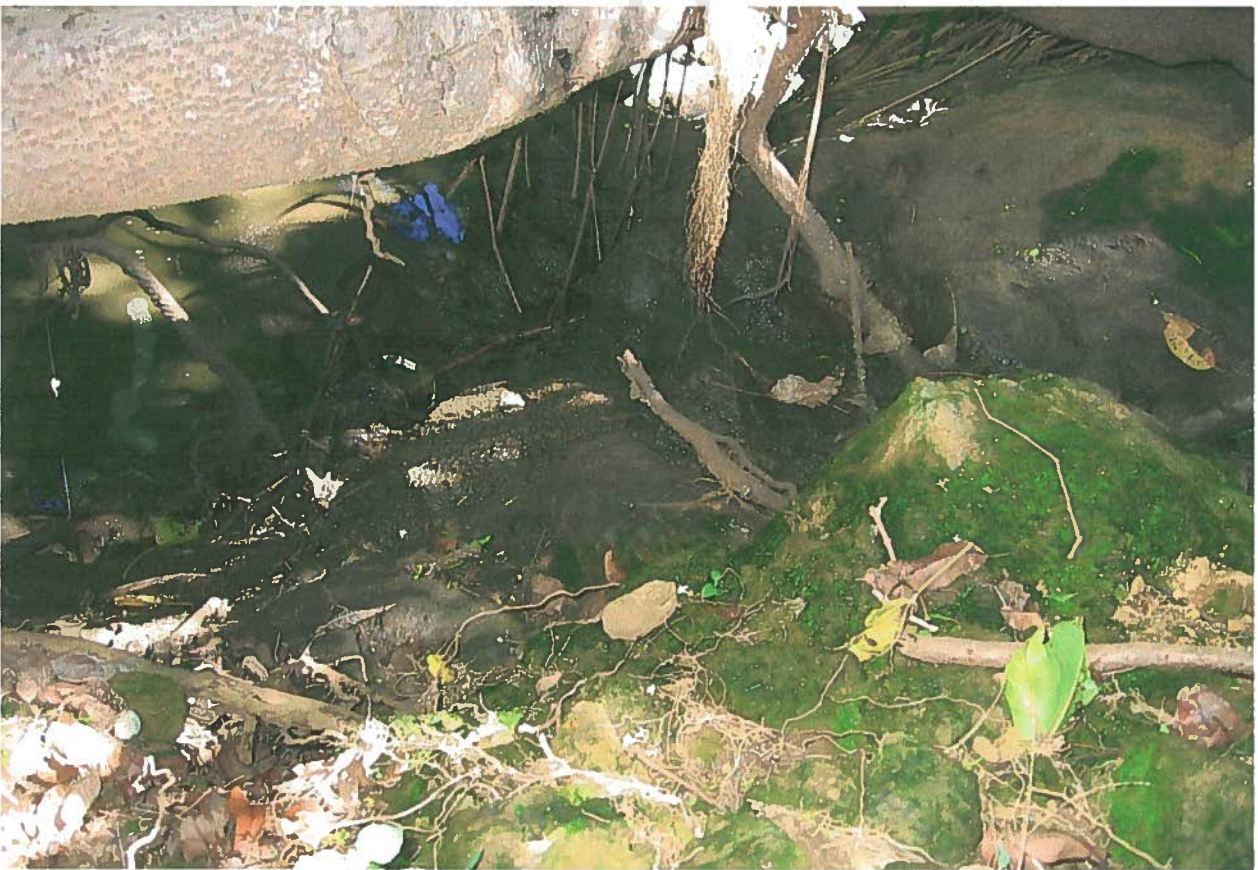
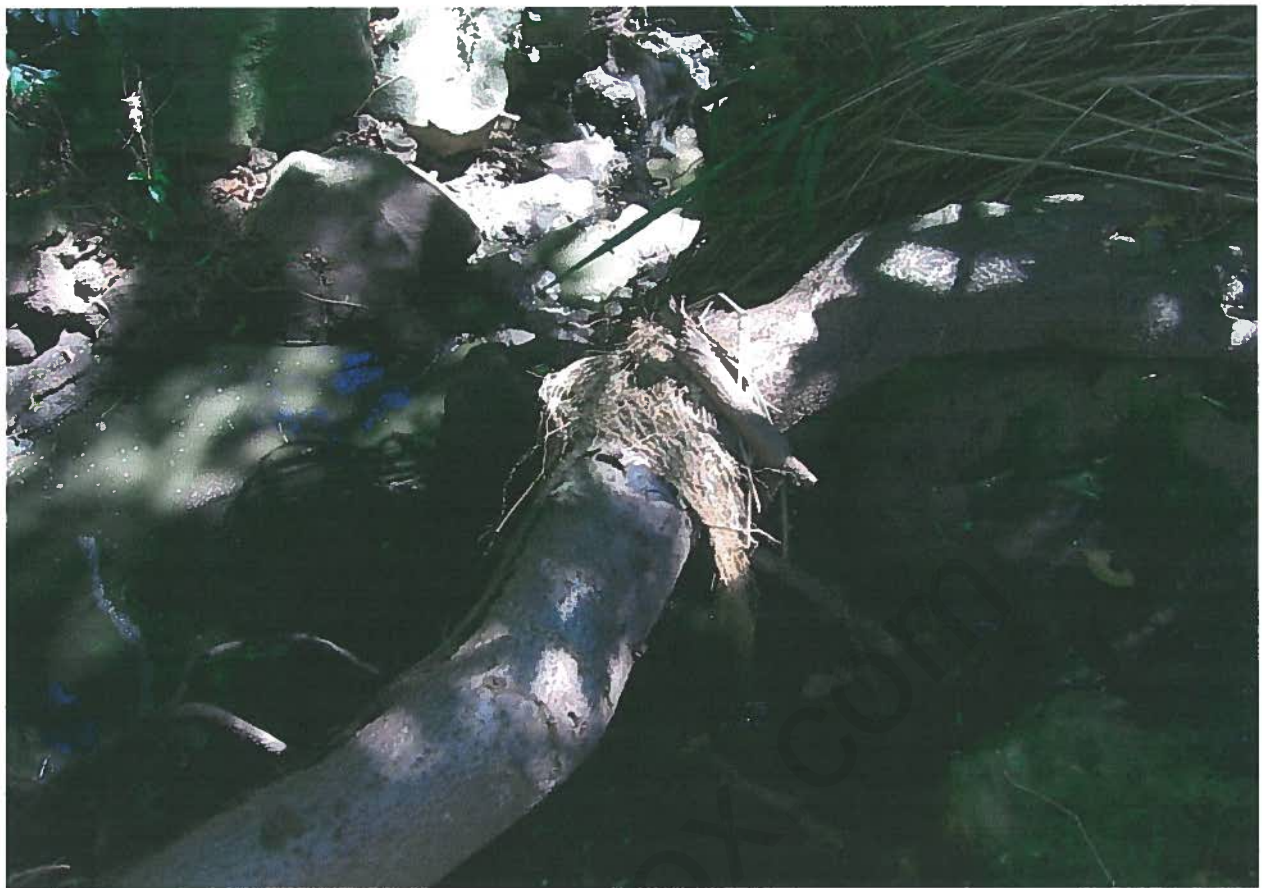
Attachment#1 (These photos were taken by Eric Honda and Michael Une on 7/2/2014)

On 6/30/2014 I received a call about smelly brown water flowing down a stream in Ookala. Later that afternoon I went to investigate the complaint. The stream in question had a steady flow of very turbid brown water that was about 2 ft. wide and 0.5 a foot deep and smelled like cow manure. I then tried to pinpoint the source, and following the flow of the stream which led up toward the highway. When I got up to the highway, there was what looked like a massive sprinkler system spraying brown water over a pasture area above the highway and below the Big Island Dairy. Since it looked like a part of the dairy operation and up a private road, I went back to the office to gather more information from the different State branches on what the dairy was allowed to do.

After inspecting the pasture and stream area we spoke to Mr. Duff and Mr. Smith, to inform them of what we observed and to get some information on their waste disposal methods and the use of their water cannon. According to Mr. Duff, the dairy consists of the milking area and the heifer sheds and has about 1,500 heifers with a little over 1,000 being milked. The sewage from the milking area is hard piped to lagoons where the waste is separated; the liquid gets pumped to the water cannons to be spread over the pastures and the solids which is called a slurry is pumped into a honey wagon and spread over the land as well. The use of the water cannons depends on the weather and the level of saturation of the soil, with the frequency being about every day to every other day for between 4 to 6 hours. In general they run it for 4 hours and check for ponding and rotate it to another location when necessary. The sewage from the heifer sheds is stored in the sewage holding tank then pumped into the honey wagon and spread over the land. When we left the trough had stopped leaking, although the waste area of the heifer sheds was still slightly overflowing.
