**Concentrated Animal Feeding Operation
NPDES Inspection Report**
Facility Name: Big Island Dairy
NPDES Permit No.: Not Permitted

Date and Time: December 14, 2016 **Entry:** 10:00 a.m. **Exit:** 4:45 p.m.

Facility Name: Big Island Dairy

Facility Address: 39-3308 Hawaii Belt Road; Hilo, Island of Hawaii, Hawaii 96720

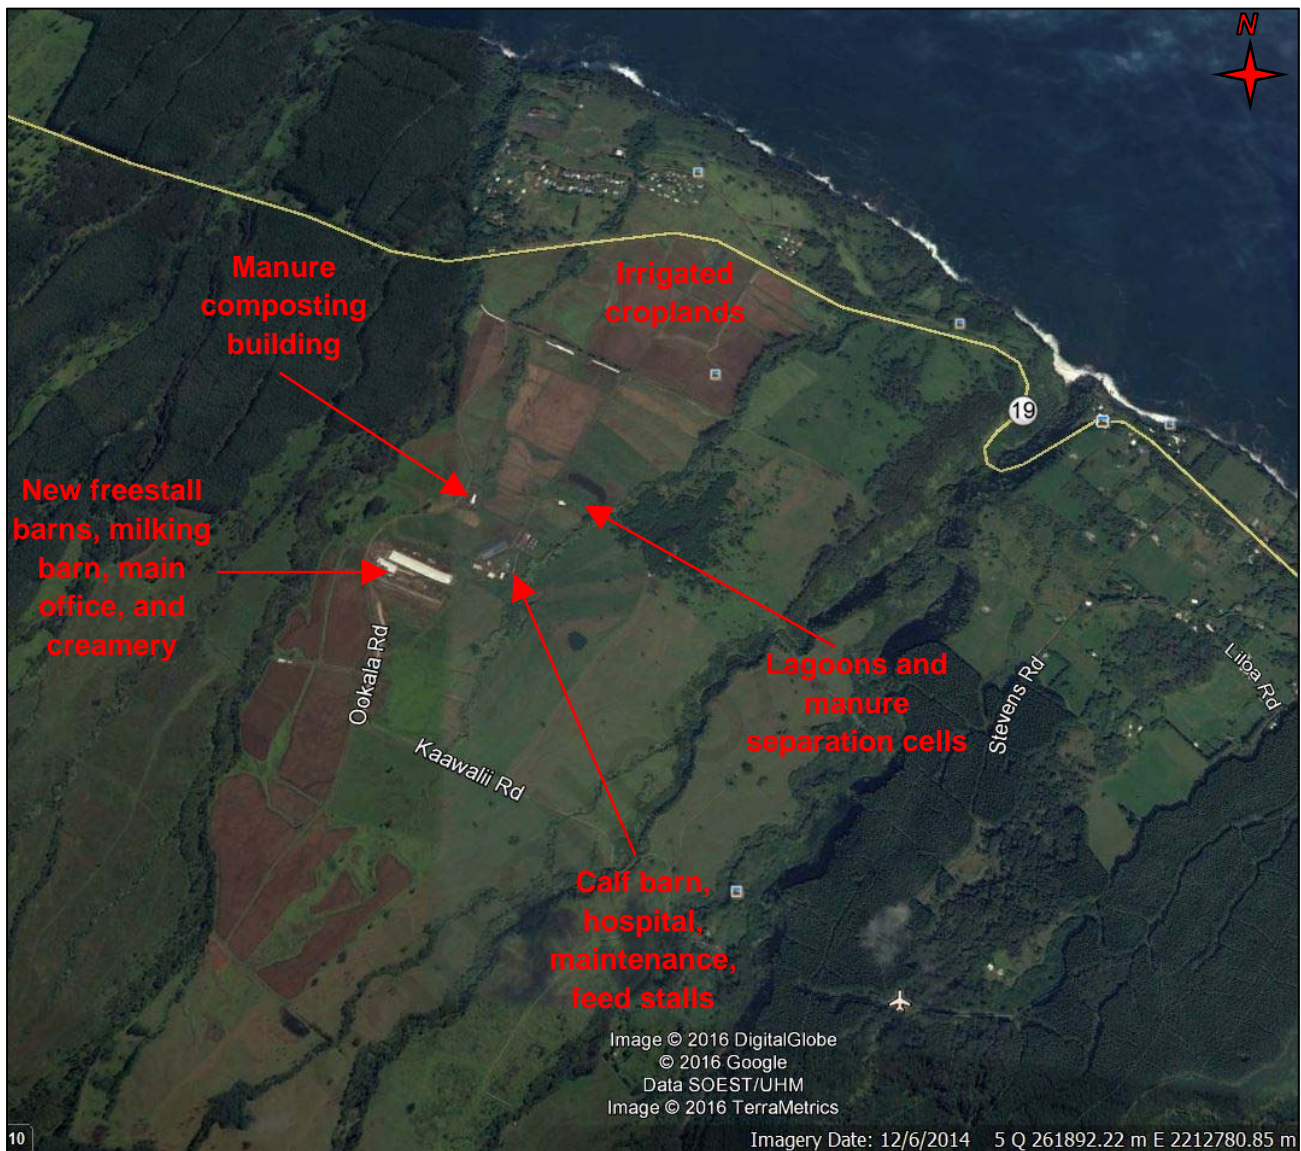
Figure 1. *GoogleEarth* aerial image of the BID Facility, imagery date December 6, 2014. The red arrows and callouts identify the various areas of the Facility visited during the inspection.

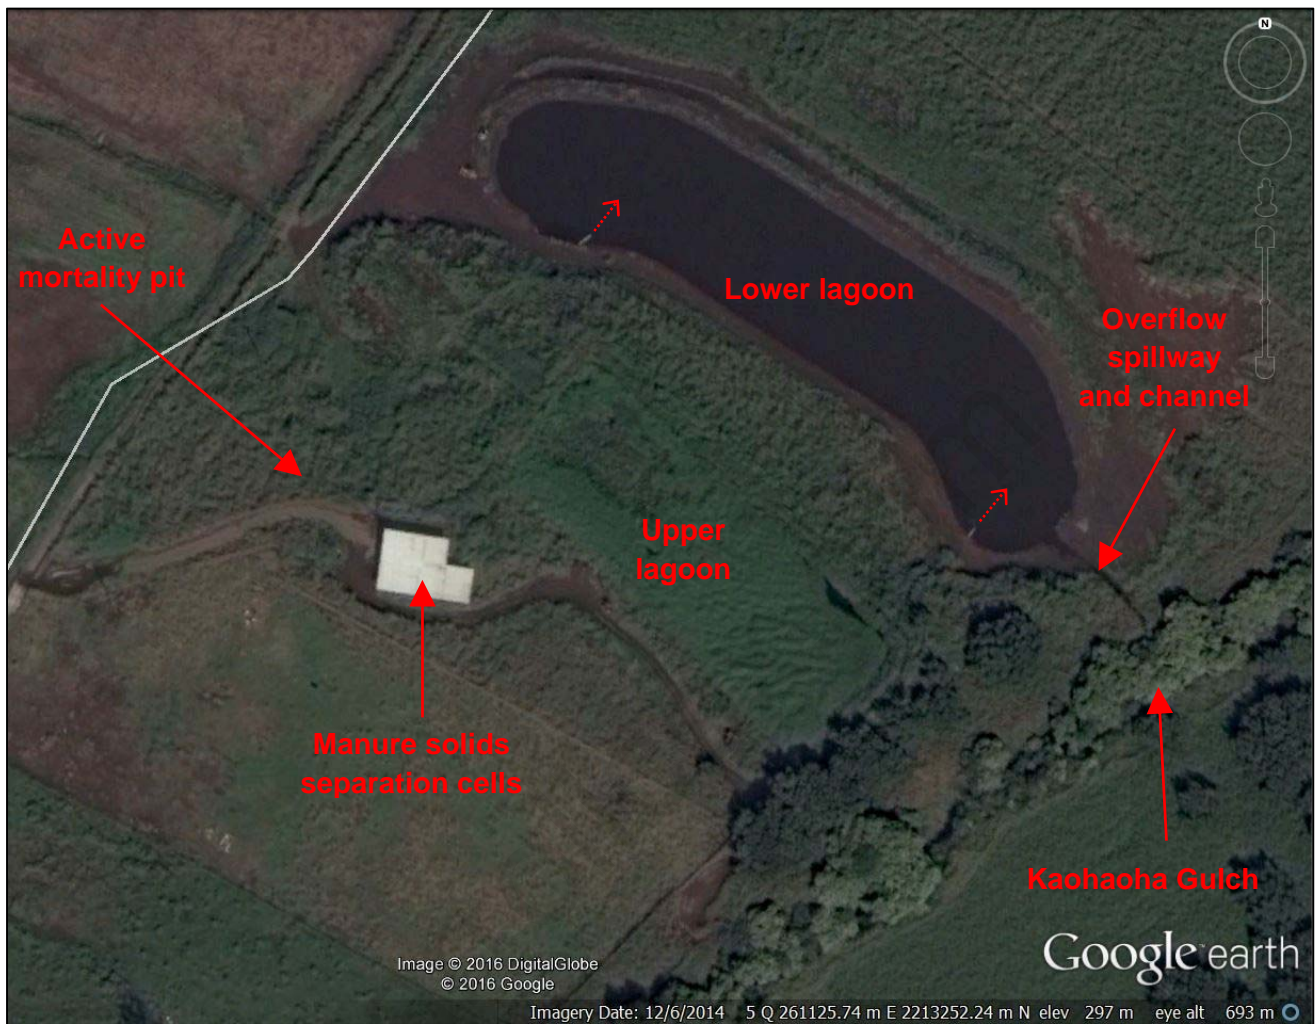
- Proximity of the upper and lower lagoons to Kaohaoha Gulch (refer to Figures 2 and 3),
- Presence of the lower lagoon overflow spillway and conveyance channel into Kaohaoha Gulch (refer to Photographs 31 through 36),
- Minimal freeboard available in the lower lagoon (refer to Photographs 31 through 34),

Figure 2. *GoogleEarth* aerial image of the BID manure separation cells and wastewater lagoons, imagery date December 6, 2014. The red arrows and callouts are approximate location estimations of Facility features observed during the inspection, described in the report, and shown in the Photograph Log.

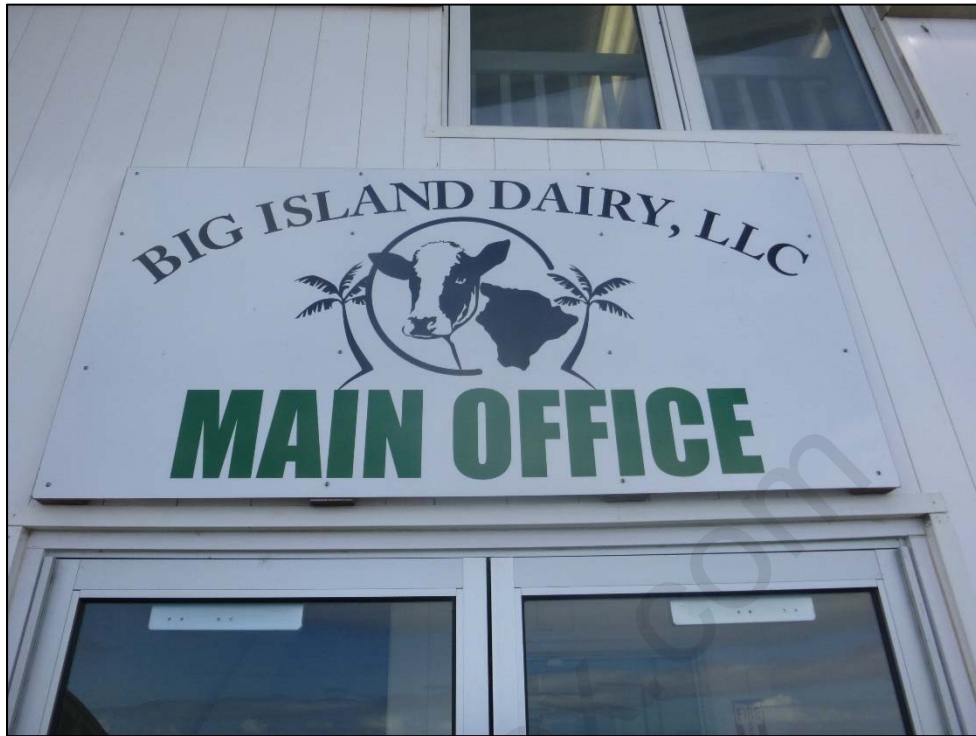
Photograph 1. Big Island Dairy main office sign. Photo by A. D'Angelo; 12/14/16.

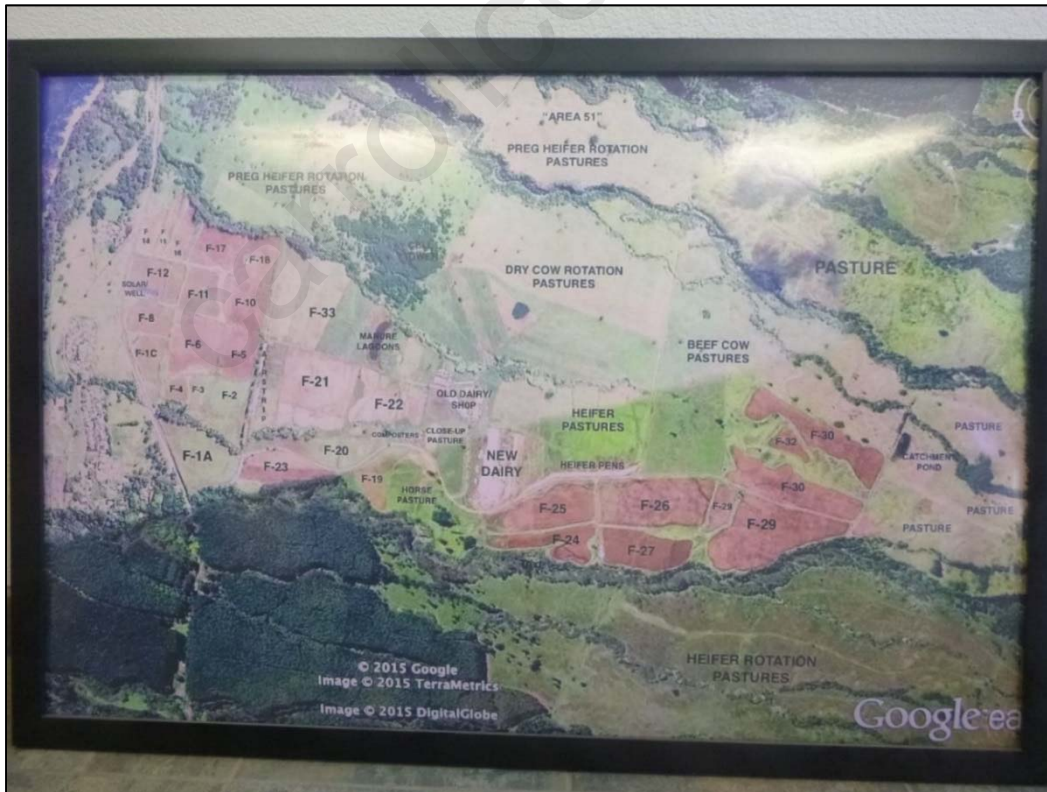
Photograph 2. BID map in main office identifying cropland and pasturelands, dairy facilities, manure composting building, and lagoons. Map oriented to the southeast. Photo by A. D'Angelo; 12/14/16.

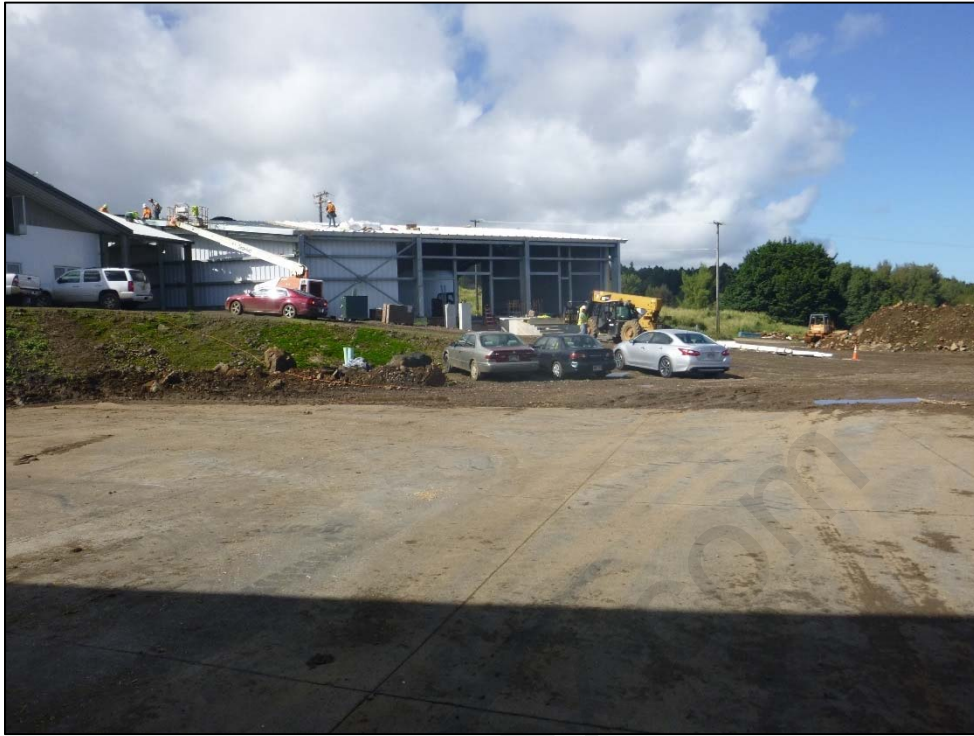
Photograph 3. View of the Facility's new building that was under construction at the time of the inspection. Photo by A. D'Angelo; 12/14/16.

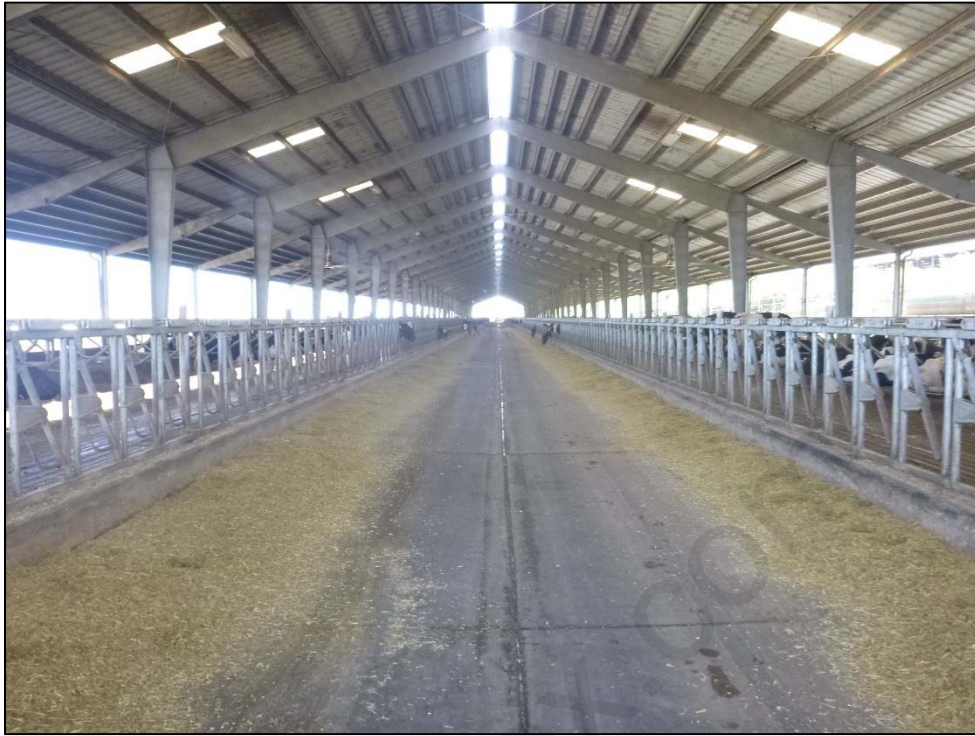
Photograph 5. View down the central feeding alley of the lower 1,000-cow freestall barn. Photo by A. D’Angelo; 12/14/16.

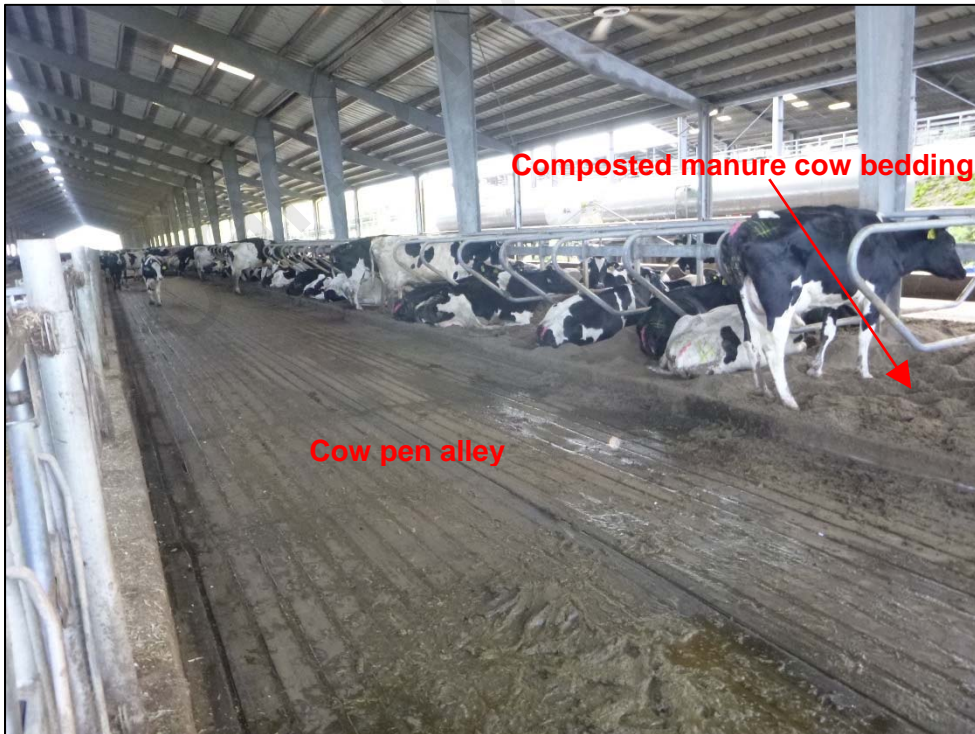
Photograph 6. The cow pen alleys of the freestall barns contain mechanically operated manure scraping systems that scraped manure toward and into a collection trough in the center of each barn. The cow pens were lined with composted manure bedding that is made onsite using recovered manure solids. Photo by A. D’Angelo; 12/14/16.

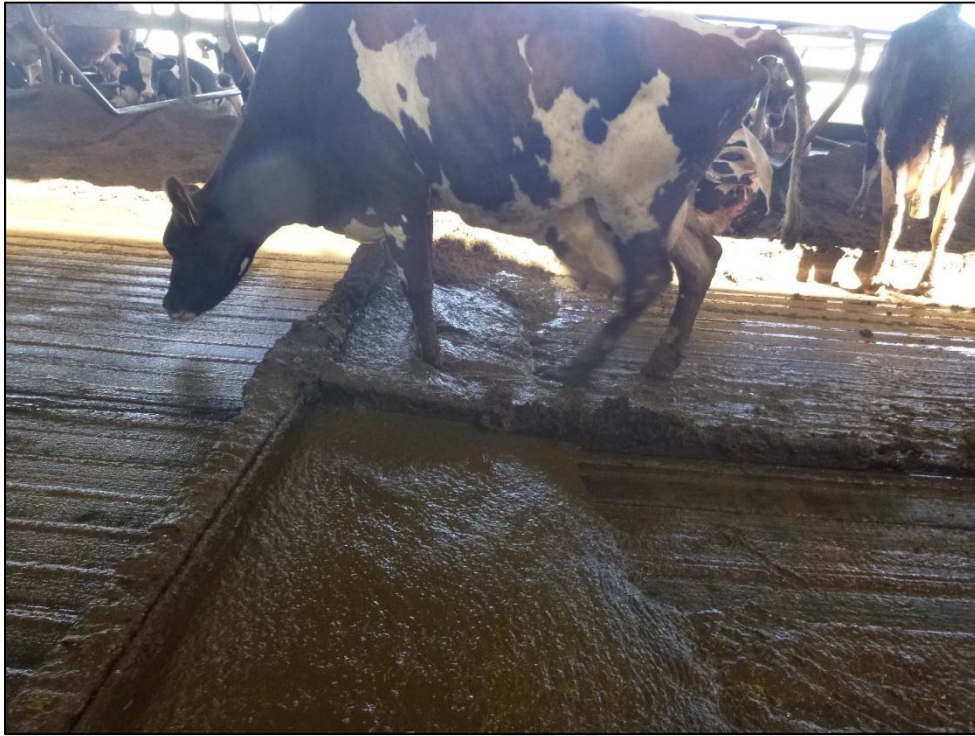
Photograph 7. Close-up view of the freestall barn manure scraping system in action. Photo by A. D'Angelo; 12/14/16.

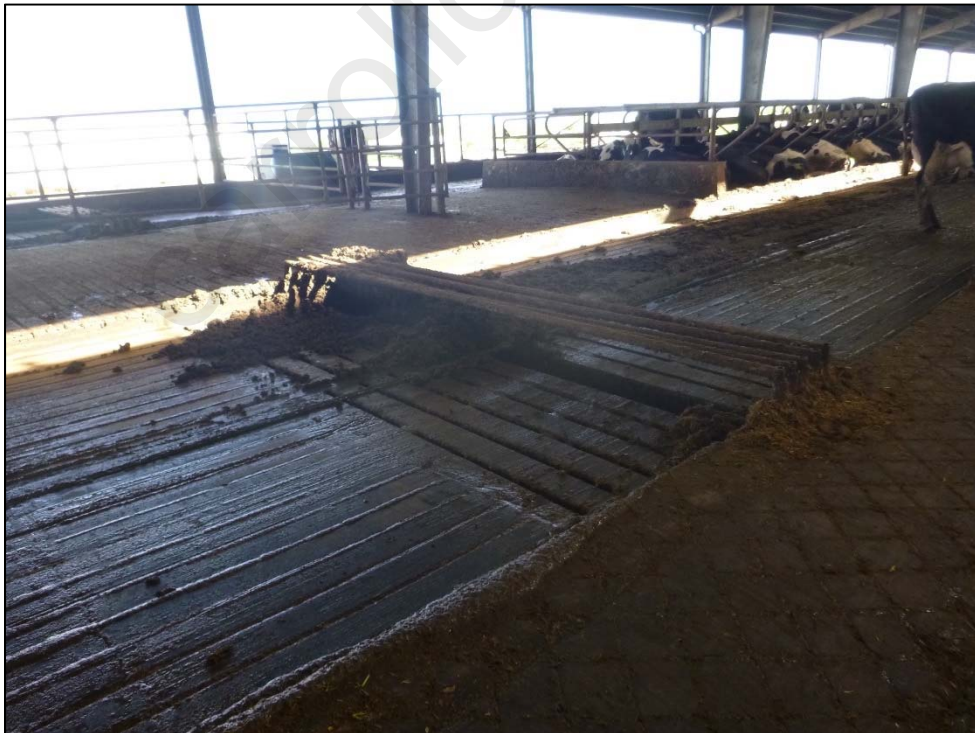
Photograph 8. View of the manure collection trough in the center of the lower freestall barn. The contents of the collection trough gravity flow into a collection pit located at the manure composting building, shown in Photographs 15 and 16. Photo by A. D'Angelo; 12/14/16.

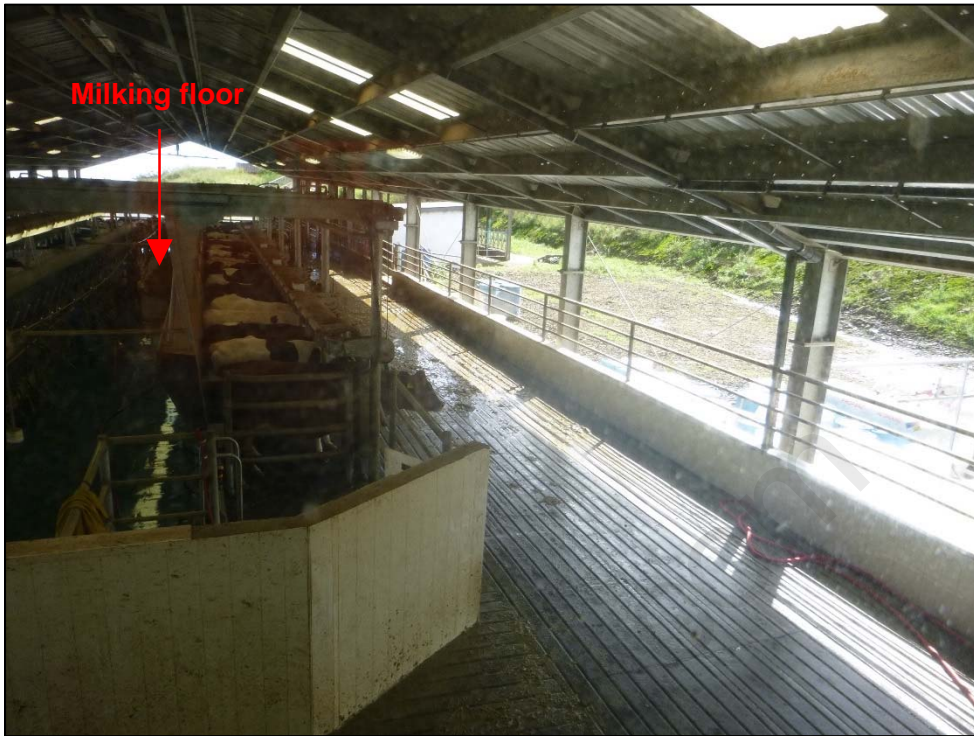
Photograph 9. View of the milking floor inside the Facility's recently constructed milking barn. Photo by A. D'Angelo; 12/14/16.

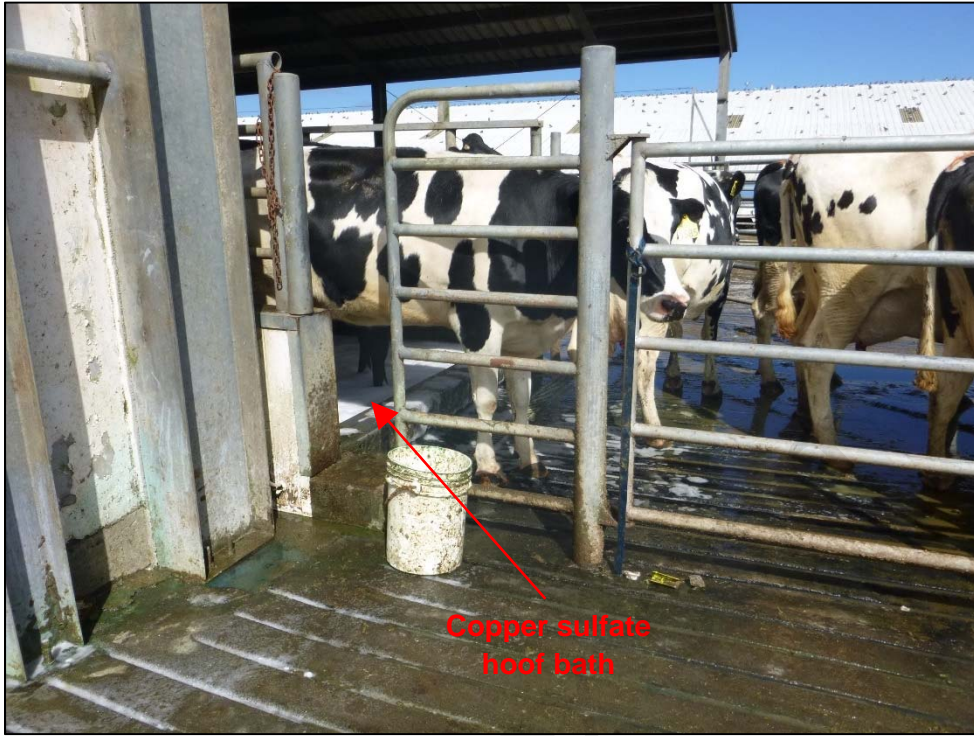
Photograph 11. View of the milking barn copper sulfate hoof bath. Photo by A. D'Angelo; 12/14/16.

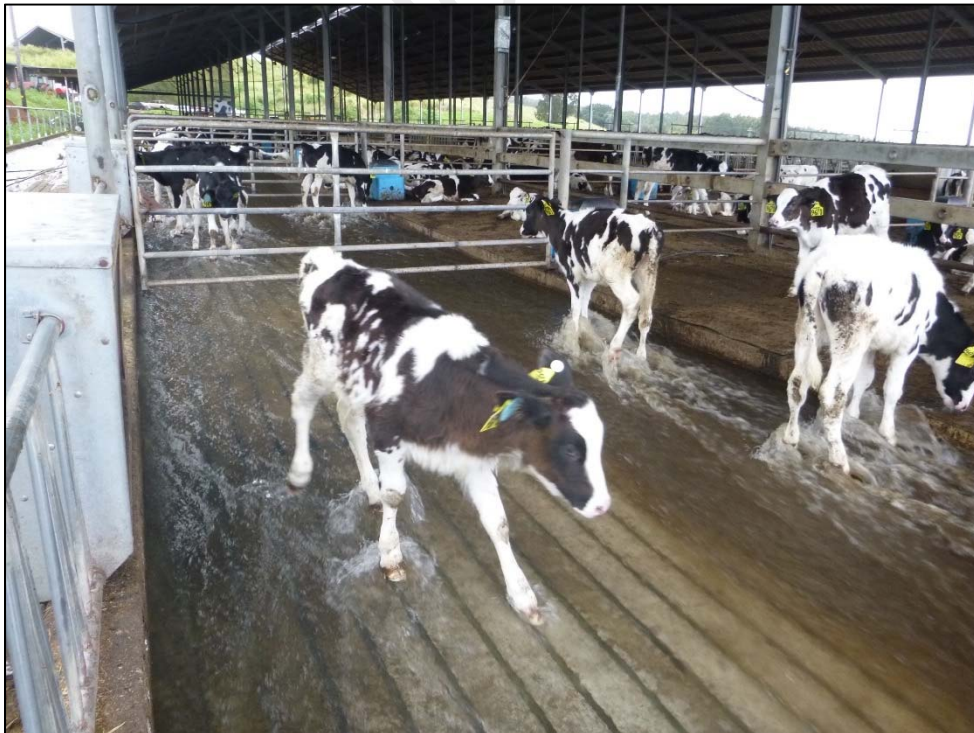
Photograph 12. View of active flushing occurring in the 380-head calf barn. Photo by A. D'Angelo; 12/14/16.

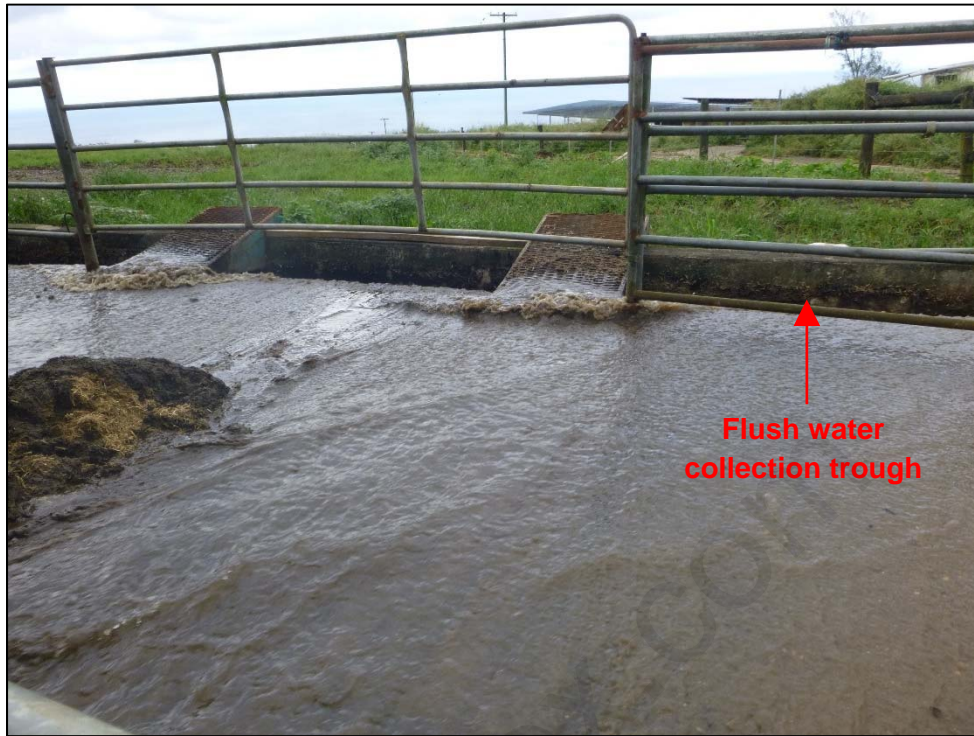
Photograph 13. Flush water from the 380-head calf barn is captured in a collection trough located at the end of the barn and conveyed to the manure composting building collection pit, shown in Photographs 15 and 16. Photo by A. D’Angelo; 12/14/16.

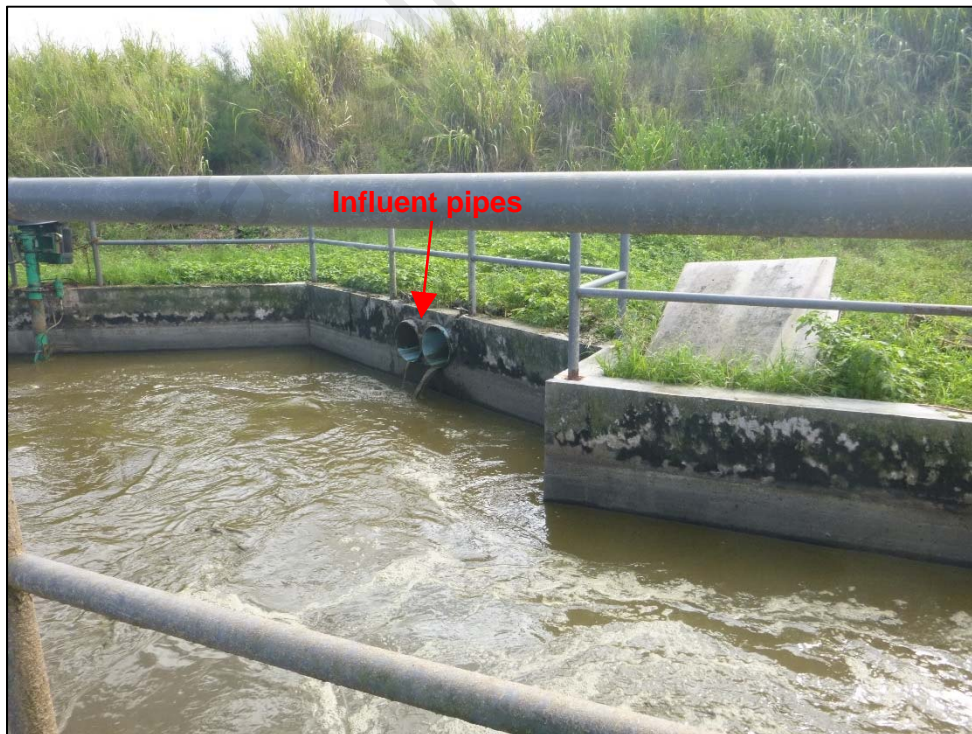
- Steep topography of the BID property, and
 - High annual rainfall amount.
3. During the inspection, I observed a potential for pollutants from the Facility's manure composting operations to contaminate storm water runoff. The manure composting building is located near the origin of Alaialoa Gulch (refer to Figure 3). Storm water runoff from the manure composting building, and uncovered concrete cow bedding loading area appears to most likely flow into the upgradient reach of Alaialoa Gulch. As previously stated, during the visit to the manure composting building, I observed a tractor actively loading a trailer with cow bedding (refer to Photographs 15 through 19, and 21).

Photograph 16. View of the manure composting building collection pit influent pipes. Photo by A. D'Angelo; 12/14/16.

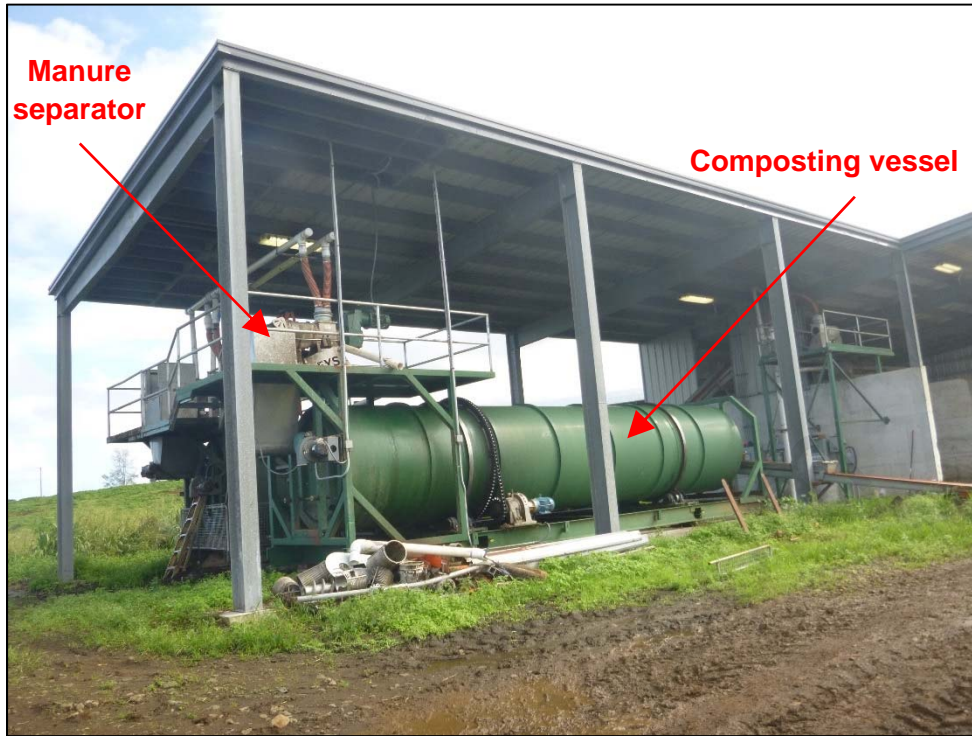
Photograph 17. View of the Facility's manure composting building which included two manure separator units, and two composting digester vessels. Photo by A. D'Angelo; 12/14/16.

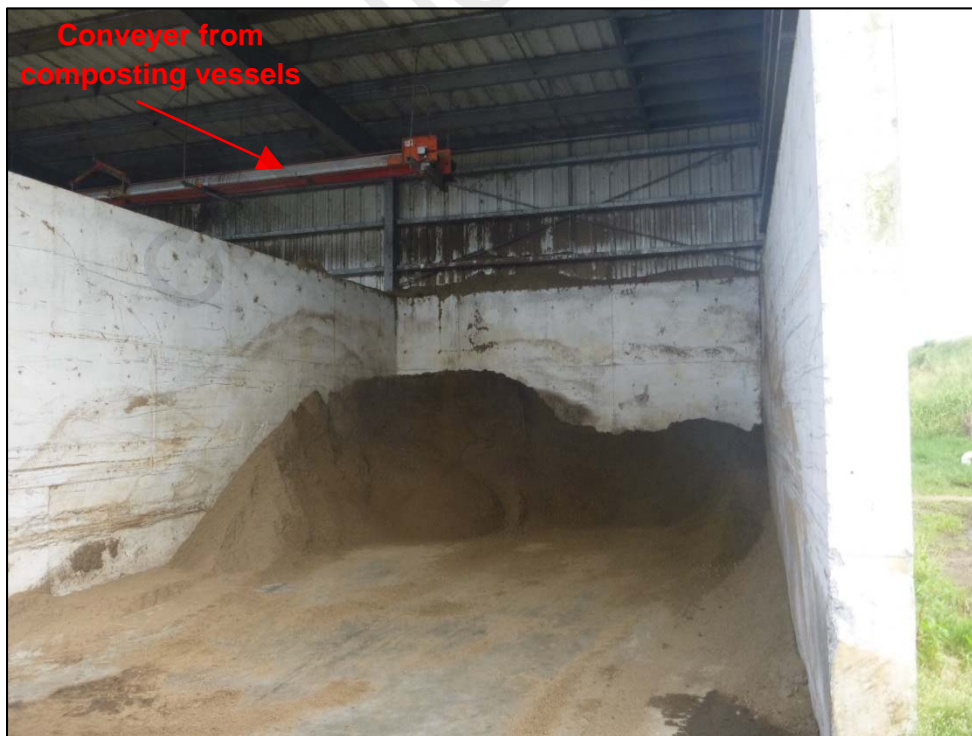
the vessels is then mechanically conveyed into a covered composted manure stockpile stall (refer to Photograph 18). During the visit to the manure composting building, I observed a tractor actively loading a trailer with cow bedding (refer to Photograph 19).

Photograph 18. A conveyor belt on the back end of the composting vessels conveys composted manure (i.e., cow bedding) into a covered stockpile stall. Photo by A. D'Angelo; 12/14/16.

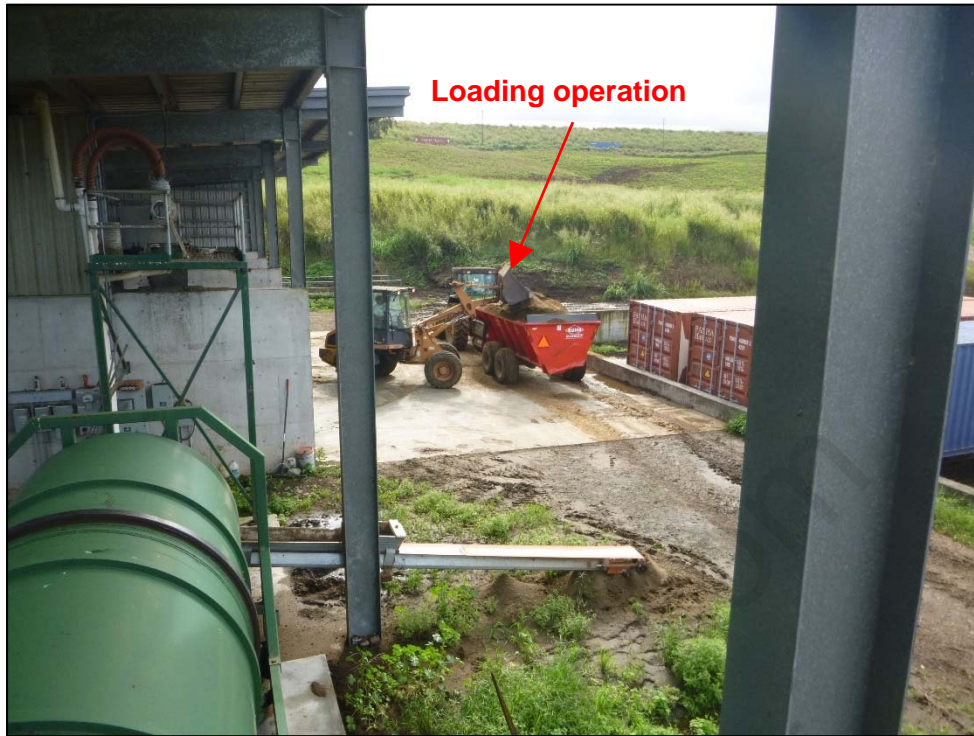
Photograph 19. View of BID staff actively loading cow bedding from the covered bedding stockpile stall into a trailer. Photo by A. D'Angelo; 12/14/16.

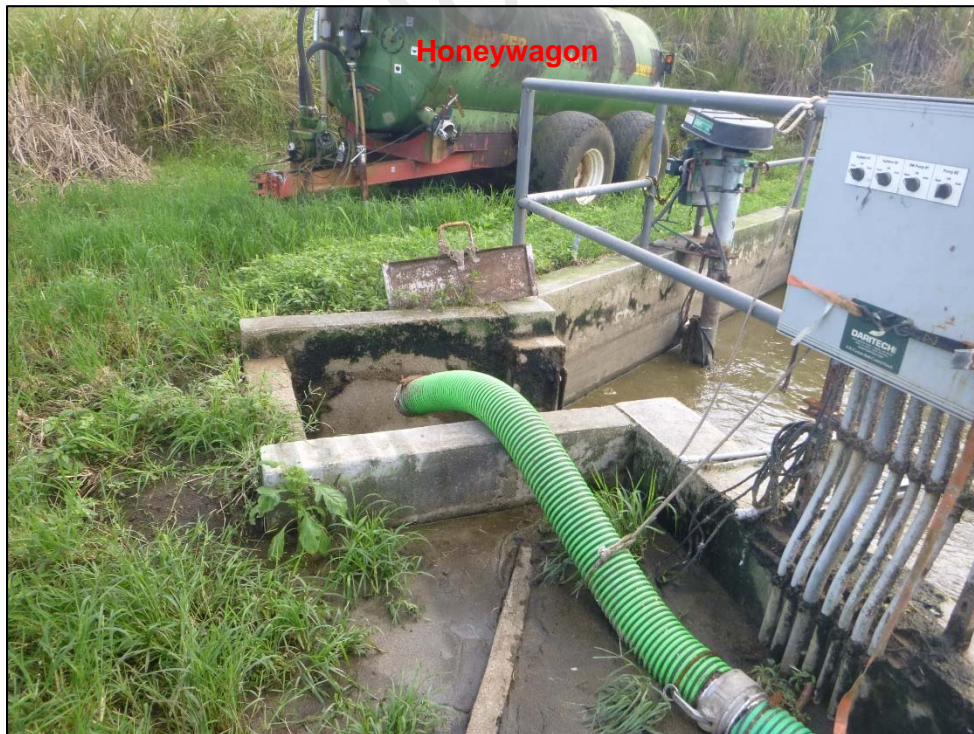
Photograph 20. View of the manure composting building collection pit overflow point. Overflow flows into the manure separation cells shown in Photographs 22 and 23. Note the honeywagon. Photo by A. D'Angelo; 12/14/16.

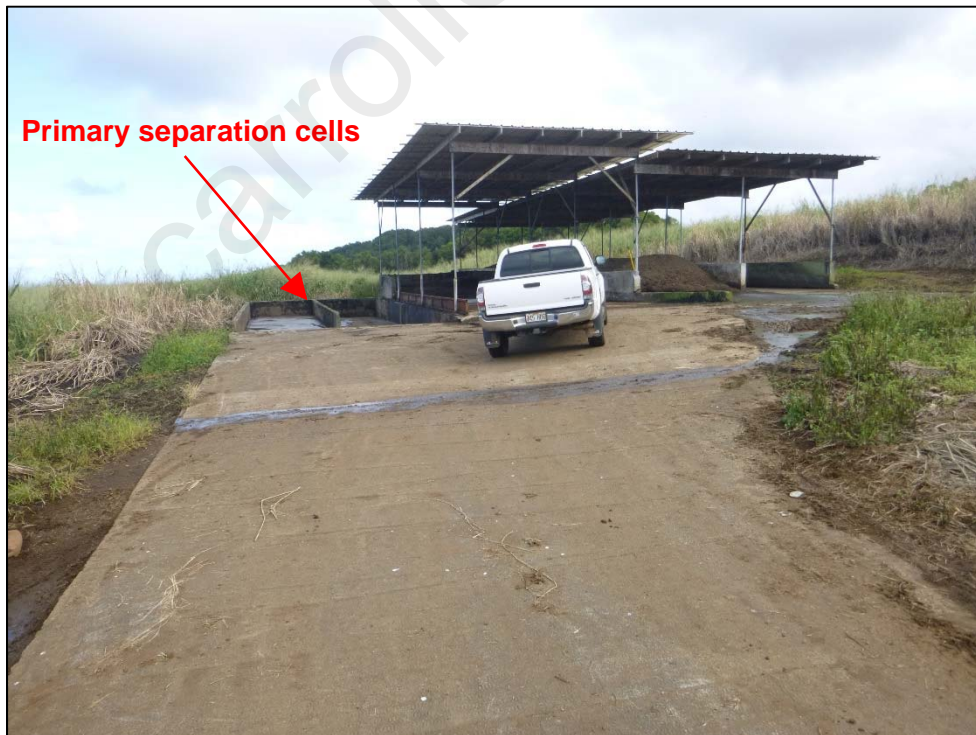
Photograph 22. View, facing east, of the Facility's manure solids separation cells located adjacent to the upper lagoon (refer to Figure 2). The uncovered cells on the left serve as the primary cells and liquid waste discharge points. Photo by A. D'Angelo; 12/14/16.

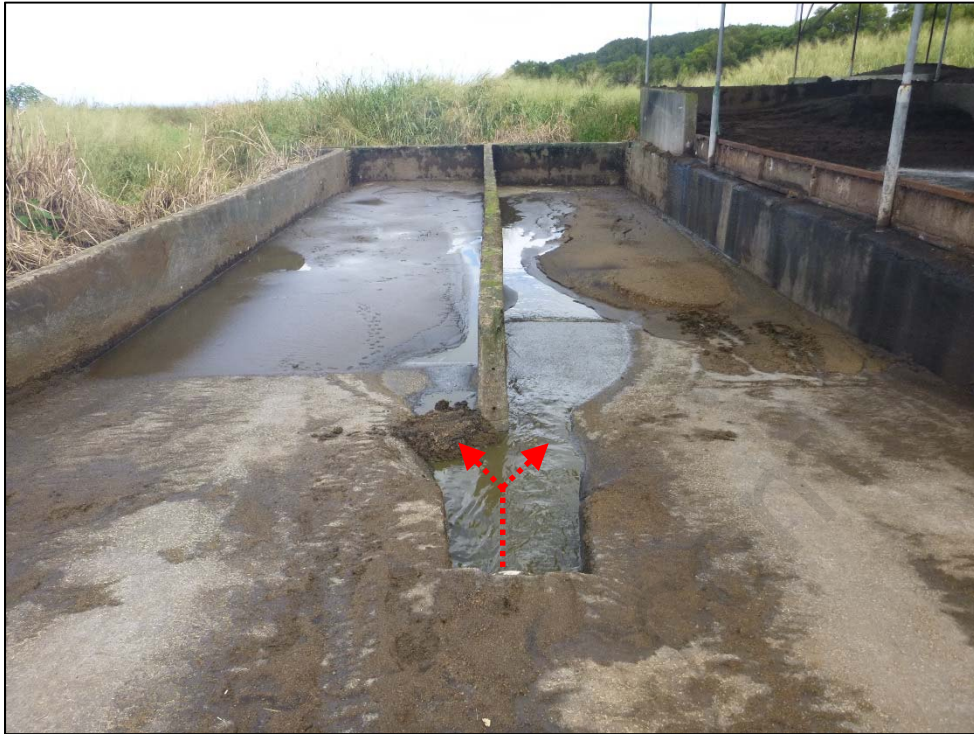
Photograph 23. View of flow from the manure composting collection pit entering the primary cells of the manure solids separation cells shown in Photograph 22. Photo by A. D'Angelo; 12/14/16.

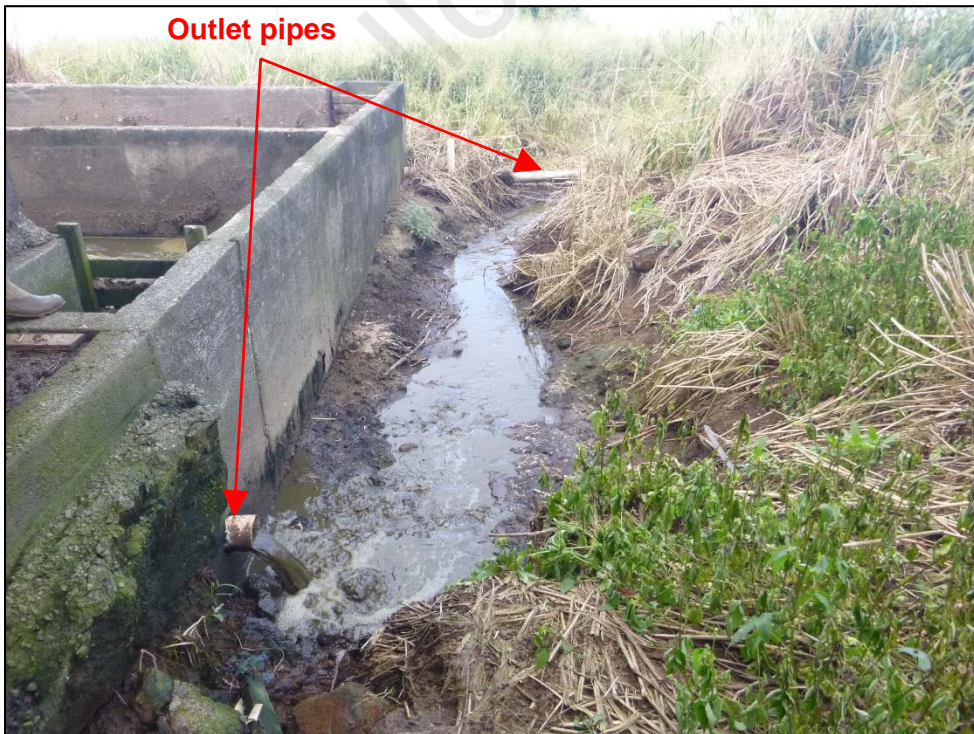
Photograph 24. View of the two pipes that drain separated liquid from the manure solids separation cells. Liquid from the cells surface flows, via an earthen conveyance channel, into the northwest side of the upper lagoon. Photo by A. D'Angelo; 12/14/16.

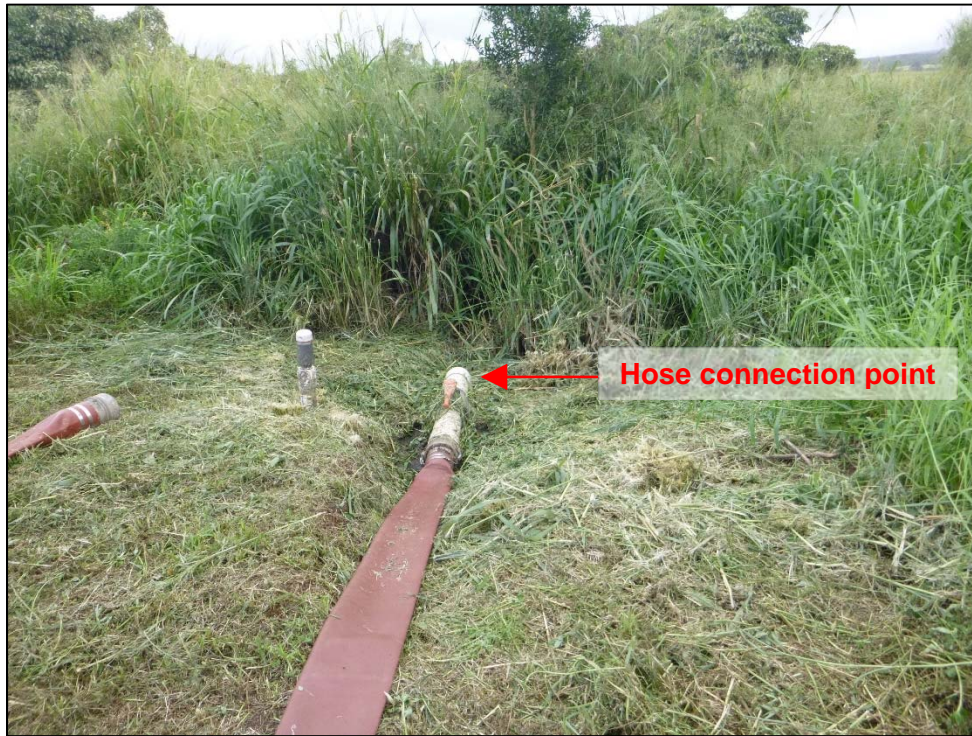
Photograph 29. View of the draw pumping system hose connection point to the Facility's irrigation system. Photo by A. D'Angelo; 12/14/16.

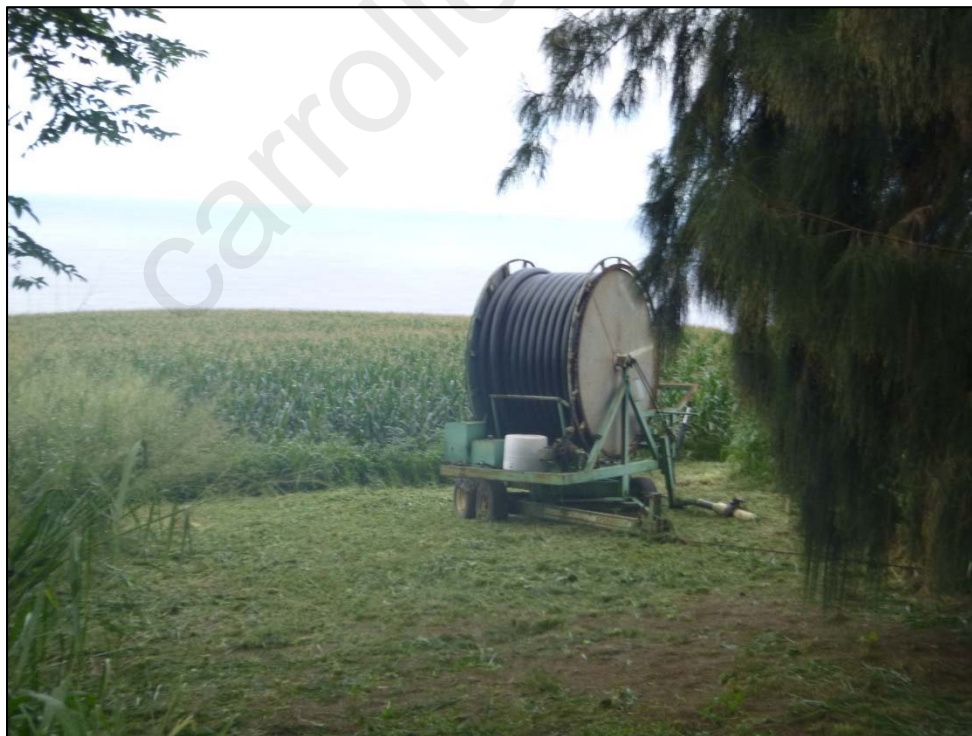
As previously stated, the contents of the lower lagoon are used to irrigate and fertilize the Facility's low elevation, high yielding croplands. Additionally, Mr. Duff stated that the manure solids separated from the manure separation cell system are directly land applied on croplands as additional fertilizer. During the Facility tour, we visited the lower croplands to view the airstrip heifer sheds, low elevation irrigated croplands, and one of the retractable irrigation sprinkle systems (refer to Photograph 30).

Photograph 30. View of one of the Facility's retractable irrigation distribution equipment which receives flow from the lower lagoon draw pumping system. Photo by A. D'Angelo; 12/14/16.
